INSPECTION REPORT  
Maple Grove Rd  
Boise ID 83709

INSPECTED BY  
Paul Duffau CCPIA  
601011  
Calibre Commercial  
Inspections, LLC

INSPECTION DATE  
📅 9/25/2024  
🕒 09:00 AM

20240925-Maple-Grove-Rd

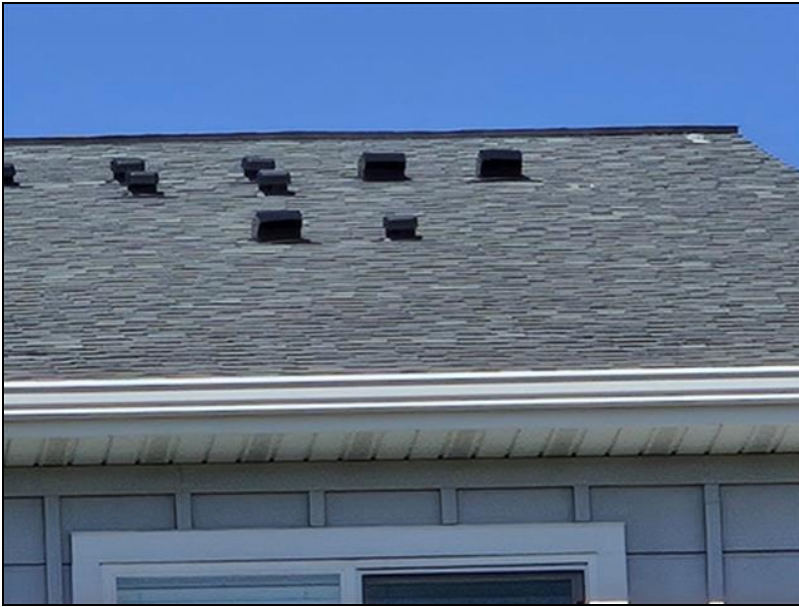
4.3 Item 1 (Picture)

The flashings for the boots for bathroom/dryer vents were lifting in multiple locations. This will lead to water intrusion. Recommend repair.

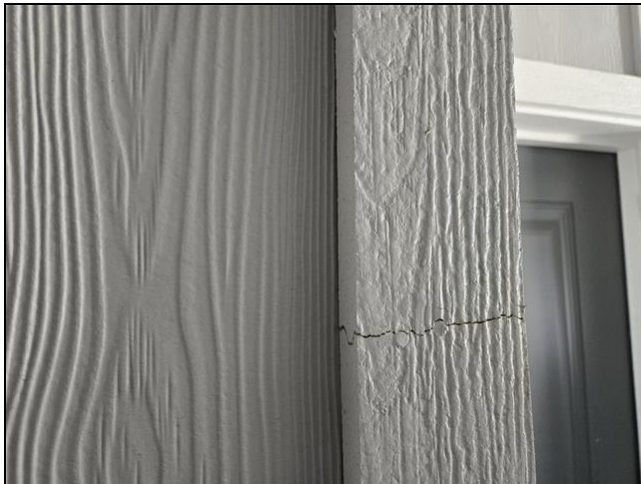
5.0 Item 1 (Picture)

(2) Cracking was noted on the battens where they were nailed. While not a structural component, these cracks should be sealed against potential water intrusion, especially where exposed to weather.

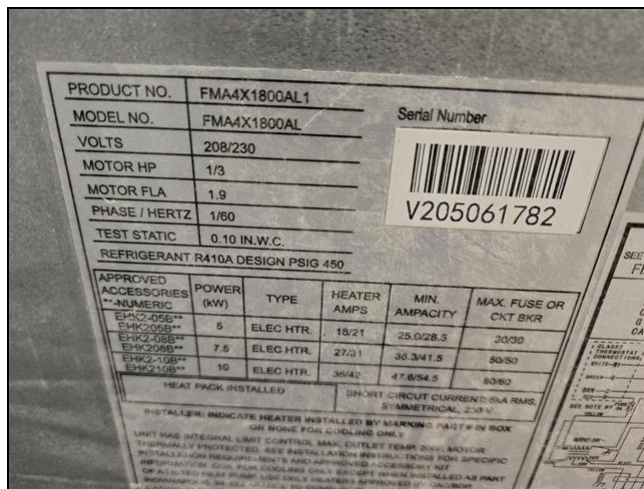
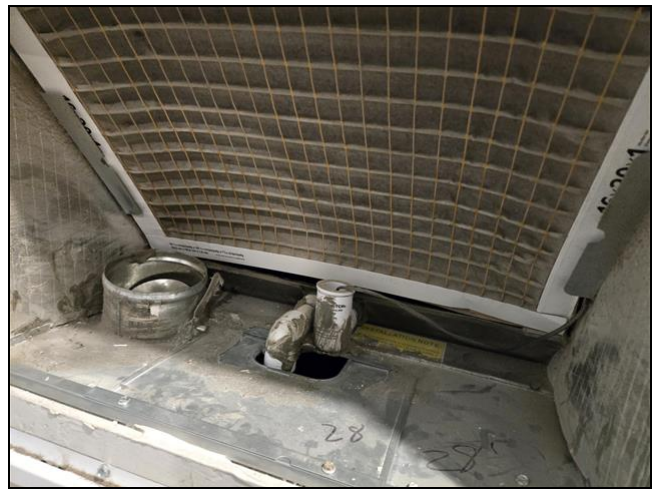
Based on available records, inspections stickers, or the lack thereof, and a number of very dirty filters, routine maintenance appears to be overdue. Recommend maintenance for this unit at this time.

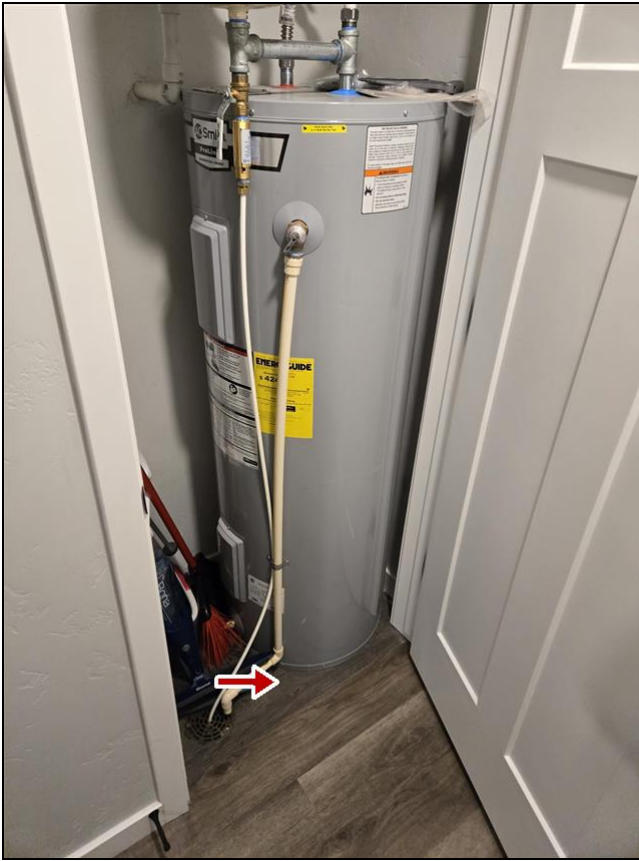
7.3 Item 3 (Picture)

(2) The water temperature in Unit 109 was 135 degrees. This is a scalding temperature. Recommend reducing temperature to prevent injury and limit liability.

(3) A drip pan was missing under the water heater in Unit 102. Recommend installing to prevent possible damage in the event the tank leaks.

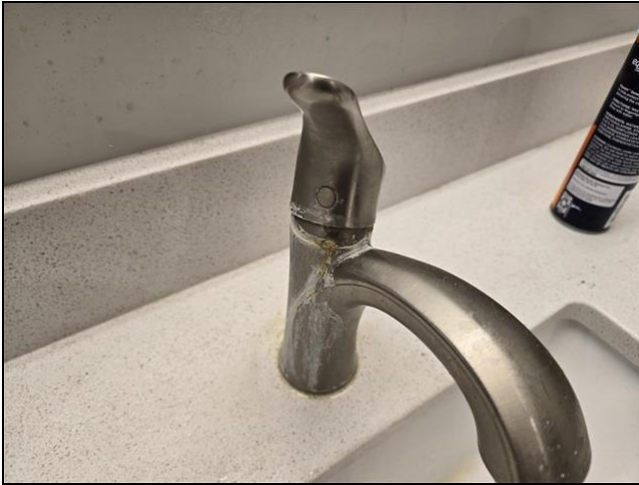
8.4 Item 1 (Picture)

- (1) Slow drains noted in Units: 202 (main bathroom); Unit 205, Unit 305. Recommend routine maintenance.
- (2) The tub in the main bathroom of Unit 202 was in use as part of a cat litter box system. Not tested.
- (3) Shower head leaks at the connection of the shower head to the supply pipe noted in: Unit 109

- (4) A leaking faucet noted at Unit 305. Recommend repair.

Recommend repair.

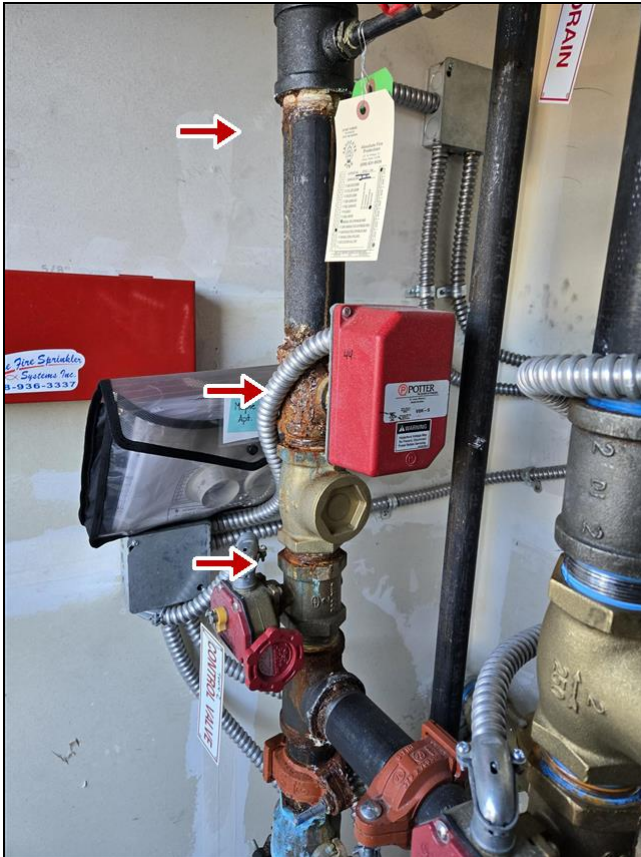
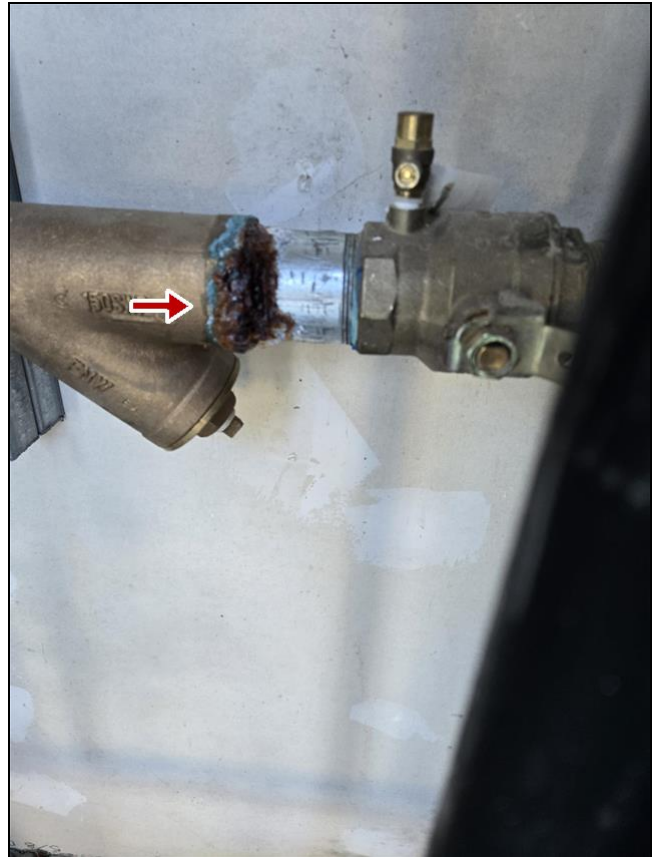
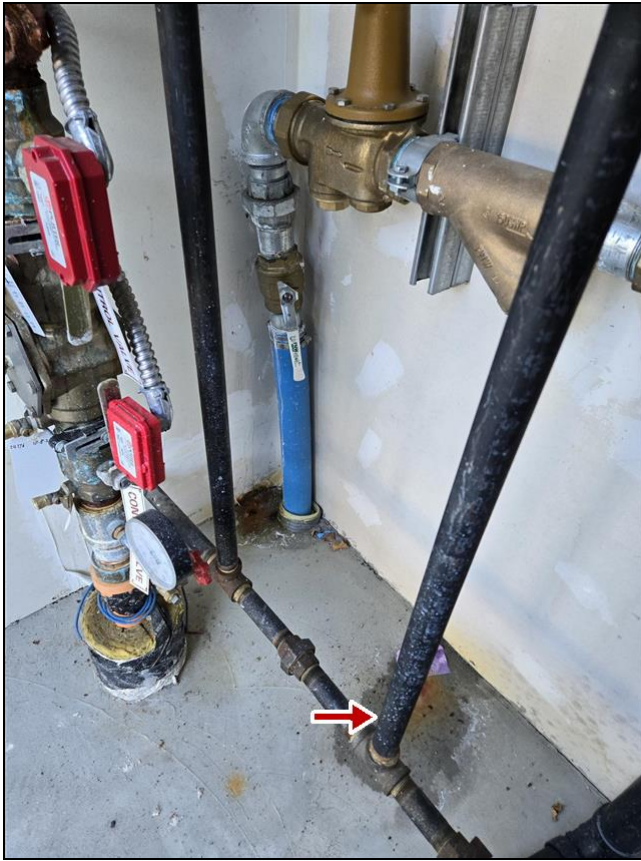
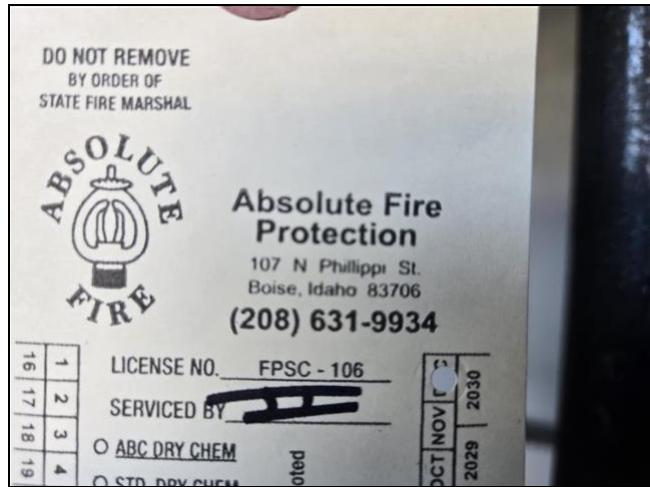
A fire suppression system was installed. Significant rust and active leaking were noted on the system during the inspection. This is highly unusual in a system that is only several years old.

Recommend inspection and repair of the entire system. The last inspection was conducted by Absolute Fire Protection of Boise.

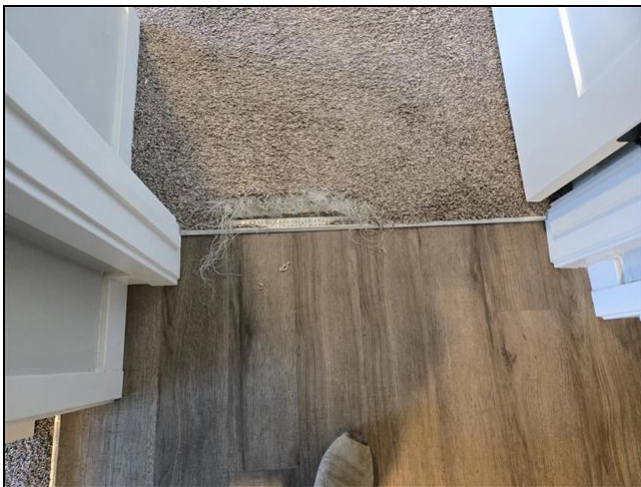
11.2 Item 1 (Picture)

Carpet damage was noted in Unit 202 and 304 from pets.

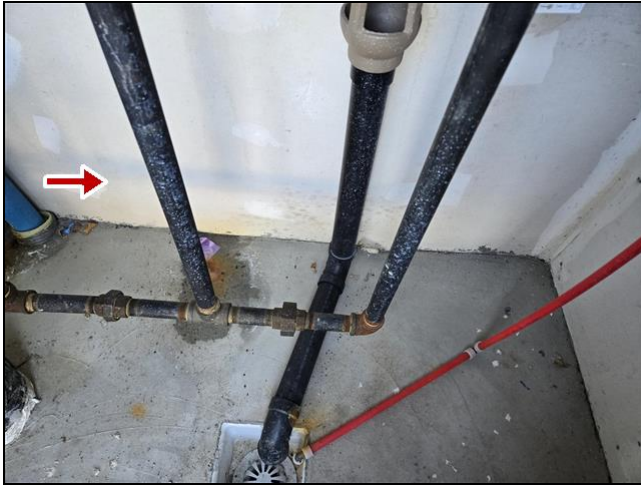
12.0 Item 1 (Picture)

Signs of fungi growth are present on the wall(s) of the FACP room. We did not inspect, test or determine if this growth is or is not a health hazard. The underlying cause is moisture or dampness. I recommend correction to meet [EPA standards](#). Recommend all work be completed by a licensed and qualified contractor.

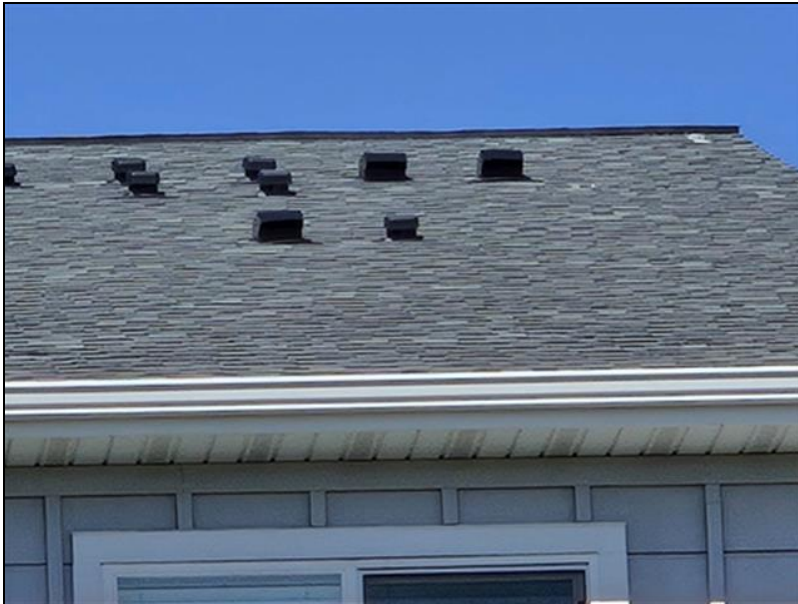
4.3 Item 1 (Picture)

The flashings for the boots for bathroom/dryer vents were lifting in multiple locations. This will lead to water intrusion. Recommend repair.

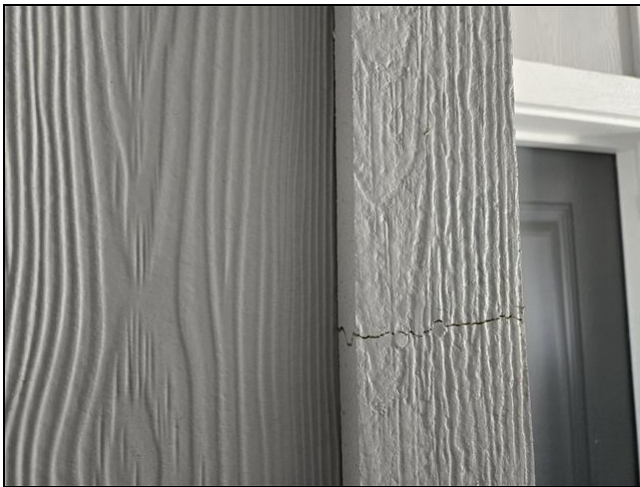
5.0 Item 1 (Picture)

(2) Cracking was noted on the battens where they were nailed. While not a structural component, these cracks should be sealed against potential water intrusion, especially where exposed to weather.

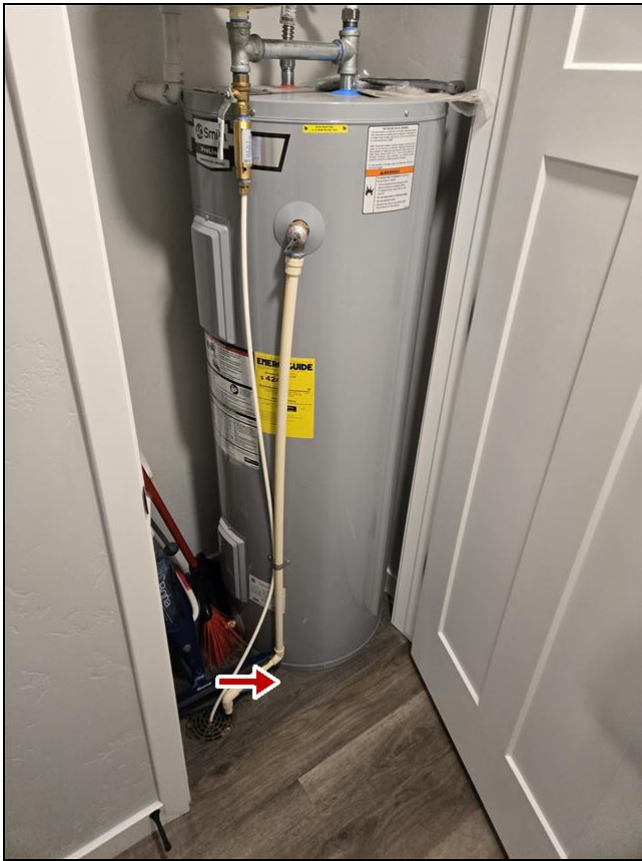
7.3 Item 3 (Picture)

(2) The water temperature in Unit 109 was 135 degrees. This is a scalding temperature. Recommend reducing temperature to prevent injury and limit liability.

(3) A drip pan was missing under the water heater in Unit 102. Recommend installing to prevent possible damage in the event the tank leaks.

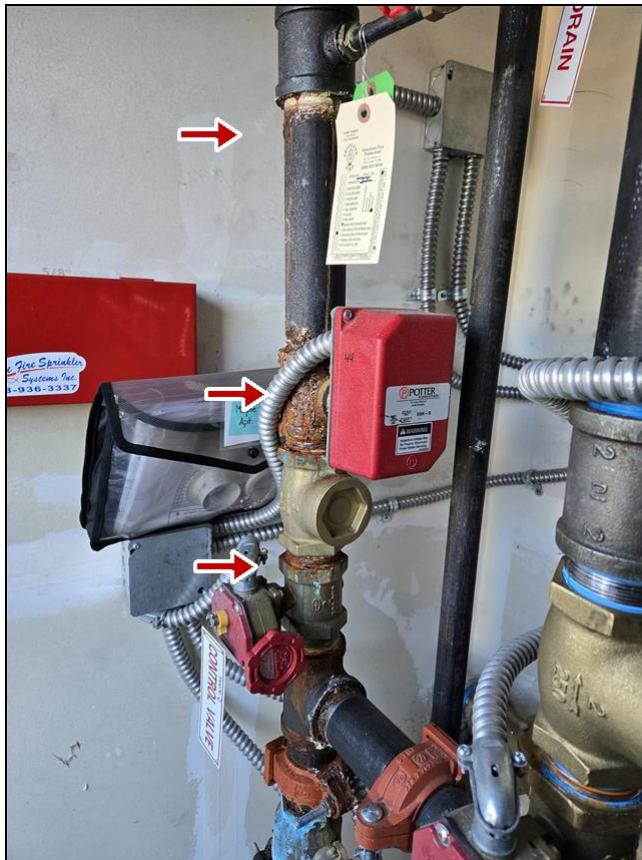
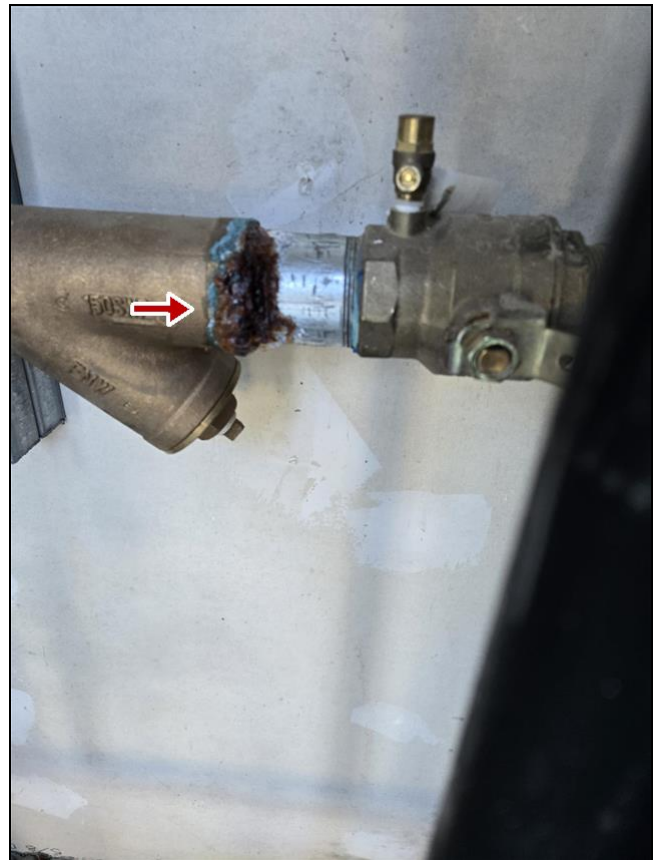
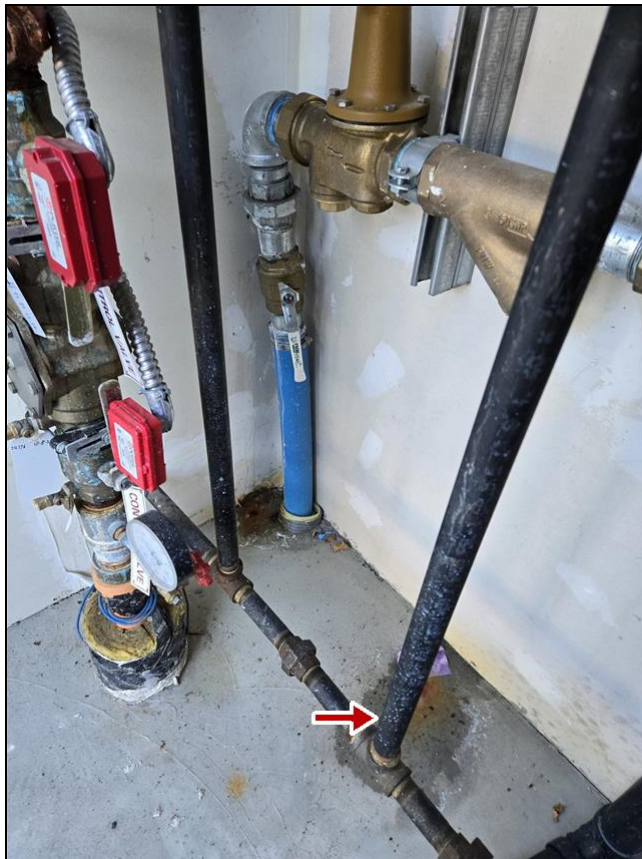
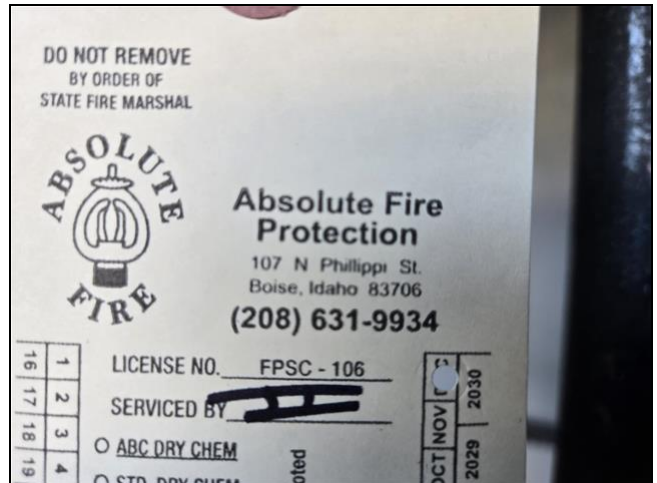
A fire suppression system was installed. Significant rust and active leaking were noted on the system during the inspection. This is highly unusual in a system that is only several years old.

Recommend inspection and repair of the entire system. The last inspection was conducted by Absolute Fire Protection of Boise.

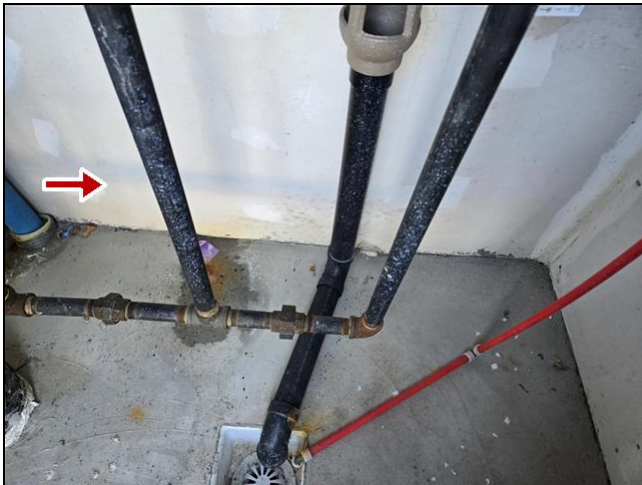
12.0 Item 1 (Picture)

Signs of fungi growth are present on the wall(s) of the FACP room. We did not inspect, test or determine if this growth is or is not a health hazard. The underlying cause is moisture or dampness. I recommend correction to meet [EPA standards](#). Recommend all work be completed by a licensed and qualified contractor.
