INSPECTION REPORT  
1736 S Broadway Ave  
Boise ID 83706

INSPECTED BY  
Paul Duffau CCPIA  
001011  
Calibre Commercial  
Inspections, LLC

INSPECTION DATE  
📅 9/3/2025  
🕒 08:25 AM

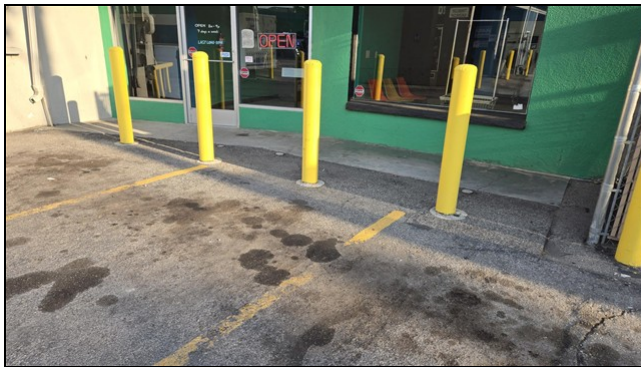
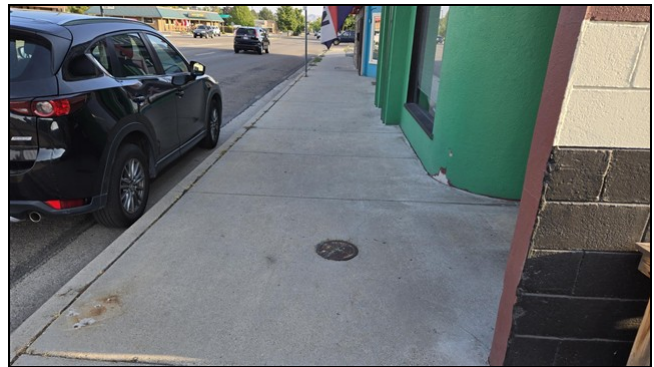
The asphalt surface in several locations was damaged as evident by localized alligator cracking suggesting a localized structural failure of the surface and possibly the subsurface structure..The asphalt surface is due for seal-coating. Recommend evaluation by a licensed and qualified paving contractor to determine the full scope of the necessary work.

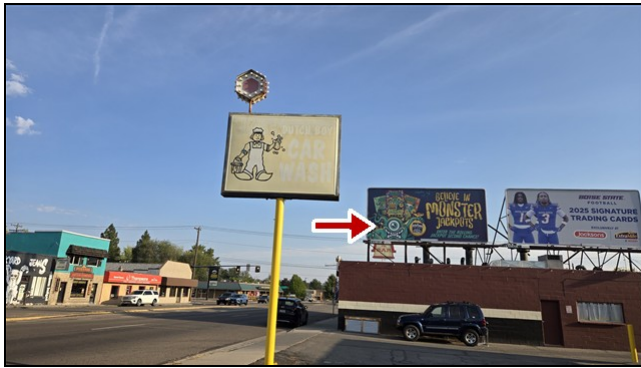
3.9 Item 1 (Picture)

(1) There were two billboards located on the roof. Recommend gathering information from the owner regarding the income derived from these.

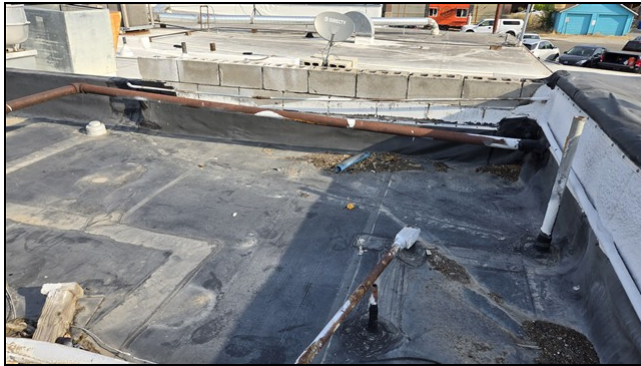
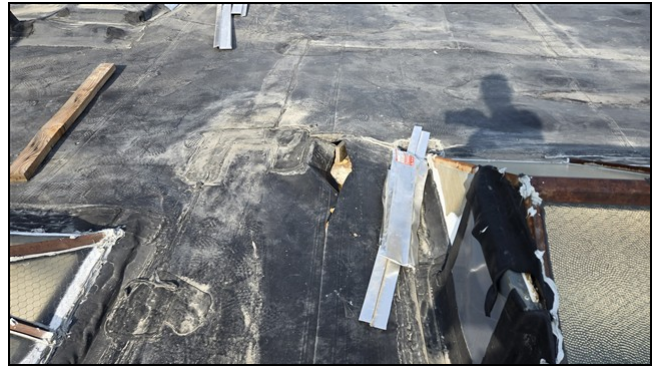
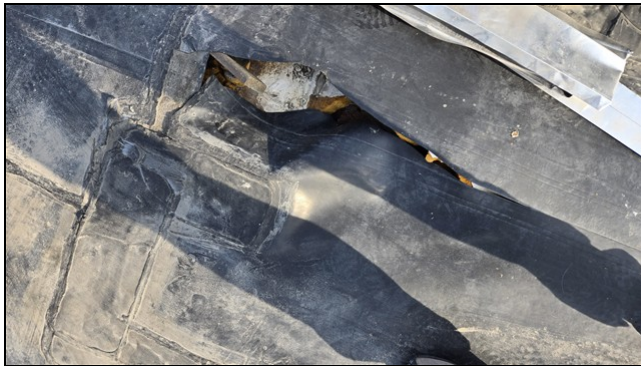
(3) The majority of the EPDM roof has failed with substantial openings in the surface.

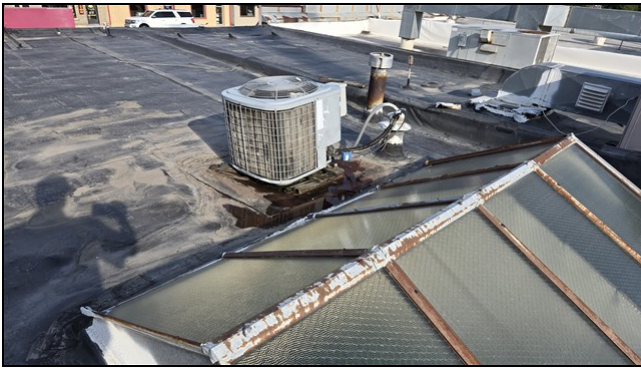
4.9 Item 1 (Picture)

Skylights are an older style with wired safety glass. Several panes of glass are broken. Wire safety glasses no longer recommended in areas where glass can become broken in a hazard. Recommend replacing with tempered glass.

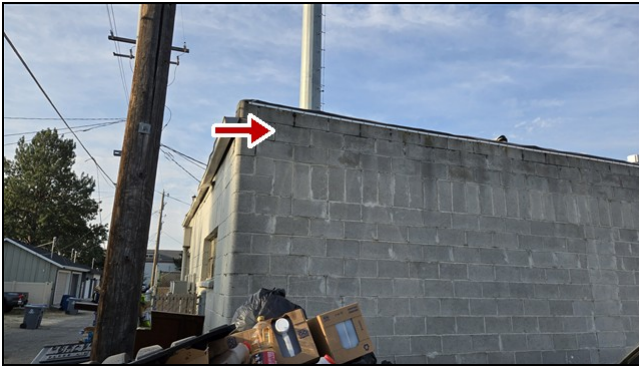
5.0 Item 1 (Picture)

- (1) The exterior wall covering materials included masonry block and stucco.
- (2) Substantial cracking with missing mortar noted at the northeast corner of the building.

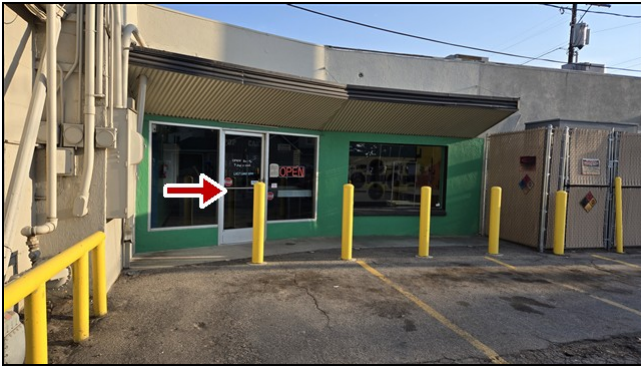
5.3 Item 1 (Picture)

- (1) Entrance doors (also used for emergency egress) should open to the outside to facilitate evacuation in an emergency. Doors on this structure opened inward, instead. This is a safety hazard.

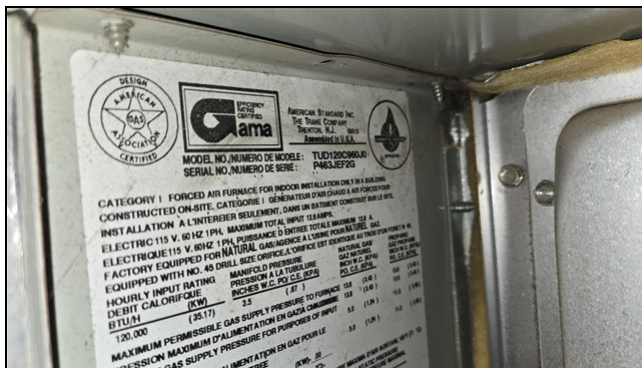
7.0 Item 1 (Picture)

Based on available records, inspections stickers, or the lack thereof, routine maintenance appears to be overdue. Recommend maintenance for this unit at this time.

This piece of equipment is beyond a normal service life. Recommend replacement..

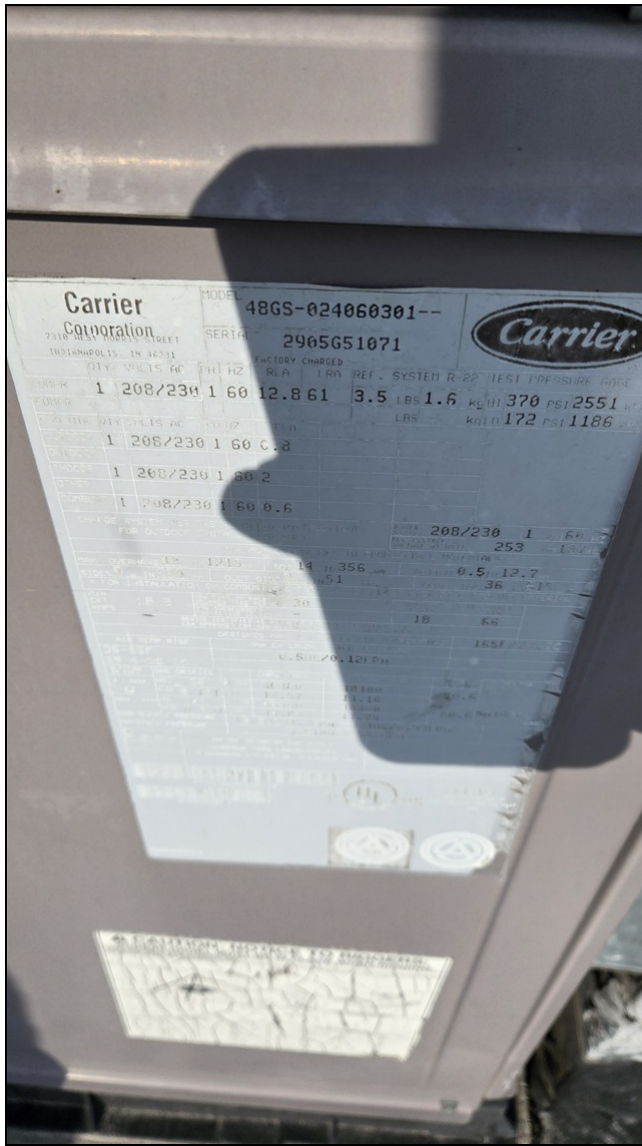
#### 7.0 Item 2 (Picture)

(4) The first rooftop unit was manufactured by Carrier and was 20 years old. It delivered 60,000 BTUs of heating capacity and 2 tons of cooling capacity.

Based on available records, inspections stickers, or the lack thereof, routine maintenance appears to be overdue. Recommend maintenance for this unit at this time.

This piece of equipment is at the end of a normal service life. Recommend continuing with routine maintenance and developing cash reserves for eventual replacement..

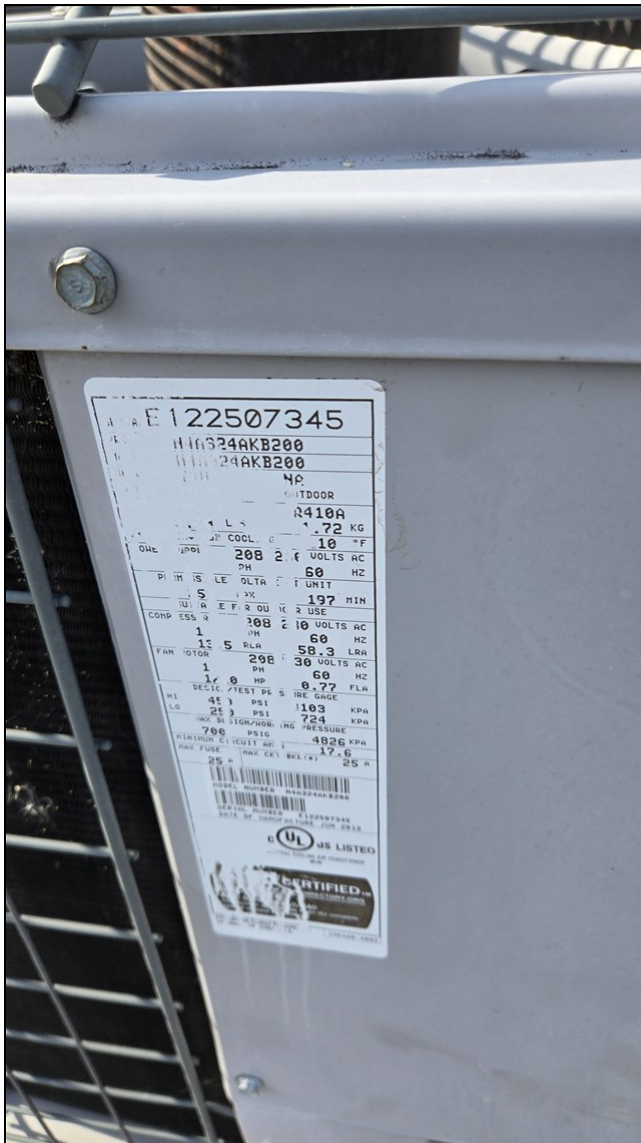
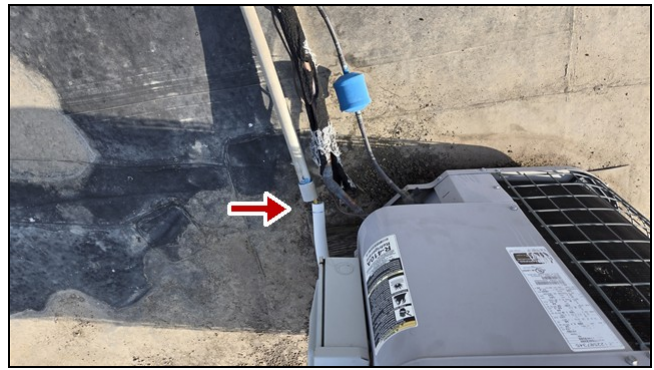
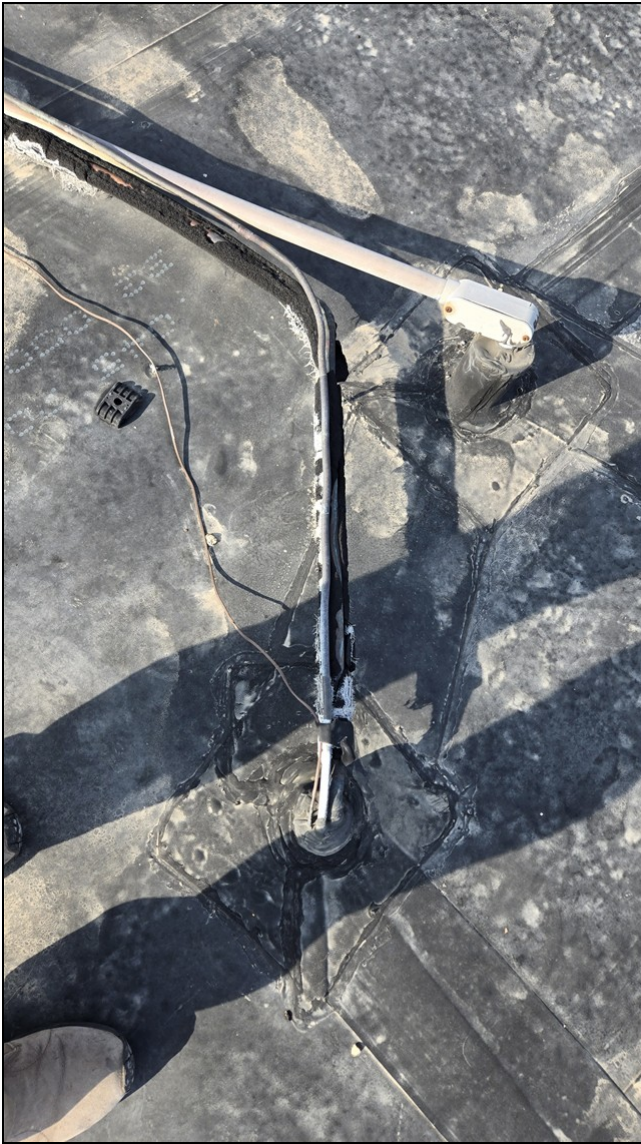
(2) The first air conditioner was manufactured by Carrier and was 1 years old. The unit was rated at 2 tons of cooling capacity.

The line sets for this unit appeared to be reused. Insulation was missing. The electrical conduit is damaged.

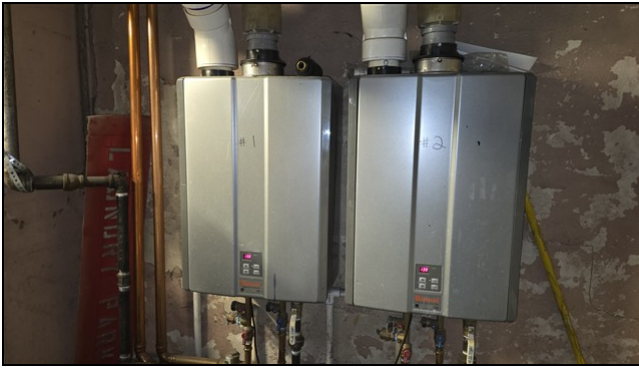
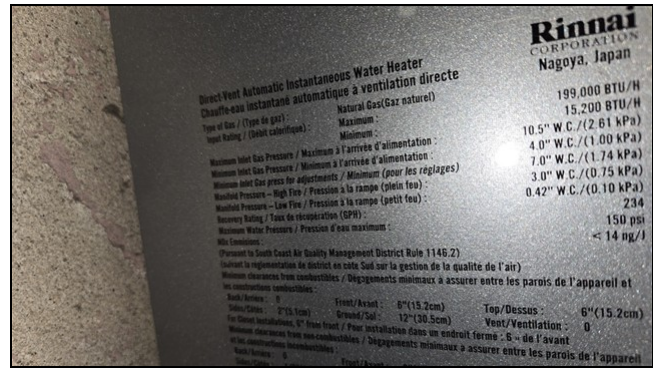
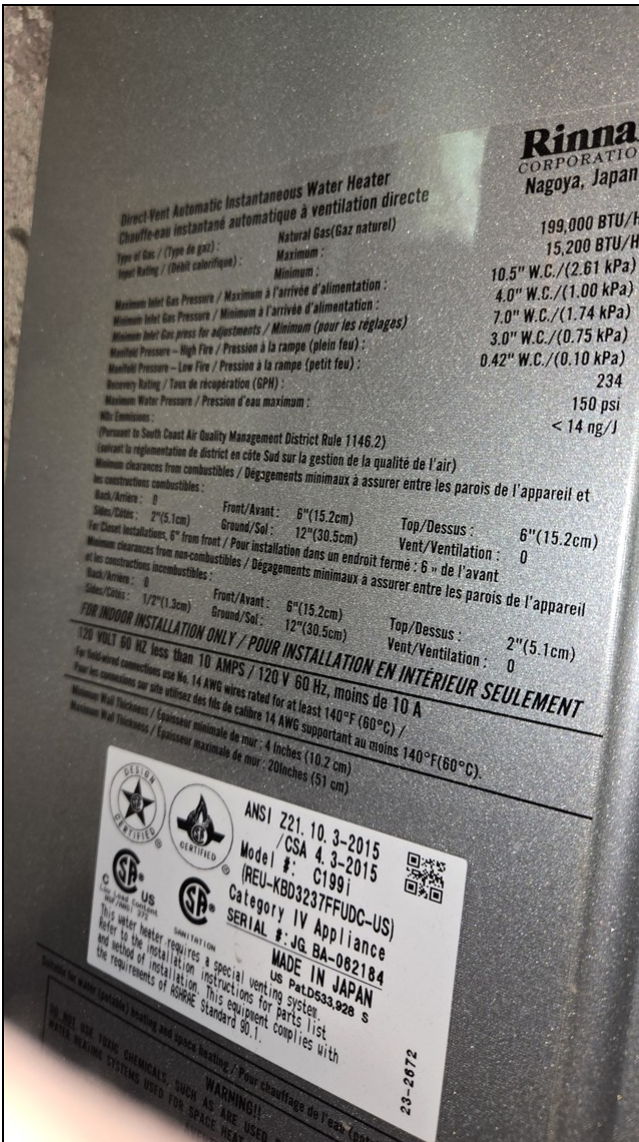
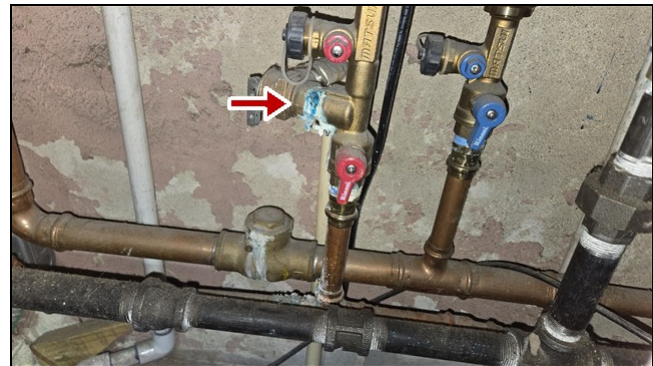
- (1) Three water heaters were noted. Two were on-demand gas-fired heaters while one was a tank heater.
- (2) The two on-demand water heaters were manufactured by Rinnai and appeared to be approximately 10 years old.

This piece of equipment is at the end of a normal service life. Recommend continuing with routine maintenance and developing cash reserves for eventual replacement..

One of the heaters was leaking at the temperature pressure relief valve.

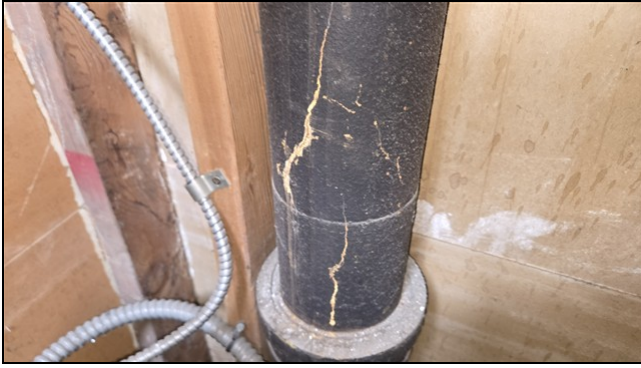
8.2 Item 3 (Picture)

(2) The vent stack in the front of the building is cracked. This will lead to the release of sewer gases.

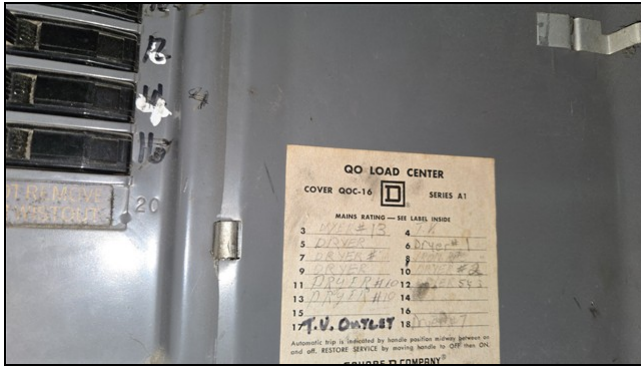
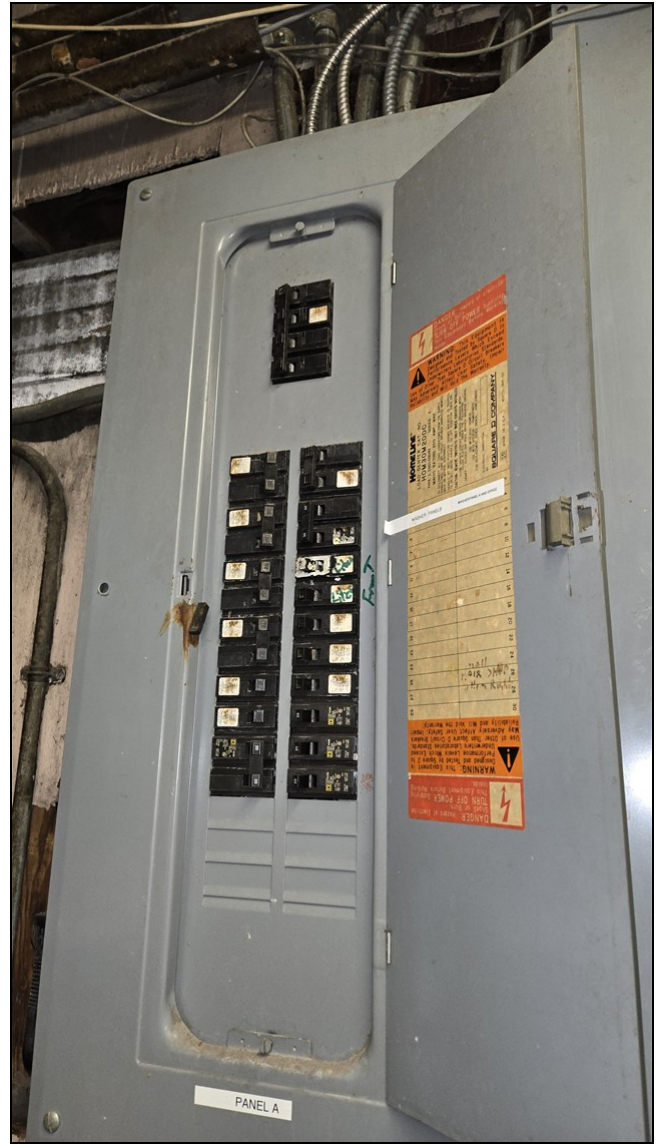
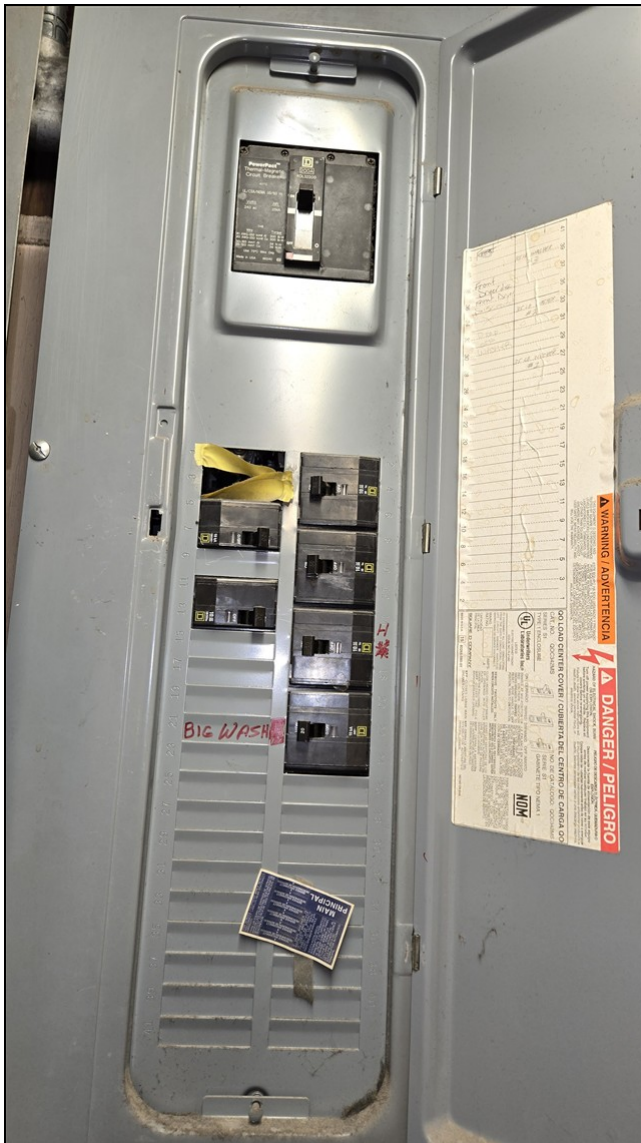
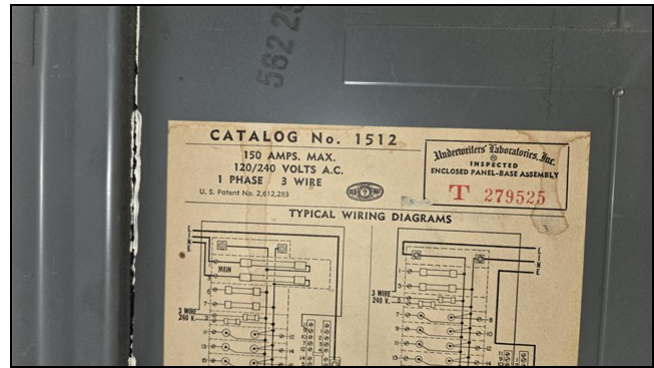
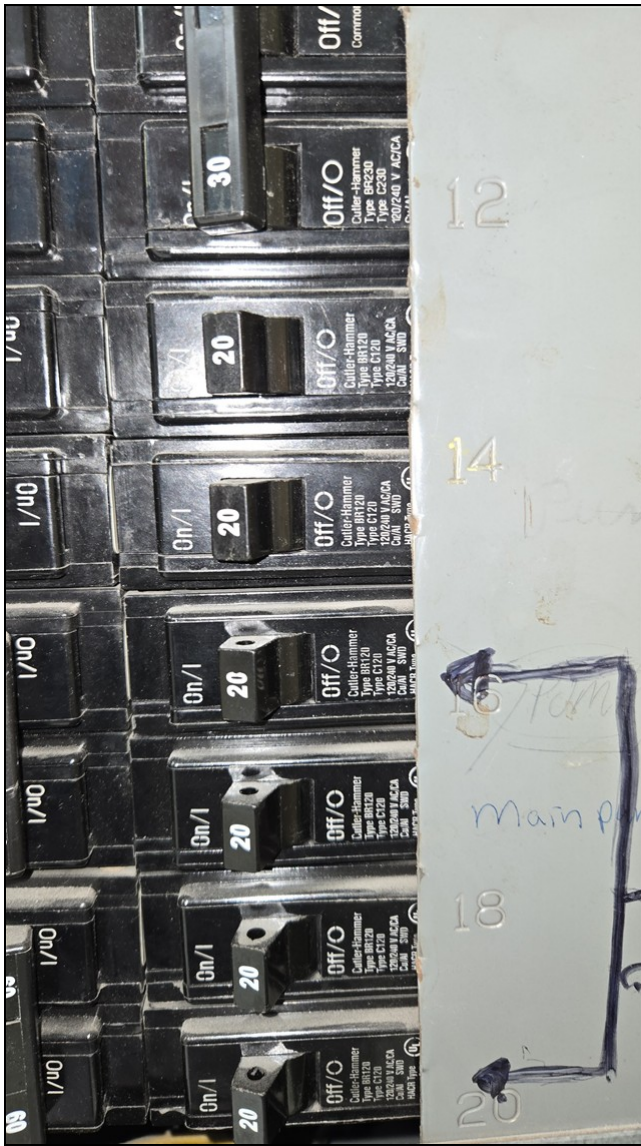
(1) A total of seven panels were observed. Covers were removed from several. Data plates were missing on several panels. In one case, the panel data plate did not match the manufacturer. One panel was not accessible as it was in a locked room and observed from a distance over a wall.

Panels were manufactured by Cutler-Hammer, Square D, and (estimated) ITE. Ratings, where visible, ranged from 125 amps to 200 amps with several panels having 3 phase wiring.

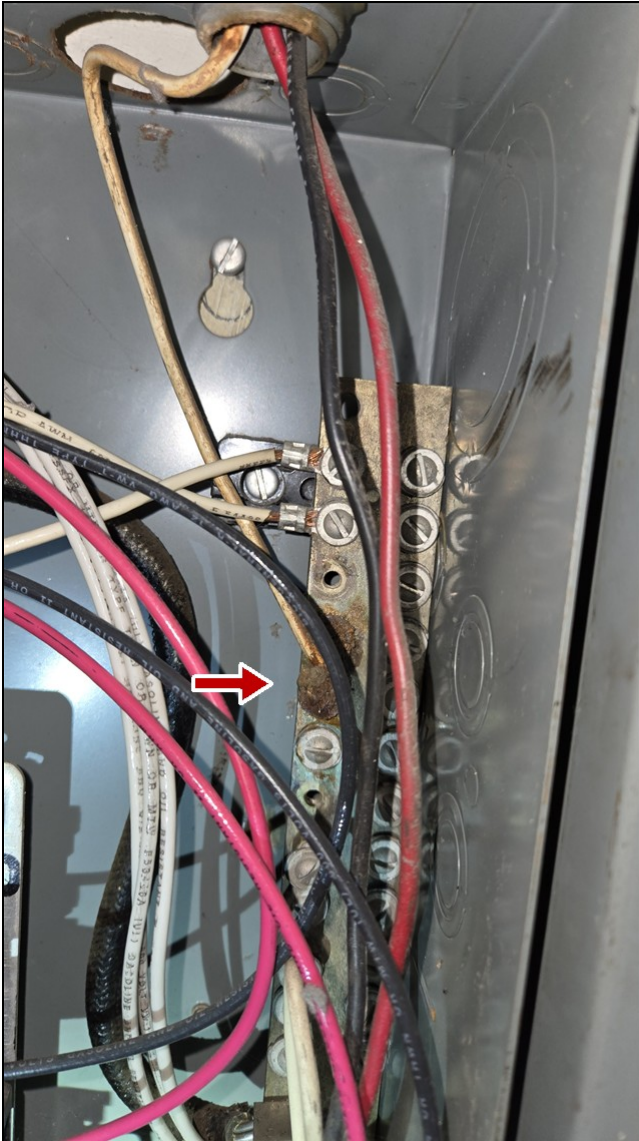
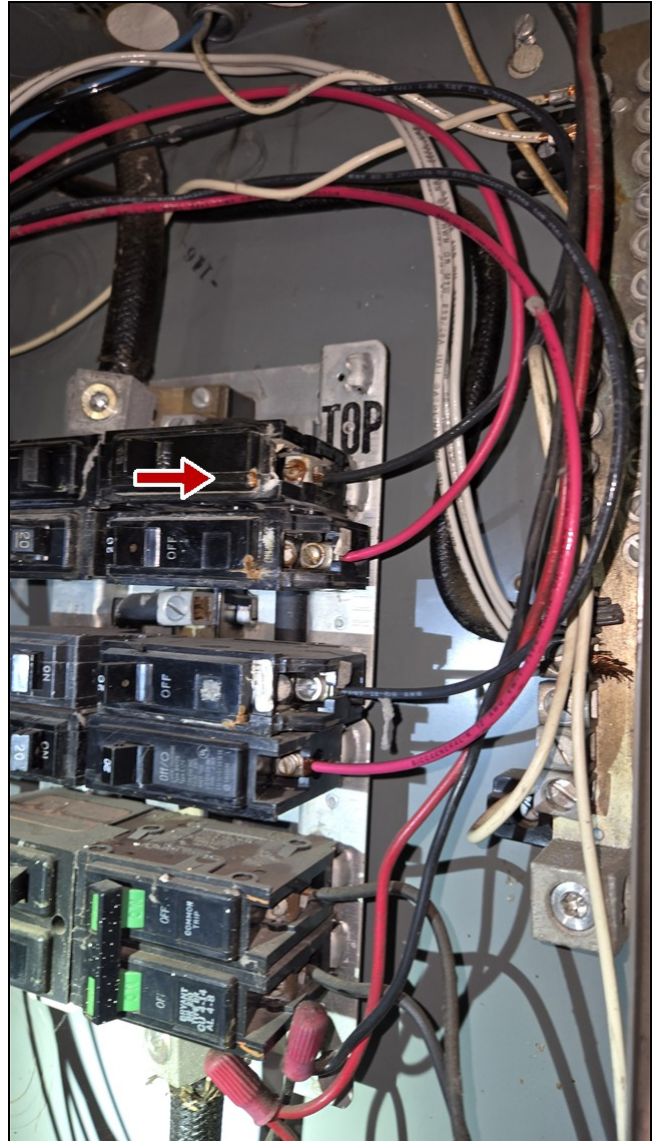
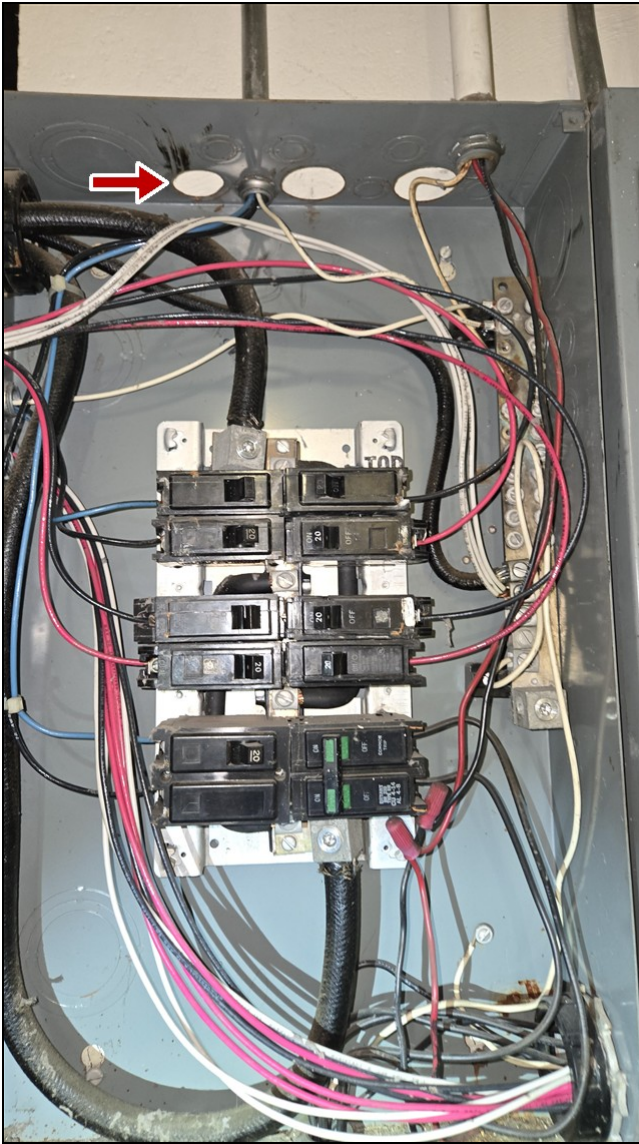
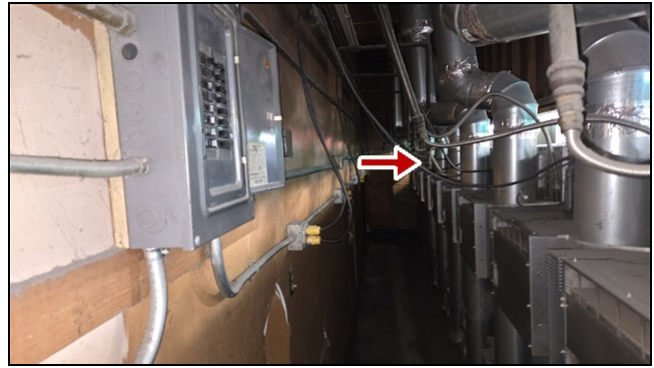
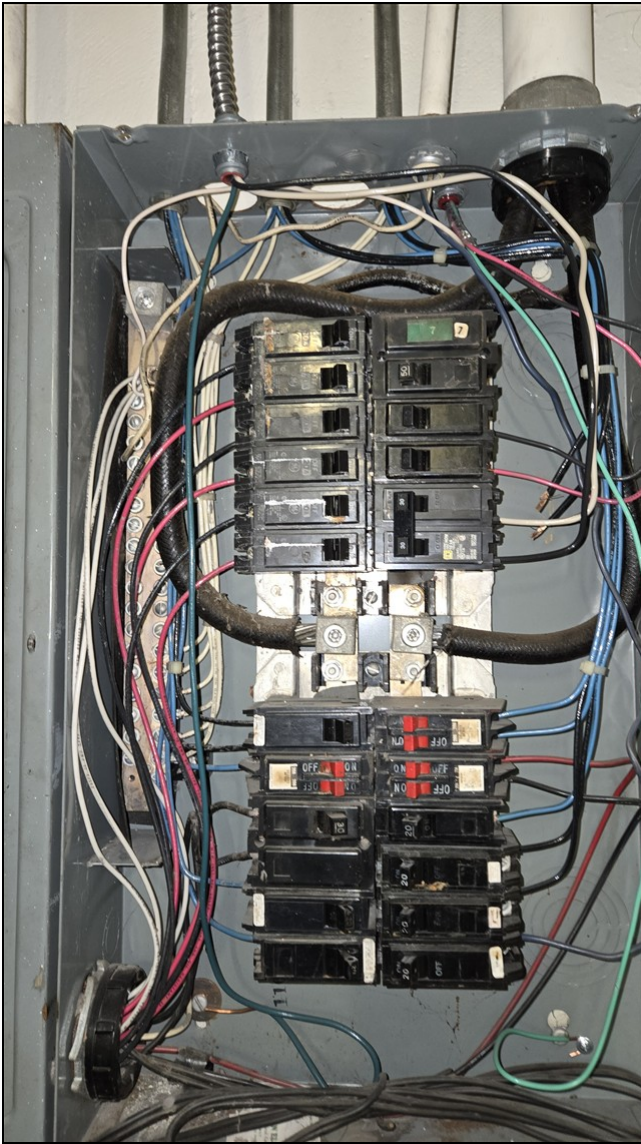
(3) Panels are poorly marked. This is a safety hazard.

Multiple panels had missing knockouts. This is a safety hazard.

Multiple circuit breaker in multiple electrical service panels were corroded. This will not allow for the proper transfer of electricity and can lead to overheating.

Breakers were mismatched with panels. In one instance, GE, ITE, and Square D breakers were noted in the same panel.

Breakers appeared to be missing bonds for 240v circuits but this is based on wiring as panel markings were inadequate.

Breakers were loose on the bus bar in two panels. This can create arcing between the contact for the breaker and the energized bus. Such arcing is a fire hazard.

A Federal Pacific Electric panel cover was used on Cutler Hammer breakers. This is not a rated cover and should be replaced.

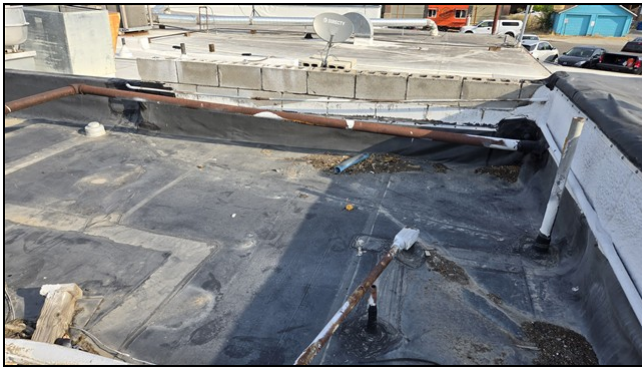
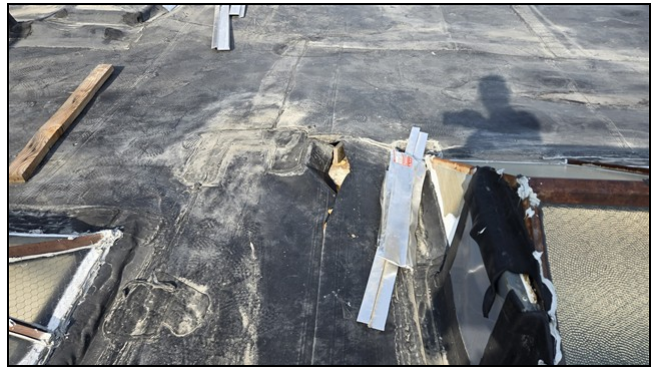
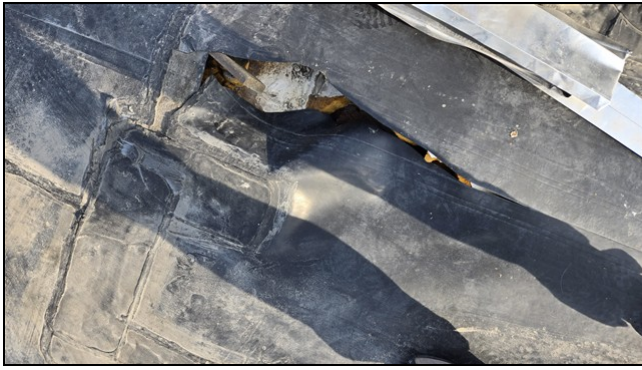
(3) The majority of the EPDM roof has failed with substantial openings in the surface.

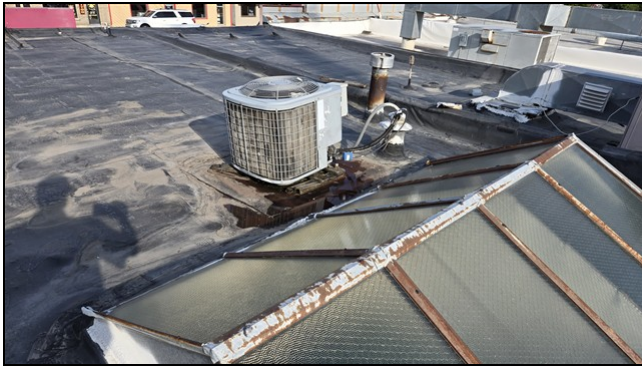
4.9 Item 1 (Picture)

Skylights are an older style with wired safety glass. Several panes of glass are broken. Wire safety glasses no longer recommended in areas where glass can become broken in a hazard. Recommend replacing with tempered glass.

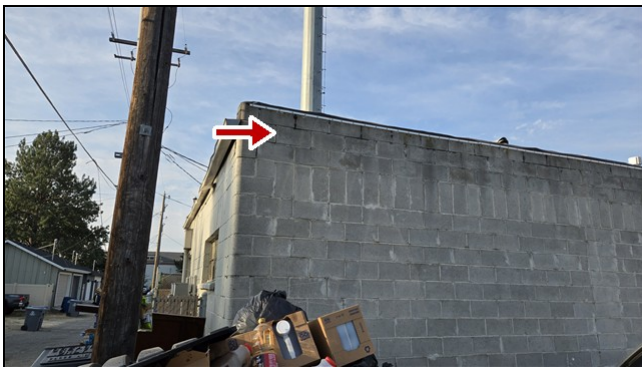
5.0 Item 1 (Picture)

(2) Substantial cracking with missing mortar noted at the northeast corner of the building.

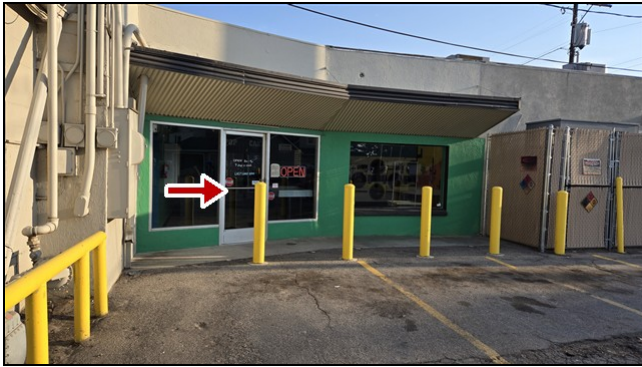
5.3 Item 1 (Picture)

(1) Entrance doors (also used for emergency egress) should open to the outside to facilitate evacuation in an emergency. Doors on this structure opened inward, instead. This is a safety hazard.

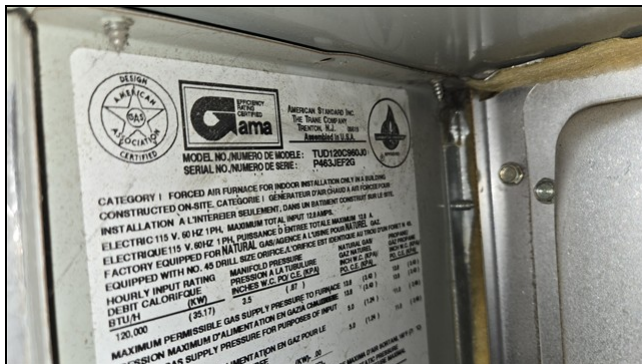
7.0 Item 1 (Picture)

Based on available records, inspections stickers, or the lack thereof, routine maintenance appears to be overdue. Recommend maintenance for this unit at this time.

This piece of equipment is beyond a normal service life. Recommend replacement..

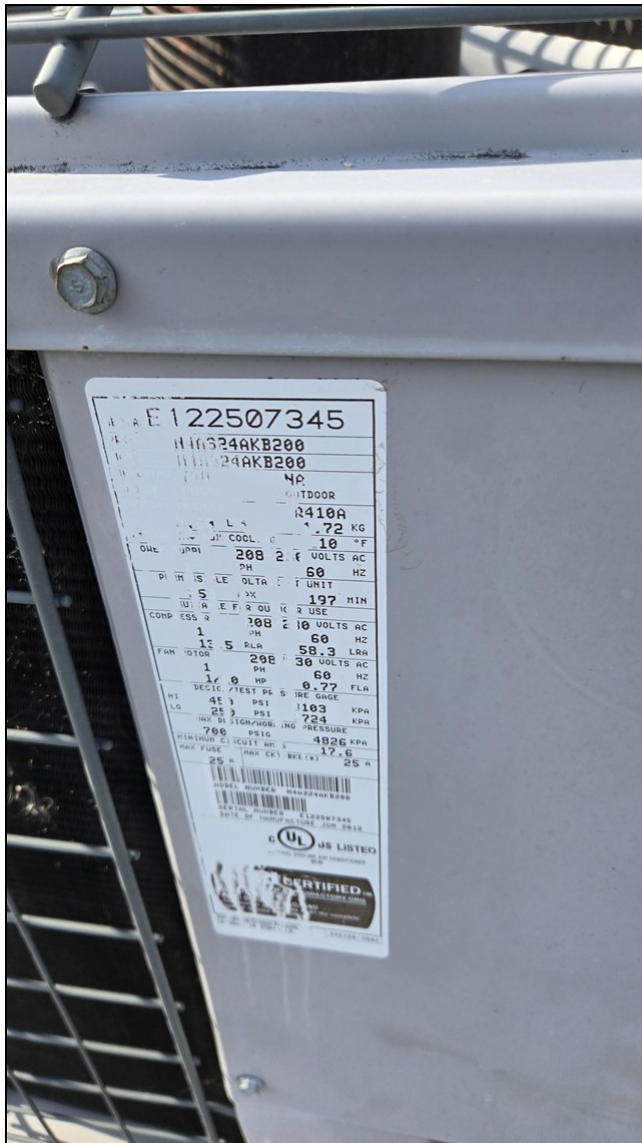
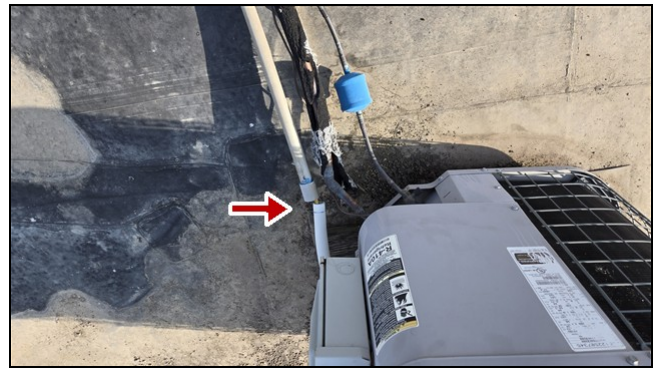
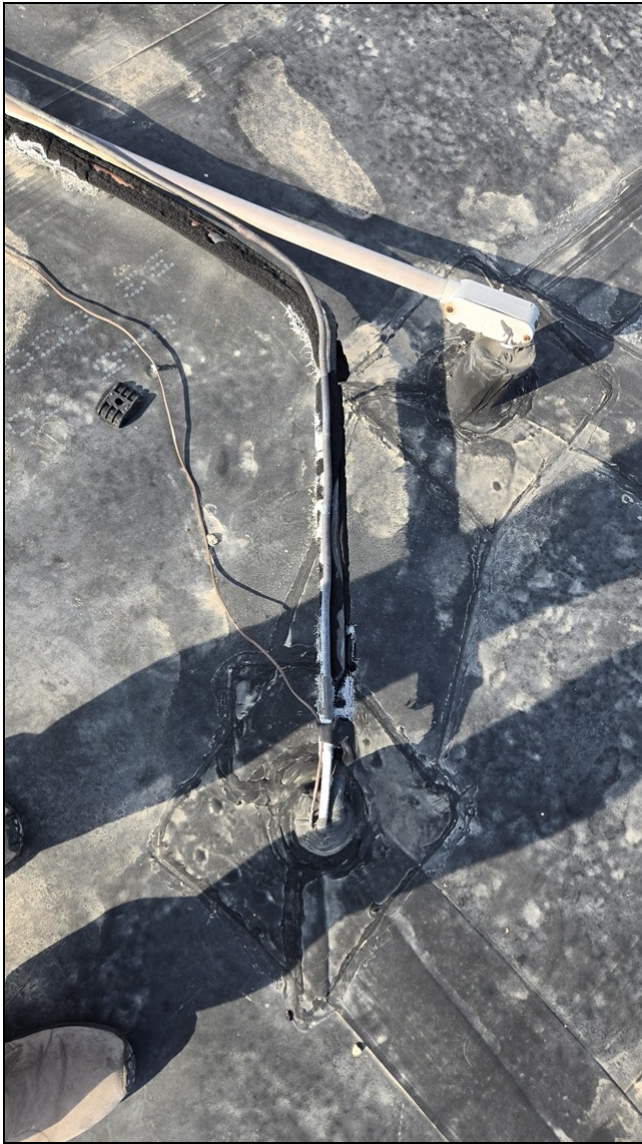
(2) The first air conditioner was manufactured by Carrier and was 1 years old. The unit was rated at 2 tons of cooling capacity.

The line sets for this unit appeared to be reused. Insulation was missing. The electrical conduit is damaged.

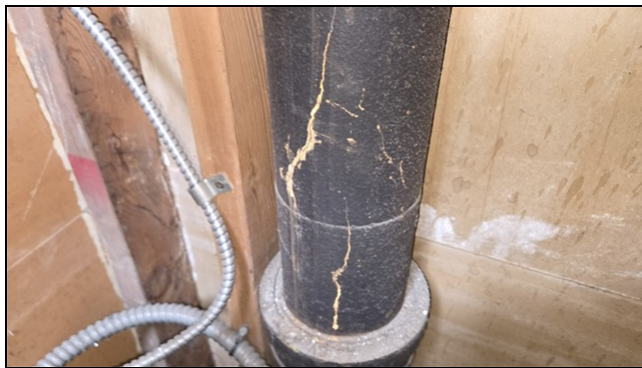
8.2 Item 3 (Picture)

(2) The vent stack in the front of the building is cracked. This will lead to the release of sewer gases.

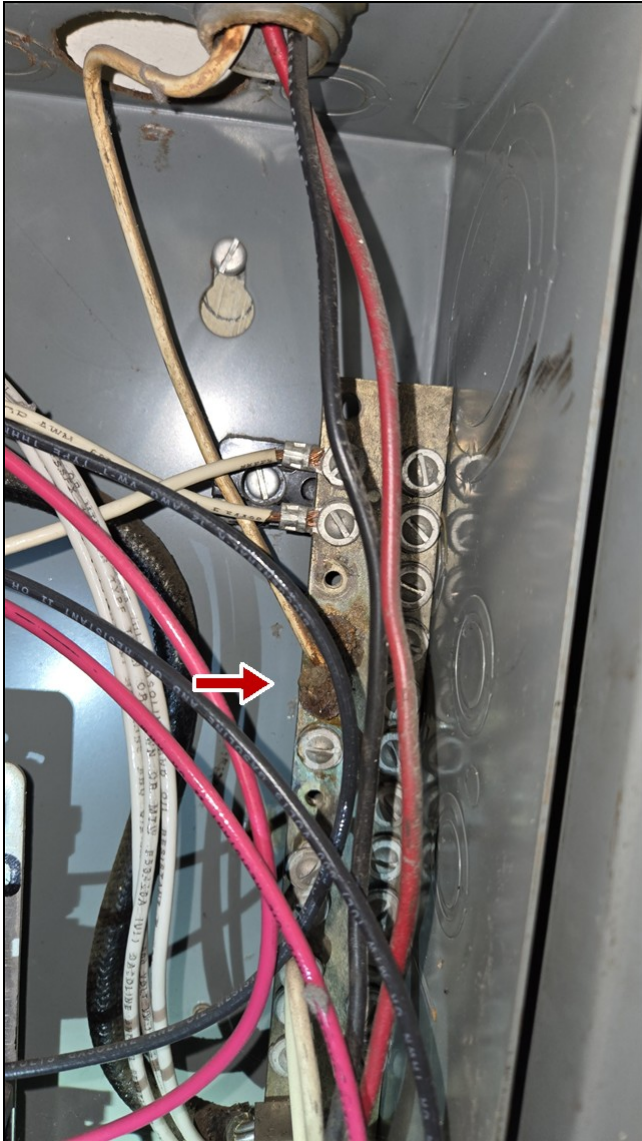
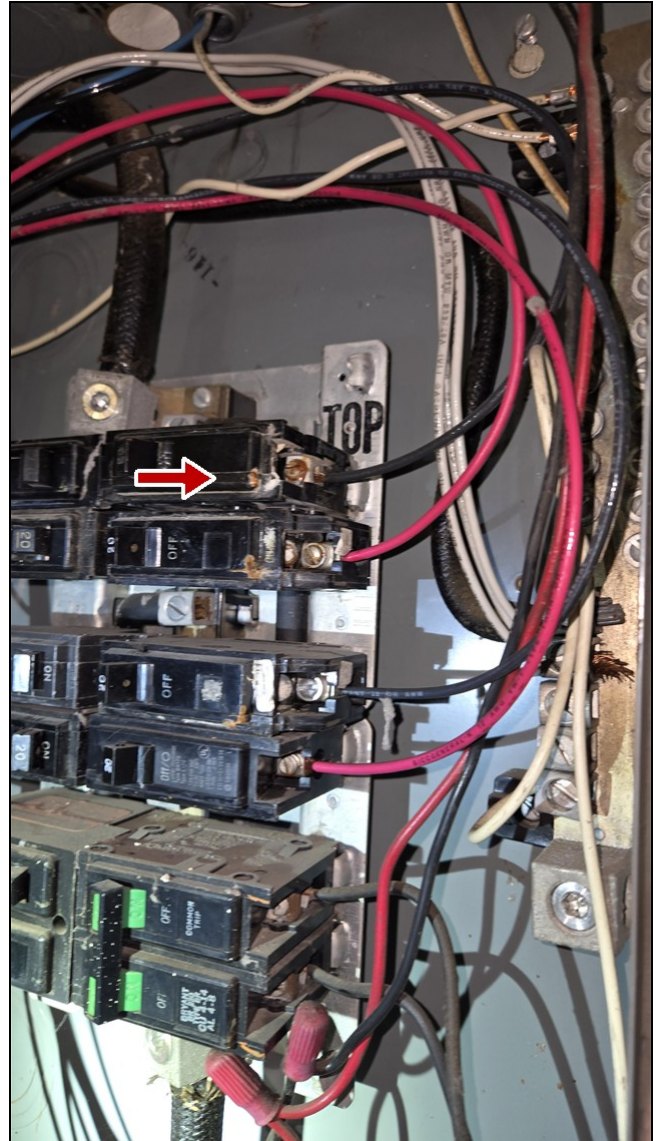
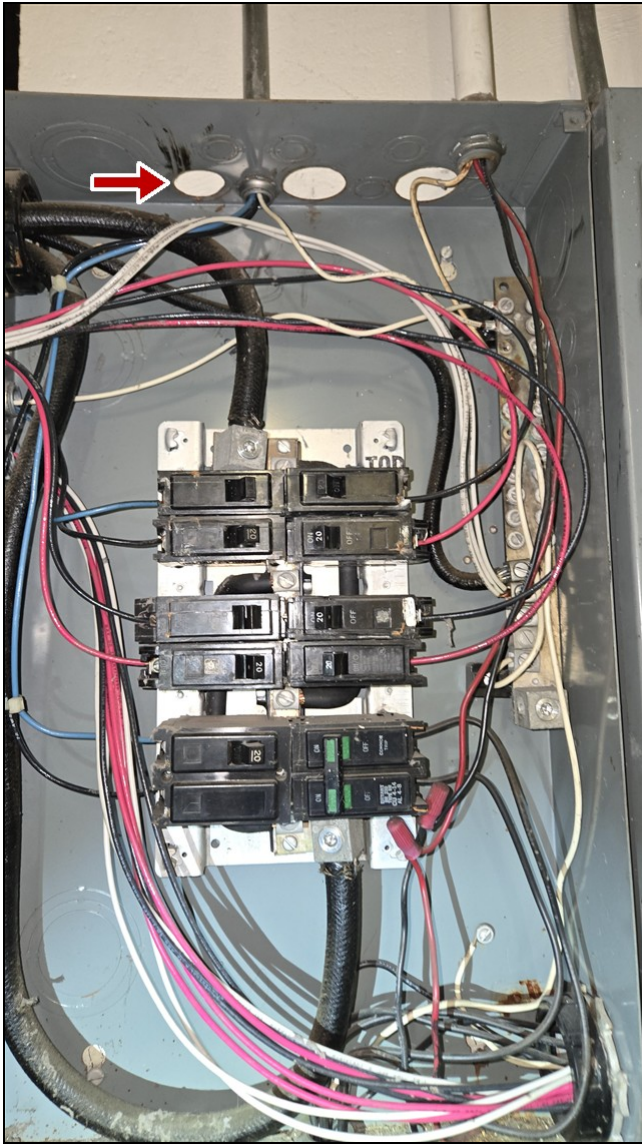
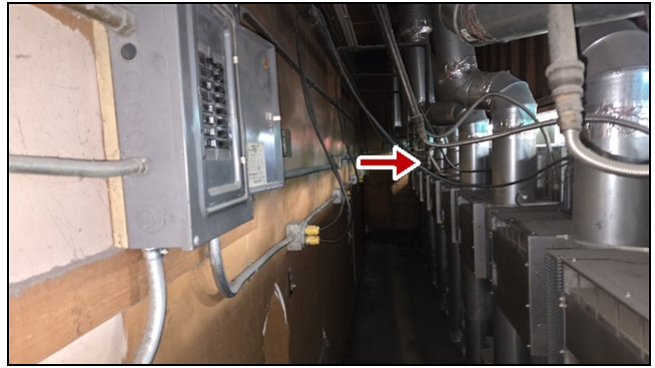
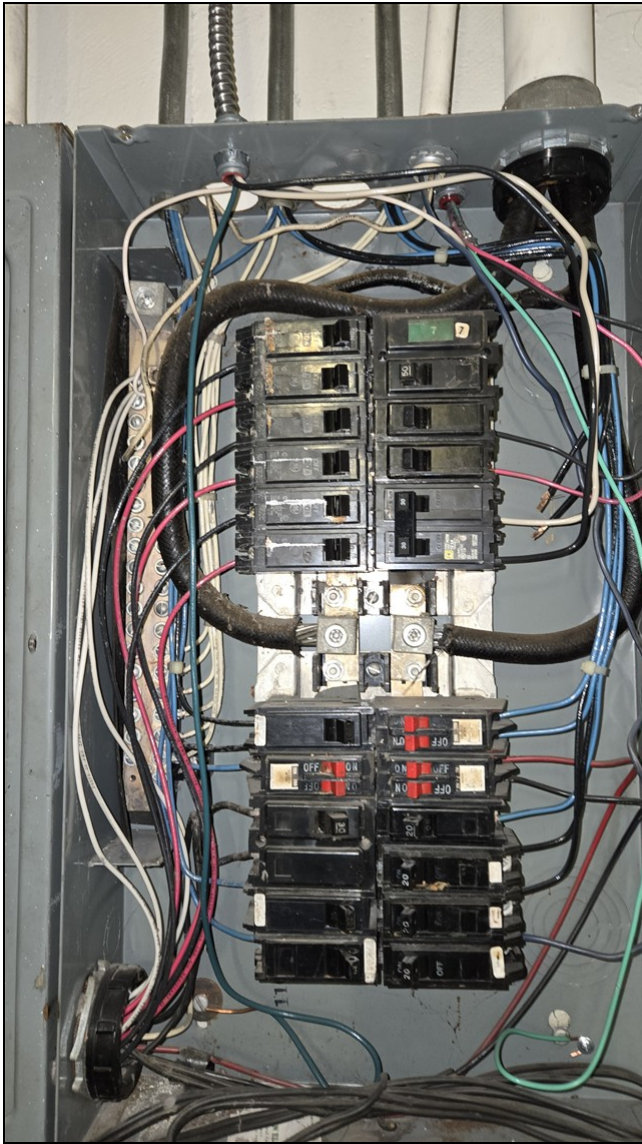
(3) Panels are poorly marked. This is a safety hazard.

Multiple panels had missing knockouts. This is a safety hazard.

Multiple circuit breaker in multiple electrical service panels were corroded. This will not allow for the proper transfer of electricity and can lead to overheating.

Breakers were mismatched with panels. In one instance, GE, ITE, and Square D breakers were noted in the same panel.

Breakers appeared to be missing bonds for 240v circuits but this is based on wiring as panel markings were inadequate.

Breakers were loose on the bus bar in two panels. This can create arcing between the contact for the breaker and the energized bus. Such arcing is a fire hazard.

A Federal Pacific Electric panel cover was used on Cutler Hammer breakers. This is not a rated cover and should be replaced.

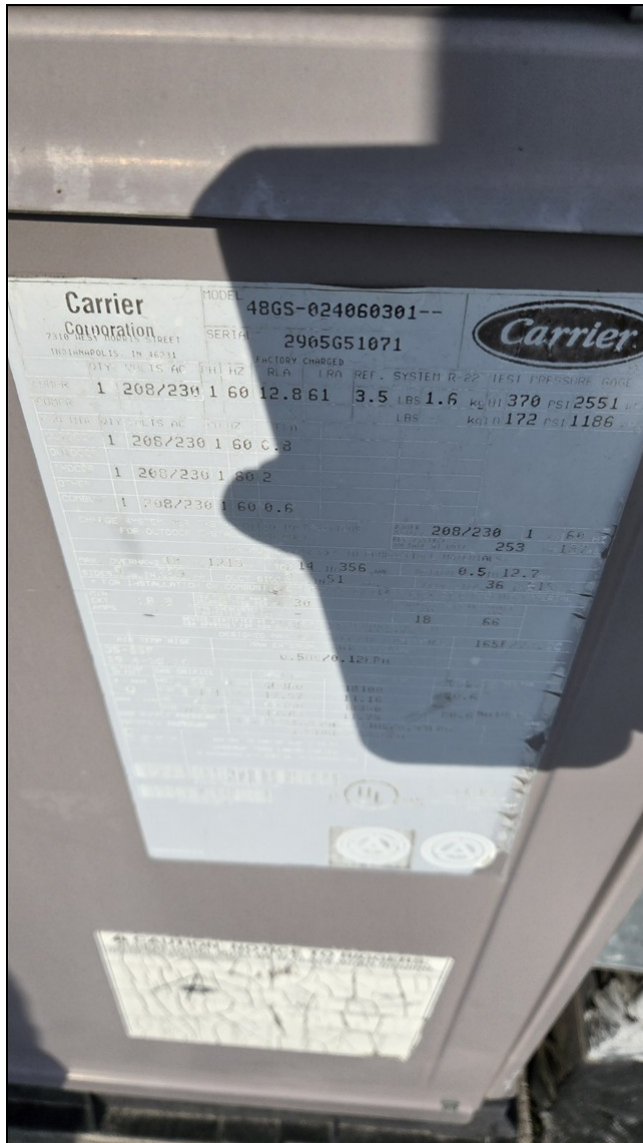
7.0 Item 2 (Picture)

Based on available records, inspections stickers, or the lack thereof, routine maintenance appears to be overdue. Recommend maintenance for this unit at this time.

This piece of equipment is at the end of a normal service life. Recommend continuing with routine maintenance and developing cash reserves for eventual replacement..
