INSPECTION REPORT  
1422 S Tech Ln  
Meridian ID 83642

INSPECTED BY  
Paul Duffau CCPIA  
001011  
Calibre Commercial  
Inspections, LLC

INSPECTION DATE  
📅 12/5/2024  
🕒 08:00 AM

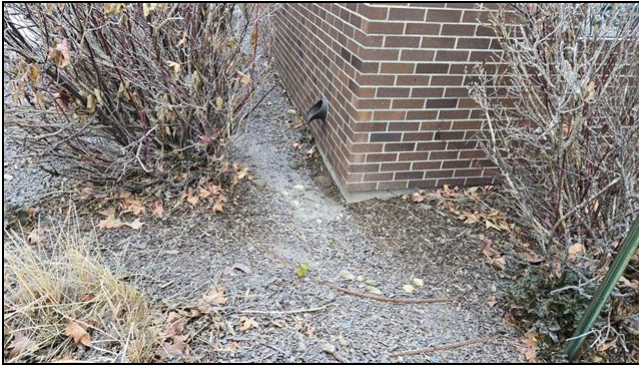
3.0 Item 1 (Picture)

Grading is negative in areas around the building especially to the left hand side where the scupper from the roof discharges. Negative grading can allow for water entry into foundational systems and lead to building damage. Recommend repair.

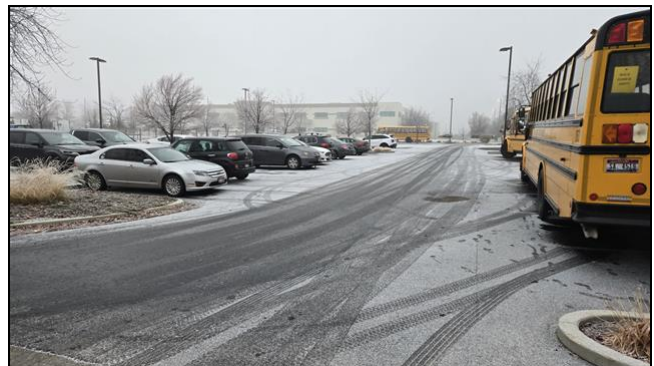
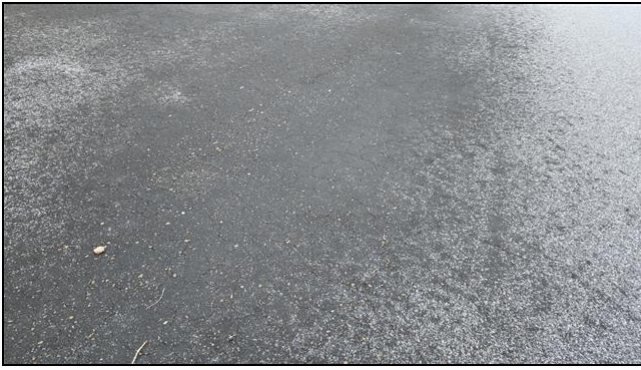
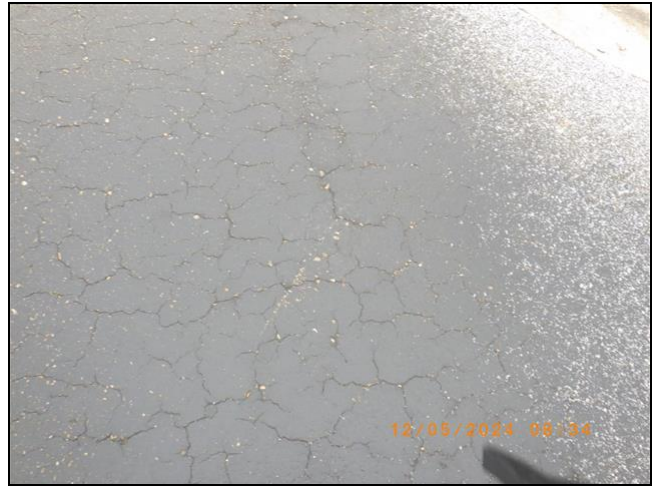
(2) Cracking and raveling of the parking lot surface, especially in the high traffic drives, was noted. At this time, it does not appear that damage has extended to the subgrade.

Recommend seal coating now to prevent additional damage and more costly repairs. Re-striping should be done at the same time.

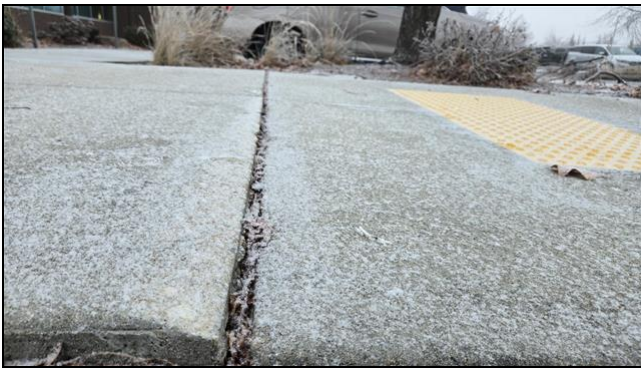
3.2 Item 1 (Picture)

(2) The concrete has settled and created a trip hazard at the walkway at the left side of the building by the bicycle racks. Recommend correction to prevent personal injury and limit liability.

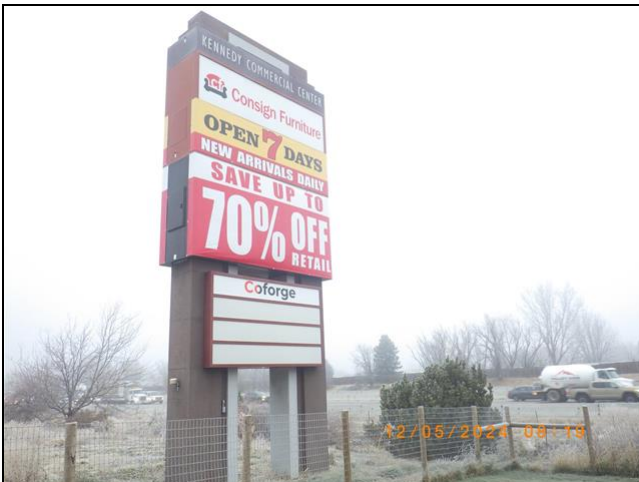
3.8 Item 1 (Picture)

A single sign was present at the entrance by Tech Lane. There is a large sign present just off the Northwest corner of the property. Recommend inquiring to determine if the subject property has authorization to use that sign structure.

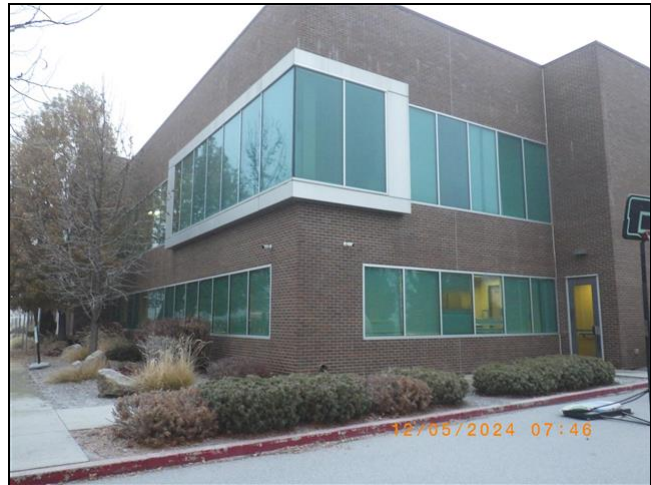
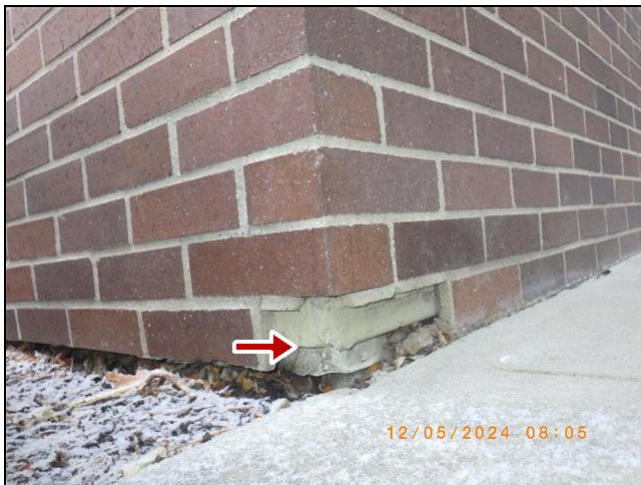
(2) Efflorescence noted on the front and right side of the building suggesting that water intrusion is occurring at the brick face. Two pieces of the veneer, both at the base of the walls, were missing.

The source of the moisture intrusion into the walls should be identified (see notes below) and corrected. Missing veneer should be replaced.

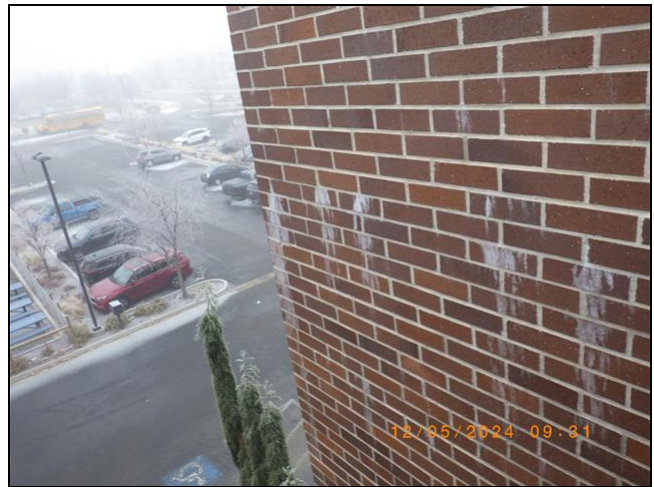
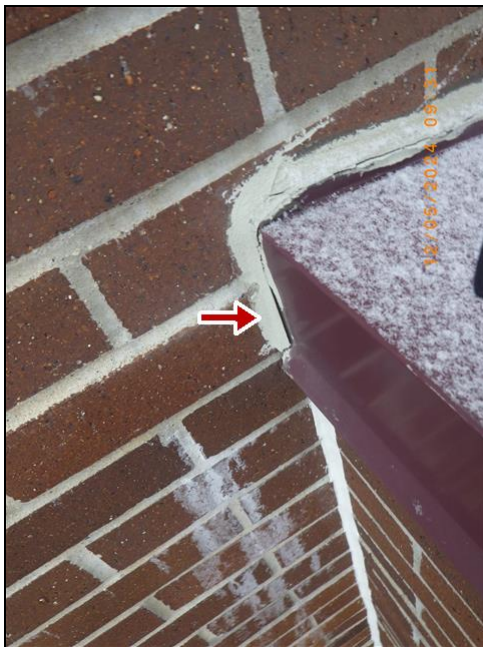
(3) Caulking is deteriorating at the edge of the windows and tops of projections as well as the intersection of wall segments. This leads to water intrusion. Recommend repair.

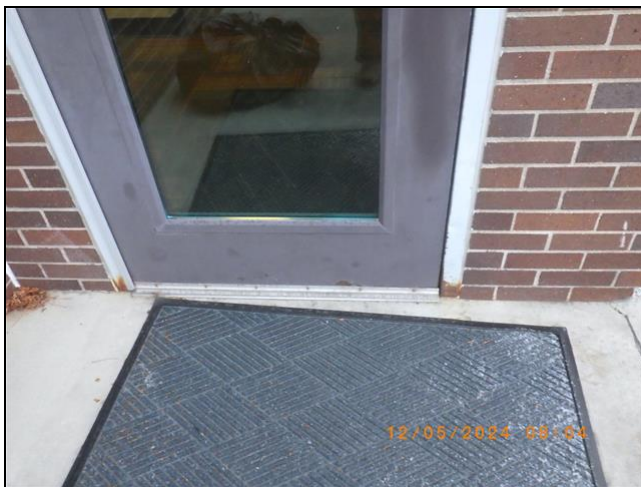
5.3 Item 1 (Picture)

(2) Rust noted at the base of the East emergency egress door. Recommend maintenance.

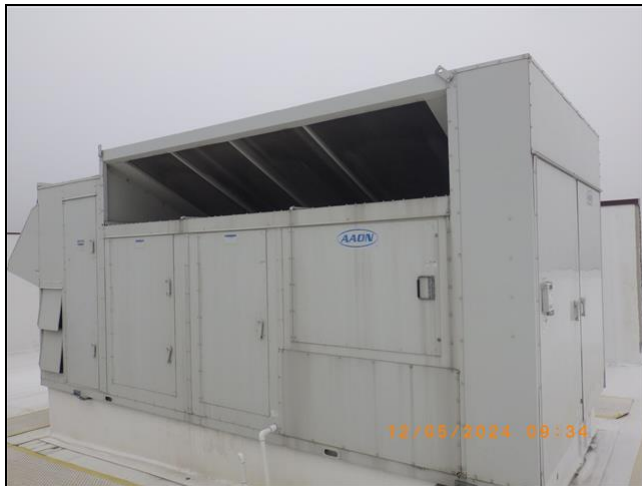
7.0 Item 1 (Picture)

The HVAC system is a deck/cold deck system with multiple zonal controls. This is an older style of conditioning air and is generally not as energy efficient as newer systems.

A servicing technician was present during the inspection. The current occupants had requested servicing due to imbalance in temperature within the building. While he was present, he agreed that the mechanical equipment was reaching the end of a normal service life. While the equipment was a good quality when installed and he is seen such equipment last longer, it would be prudent to set aside financial reserves to cover the necessity of future replacement. When asked regarding the cost of replacement of the existing equipment, the technician suggested that pricing would be between \$120,000 and \$150,000. Recommend securing confirmation of the cost of replacement to ensure that adequate reserves are held.

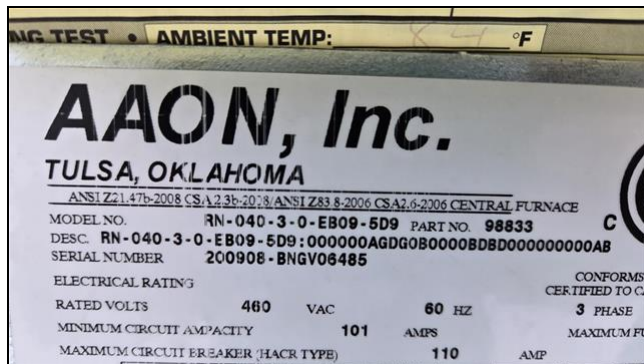
7.0 Item 2 (Picture)

(2) RTU 1 - This is a unitary system, with both heating and cooling, manufactured by Aaon. in 2009. The unit is gas-fired with 723 MBH capacity (input) and 578 MBH (output).

This piece of equipment is approaching the end of a normal service life. Recommend continuing with routine maintenance and developing cash reserves for eventual replacement.

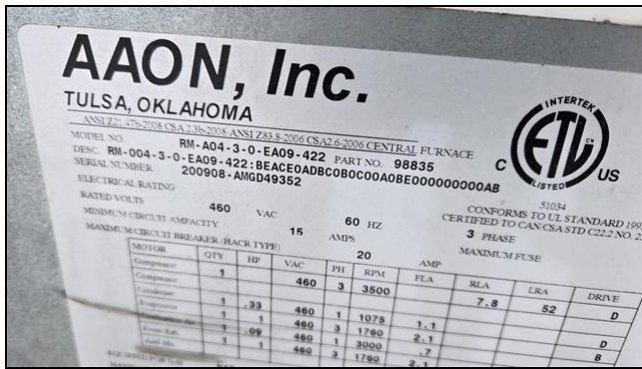
7.0 Item 3 (Picture)

(3) RTU 3 - This is a unitary system, with both heating and cooling, manufactured by Aaon. in 2009. The unit is gas-fired with 80 MBH capacity (input) and 65 MBH (output).

This piece of equipment is approaching the end of a normal service life. Recommend continuing with routine maintenance and developing cash reserves for eventual replacement.

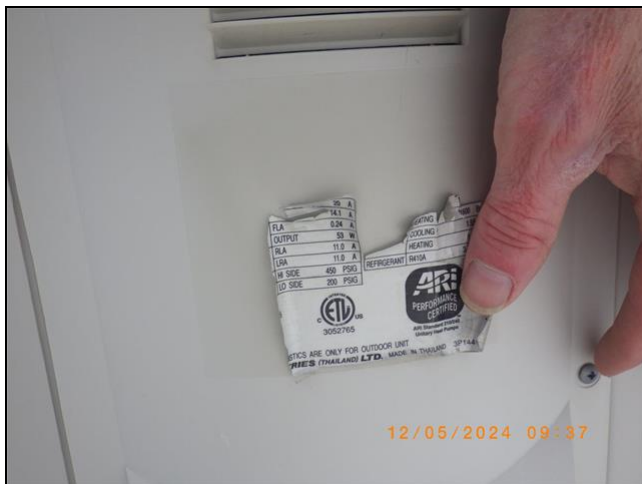
7.0 Item 4 (Picture)

(4) CU101- This is a mini-split heat pump system, with both heating and cooling, manufactured by Daiken. in 2009. The unit has a 21,00 BTU capacity.

This piece of equipment is approaching the end of a normal service life. Recommend continuing with routine maintenance and developing cash reserves for eventual replacement.

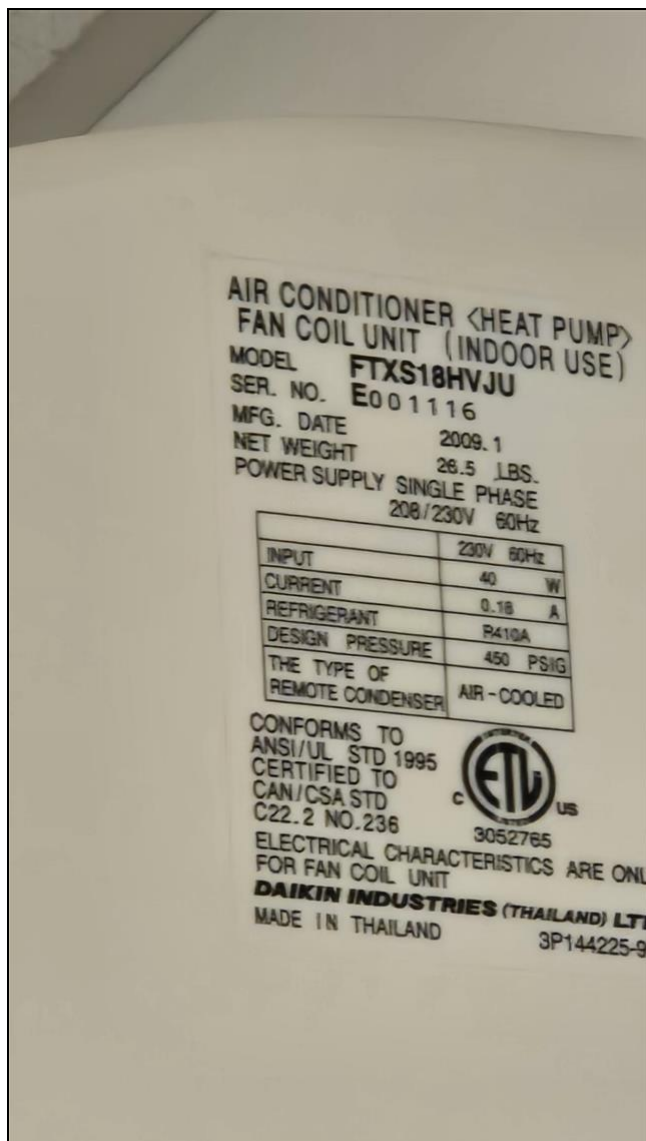
### 7.1 Item 2 (Picture)

(3) RTU 3 - This is a unitary system, with both heating and cooling, manufactured by Aaon. in 2009. The unit is rated at 4 tons of cooling capacity.

This piece of equipment is approaching the end of a normal service life. Recommend continuing with routine maintenance and developing cash reserves for eventual replacement.

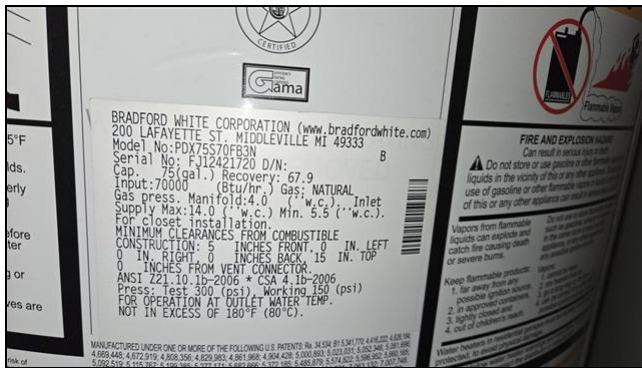
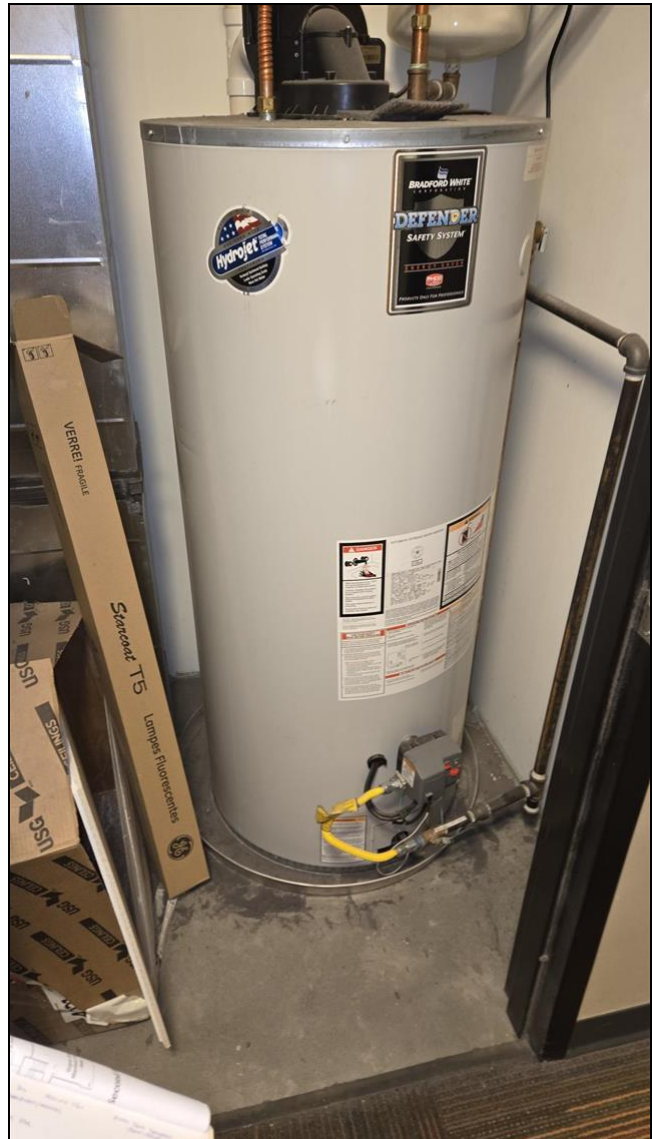
Based on available records, inspections stickers, or the lack thereof, routine maintenance appears to be overdue. Recommend maintenance for this unit at this time. The water heater is making a "popcorn" sound when in the heating mode. This is usually a result of sedimentation in the bottom of the water storage tank. The sound is a result of small air bubbles "popping" when heated and is indicative of a lack of maintenance.

This water heater is original to the date of construction. This piece of equipment is beyond a normal service life. Recommend replacement..

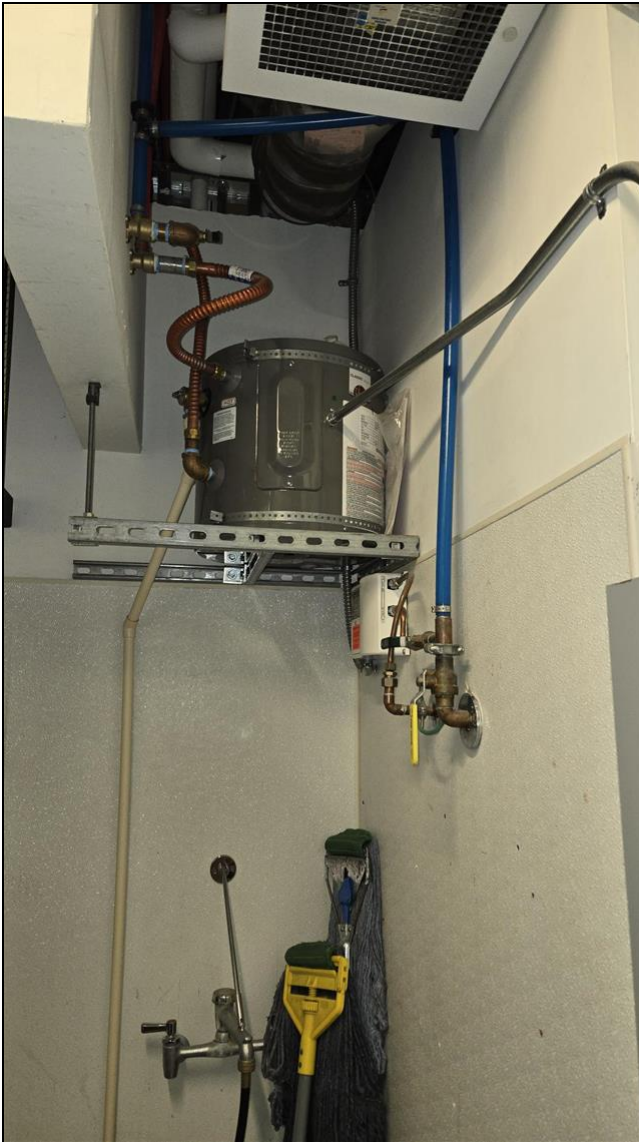
7.3 Item 3 (Picture)

(2) The secondary water heater is an electric system manufactured by Rheem in 2014 with a 6 gallon capacity.

This piece of equipment is at the end of a normal service life. Recommend continuing with routine maintenance and developing cash reserves for eventual replacement..

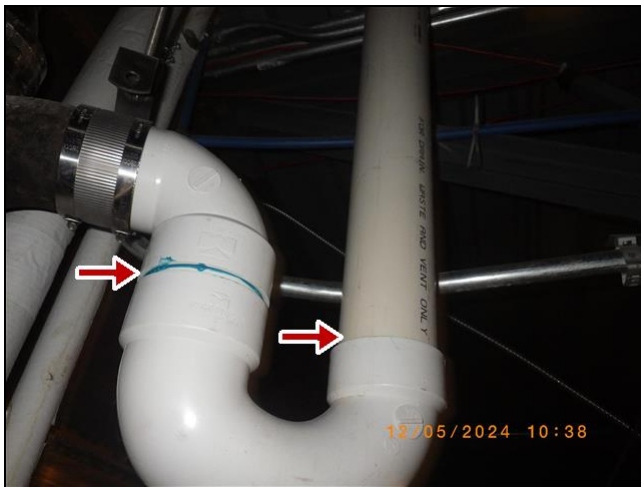
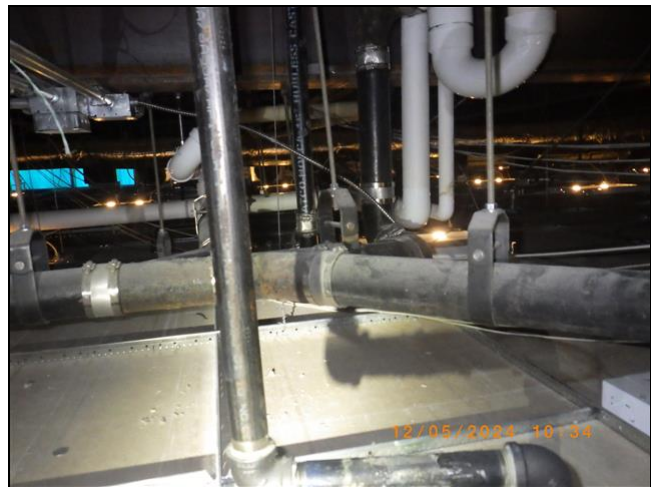
(2) Joints on waste/vent plumbing did not appear to be properly joined as sealant was not visible at multiple connections. These observations were made in the areas where staining of ceiling tiles was noted. Recommend evaluation by a licensed and qualified plumbing contractor.

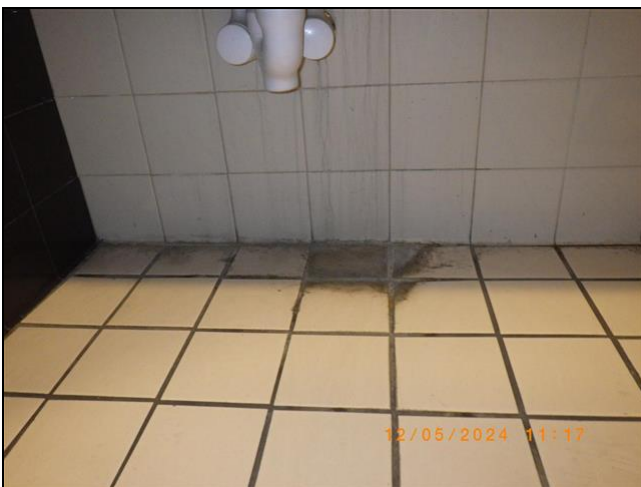
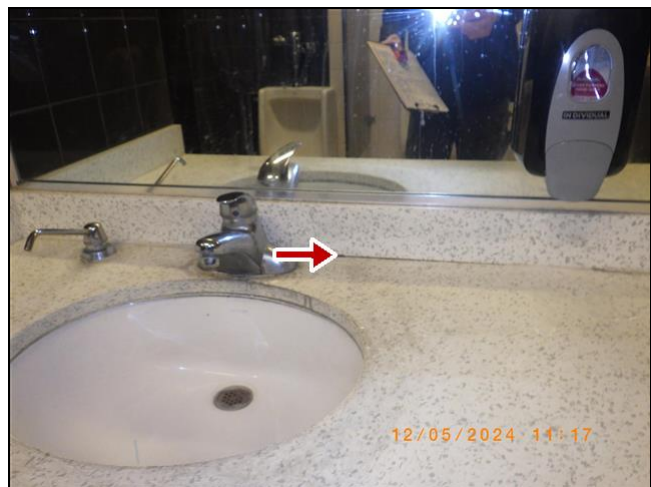
(2) Minor water damage noted in all the bathrooms from failed caulking at the sinks. Recommend repair.

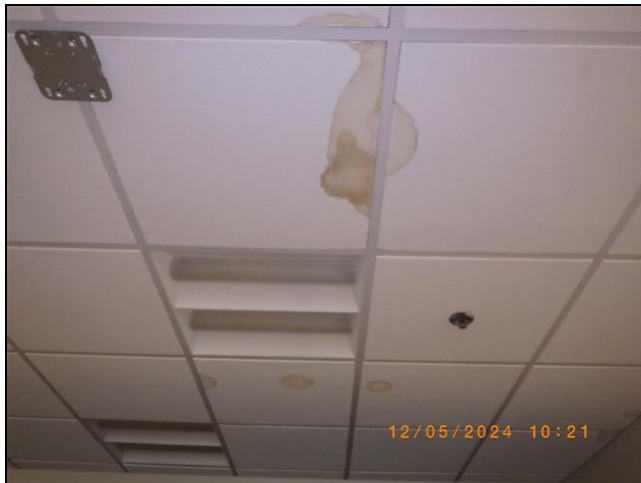
11.0 Item 1 (Picture)

The ceilings finishes were acoustic tile (majority of building) with some drywall (restrooms, front entry). Tiles were in generally good condition. However, substantial staining was noted on both floor.

Monitoring is recommended.

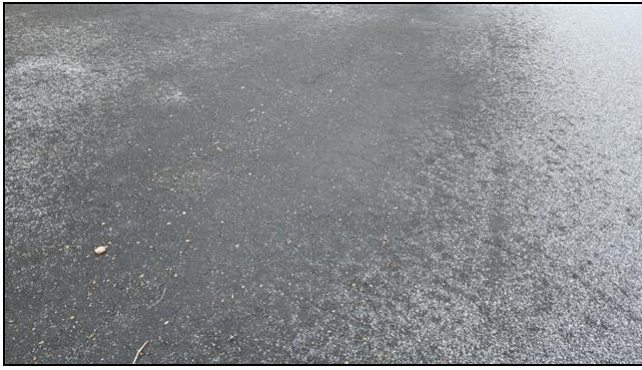
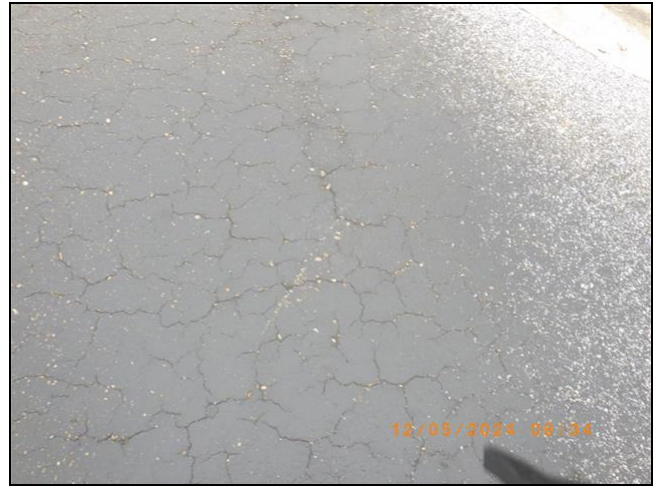
Recommend seal coating now to prevent additional damage and more costly repairs. Re-striping should be done at the same time.

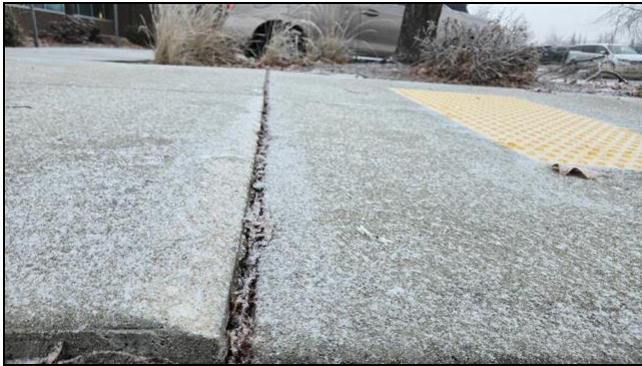
3.2 Item 1 (Picture)

(2) The concrete has settled and created a trip hazard at the walkway at the left side of the building by the bicycle racks. Recommend correction to prevent personal injury and limit liability.

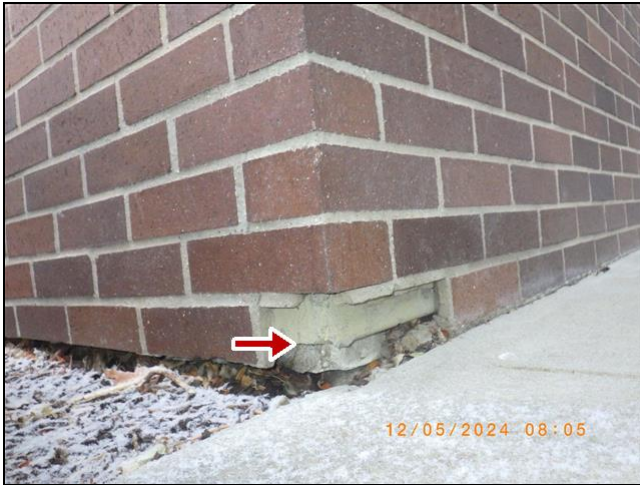
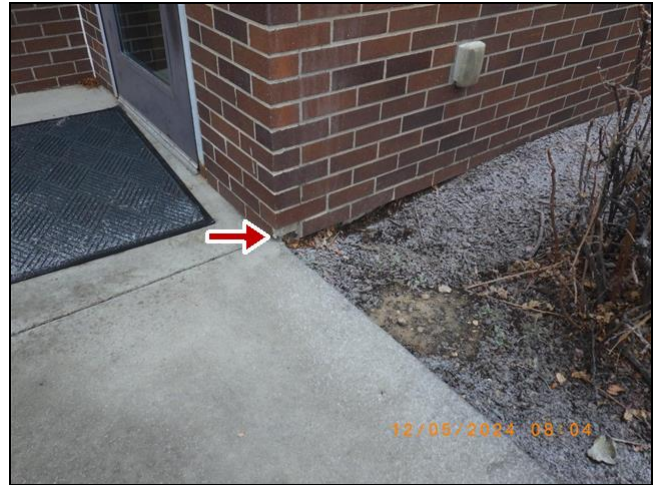
The source of the moisture intrusion into the walls should be identified (see notes below) and corrected. Missing veneer should be replaced.

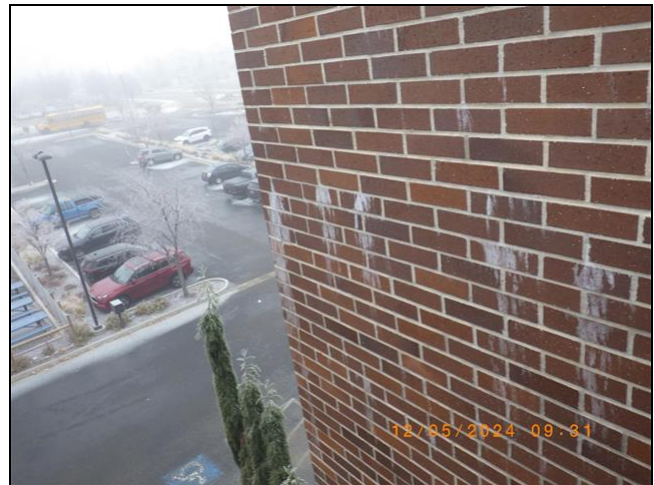
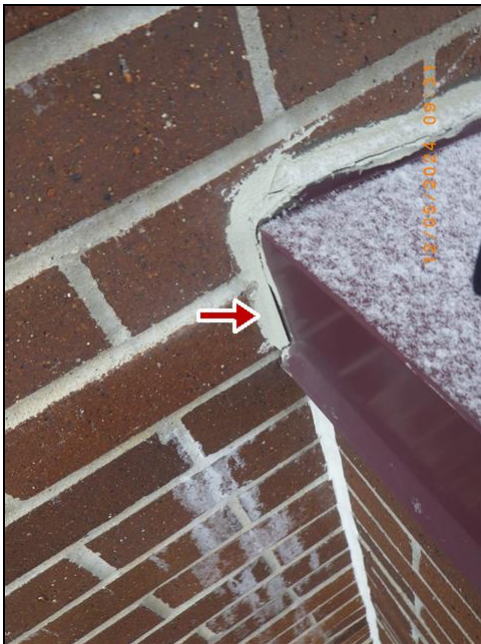
(3) Caulking is deteriorating at the edge of the windows and tops of projections as well as the intersection of wall segments. This leads to water intrusion. Recommend repair.

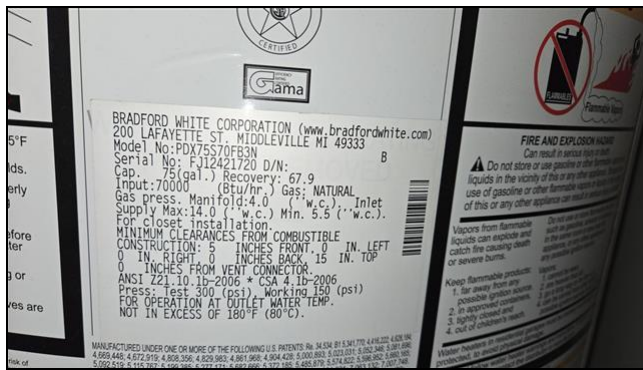
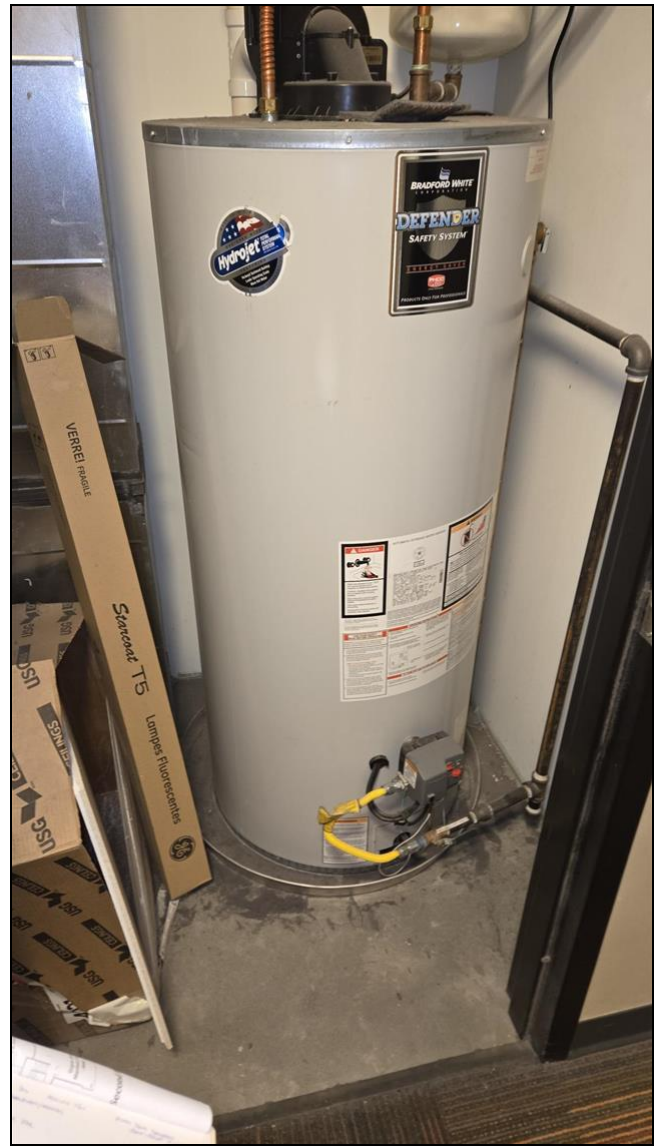
This water heater is original to the date of construction. This piece of equipment is beyond a normal service life. Recommend replacement..

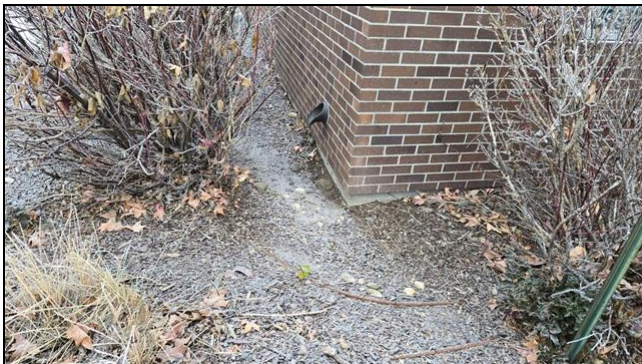
3.0 Item 1 (Picture)

Grading is negative in areas around the building especially to the left hand side where the scupper from the roof discharges. Negative grading can allow for water entry into foundational systems and lead to building damage. Recommend repair.

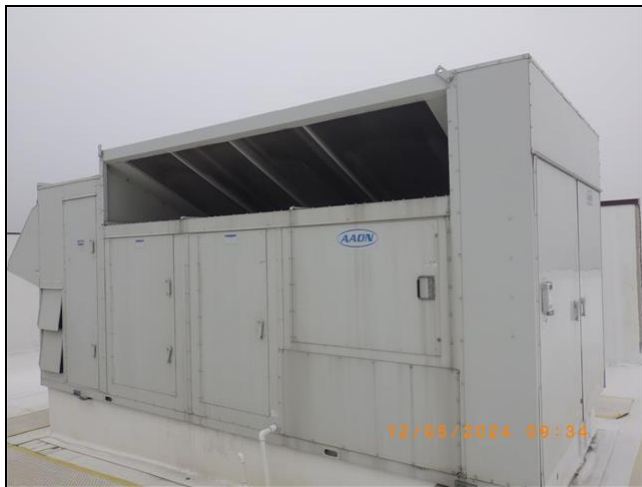
7.0 Item 1 (Picture)

A servicing technician was present during the inspection. The current occupants had requested servicing due to imbalance in temperature within the building. While he was present, he agreed that the mechanical equipment was reaching the end of a normal service life. While the equipment was a good quality when installed and he is seen such equipment last longer, it would be prudent to set aside financial reserves to cover the necessity of future replacement. When asked regarding the cost of replacement of the existing equipment, the technician suggested that pricing would be between \$120,000 and \$150,000. Recommend securing confirmation of the cost of replacement to ensure that adequate reserves are held.

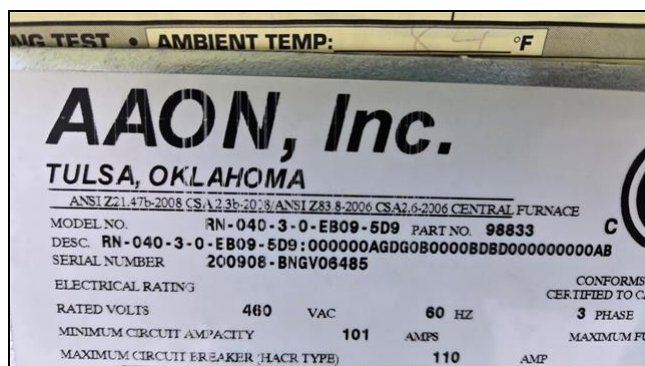
7.0 Item 2 (Picture)

(2) RTU 1 - This is a unitary system, with both heating and cooling, manufactured by Aaon. in 2009. The unit is gas-fired with 723 MBH capacity (input) and 578 MBH (output).

This piece of equipment is approaching the end of a normal service life. Recommend continuing with routine maintenance and developing cash reserves for eventual replacement.

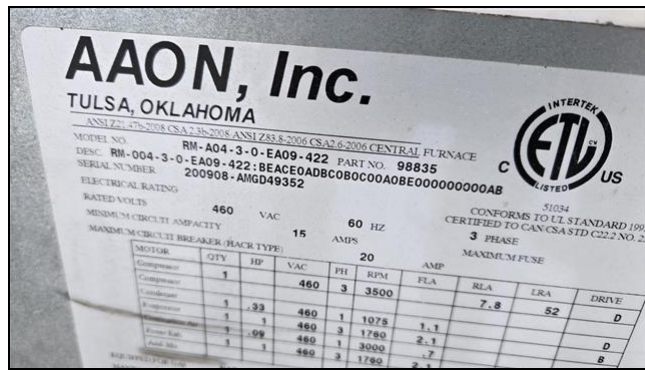
7.0 Item 3 (Picture)

(3) RTU 3 - This is a unitary system, with both heating and cooling, manufactured by Aaon. in 2009. The unit is gas-fired with 80 MBH capacity (input) and 65 MBH (output).

This piece of equipment is approaching the end of a normal service life. Recommend continuing with routine maintenance and developing cash reserves for eventual replacement.

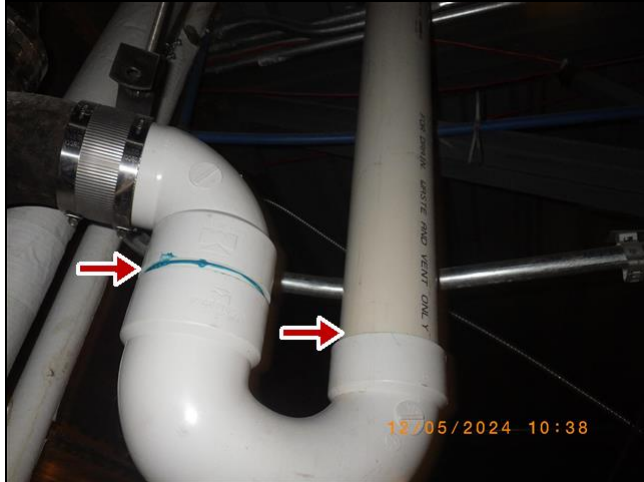
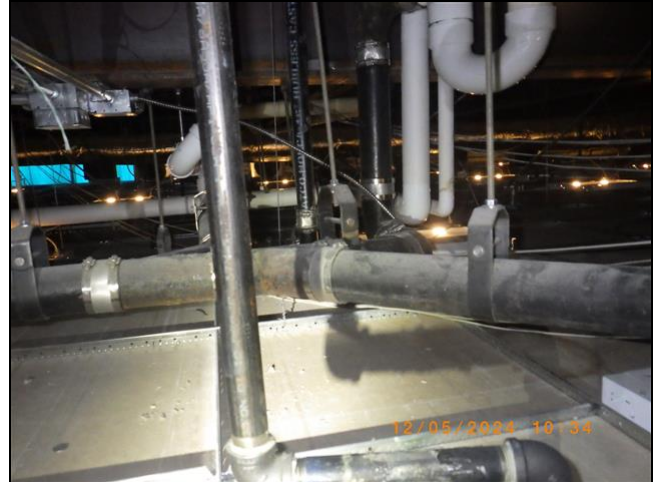
(2) Joints on waste/vent plumbing did not appear to be properly joined as sealant was not visible at multiple connections. These observations were made in the areas where staining of ceiling tiles was noted. Recommend evaluation by a licensed and qualified plumbing contractor.
