# Table of Contents

## General Info

| <b>Building Use:</b><br>MULTI-FAMILY | <b>Number of Buildings:</b><br>SIX | <b>Number of floors/stories:</b><br>2- Story |

This is a Commercial Building Inspection Report developed using the Standards of Practice for the CCPIA.

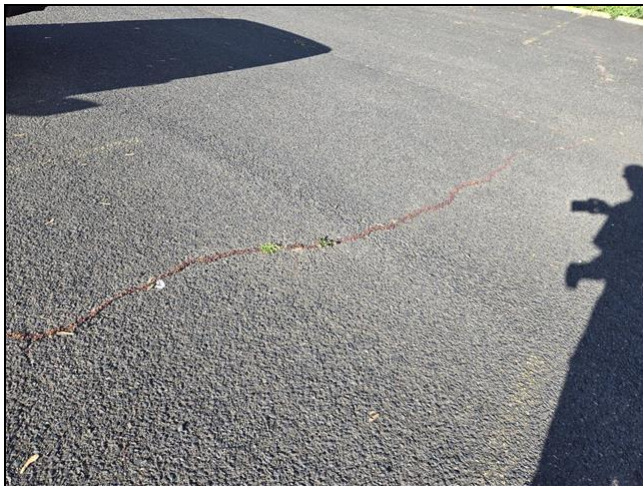
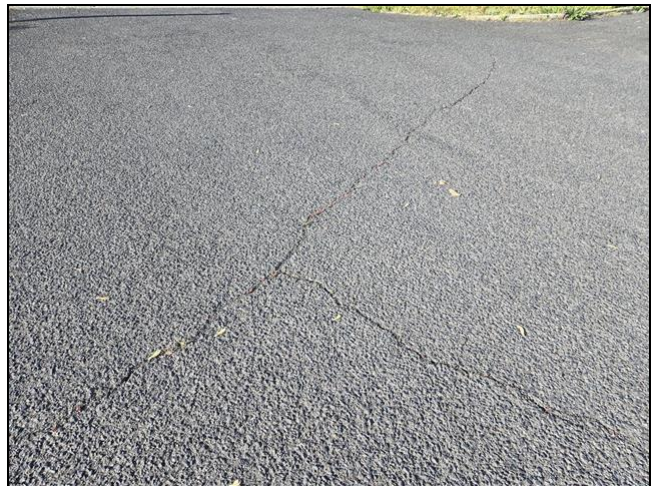
(3) Asphalt surface of the parking lot is in an average condition. It is overdue for crack sealing, sealcoating, and restriping. Recommend obtaining estimates for the necessary work and setting aside reserves to complete work within the next 1 to 5 years.

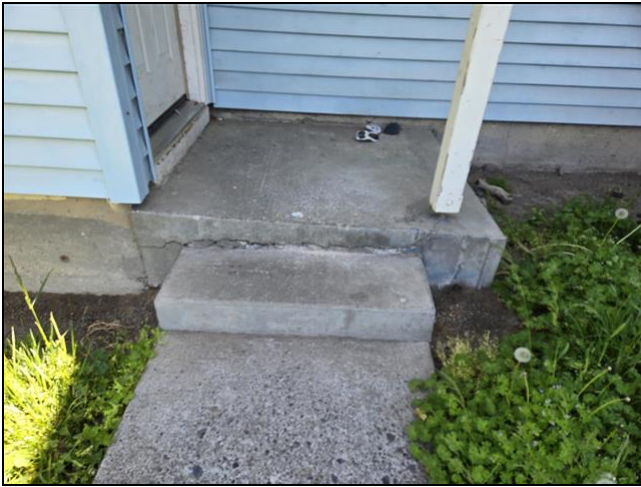
2.2 Item 1 (Picture)

(2) The steps were not constructed in a manner consistent with good construction practice. The rise and run of the steps was uneven by a greater margin than generally allowed by modern safety standards and poses a trip and fall hazard for persons traversing the steps. Repairs are recommended to bring steps into safe and useable condition. Repairs should be made by a qualified contractor.

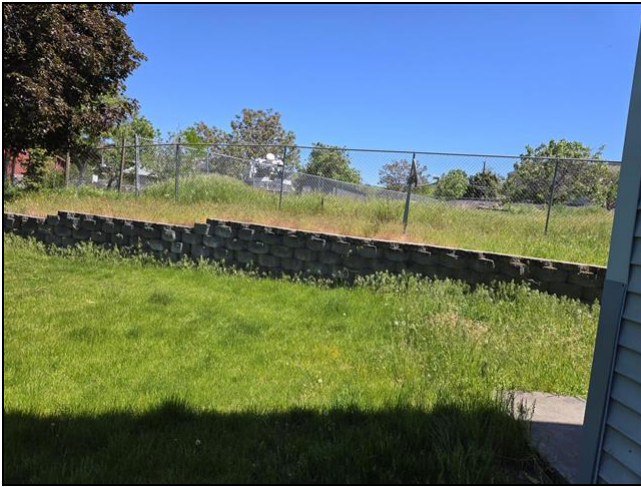
2.6 Item 1 (Picture)

The retaining wall appears serviceable, but a guardrail and should be installed to protect children or other pedestrians from an accidental fall. This is a significant liability issue. Recommend repair by a licensed and qualified contractor.

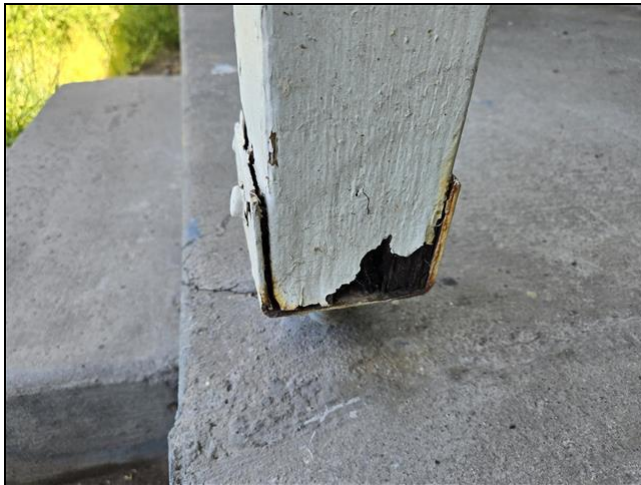
3.1 Item 1 (Picture)

(2) The column supports for the front porch overhangs have rot at the bases. This was observed on six units. Hidden damage might be present on the remainder. Replacement by a licensed and qualified contractor is recommended.

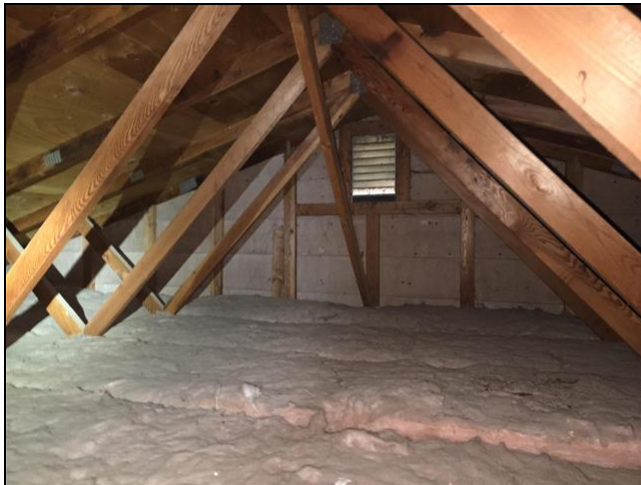
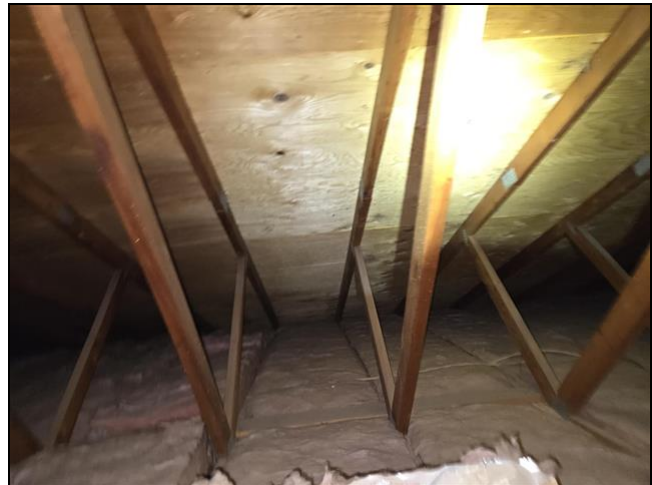
The roof was framed using manufactured roof trusses with plywood sheathing.

No readily observable material deficiencies were noted.

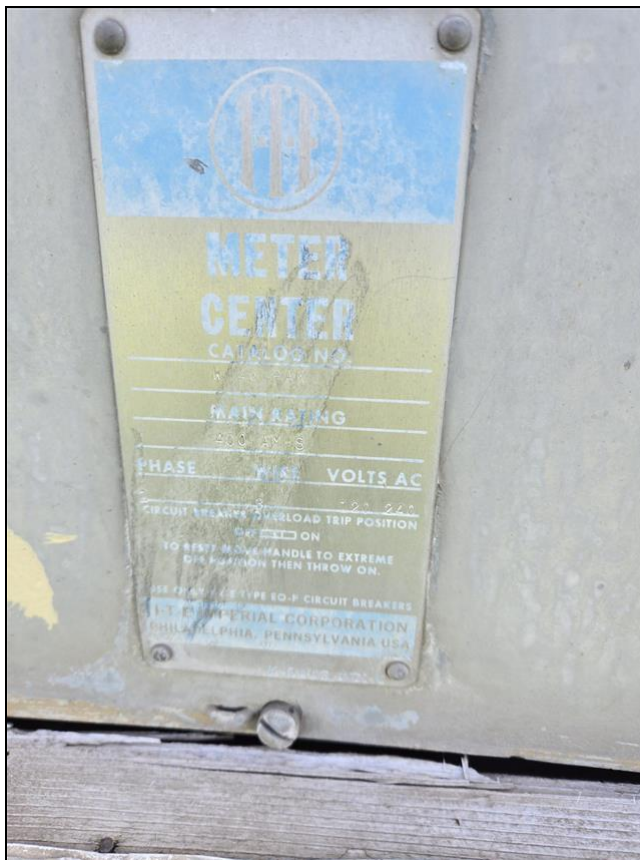
5.0 Item 1 (Picture)

Electrical services were located at ITE meter centers on the south side of the buildings. These meter centers were rated at 400 amps. They delivered 120/240 volt power to the units. Individual breakers were rated for 125 amps. There were a total of 10 meters for the living spaces. A separate meter was located on the south side of the community building.

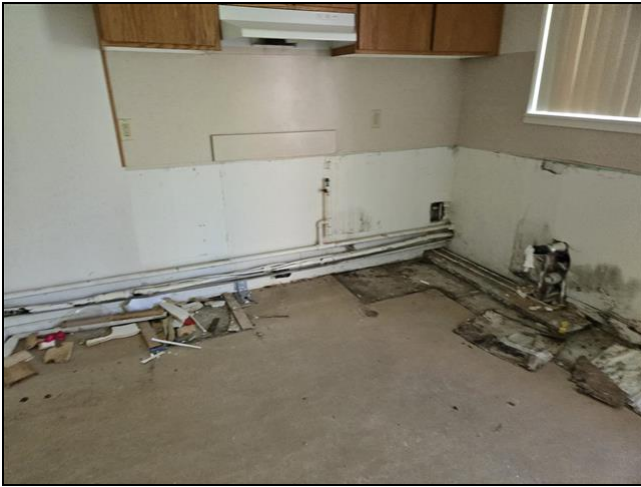
6.5 Item 1 (Picture)

Cabinets were removed in Units 6 and 9. Damage was noted in multiple other units. Cabinetry is generally worn. Recommend repairs and replacement as needed.

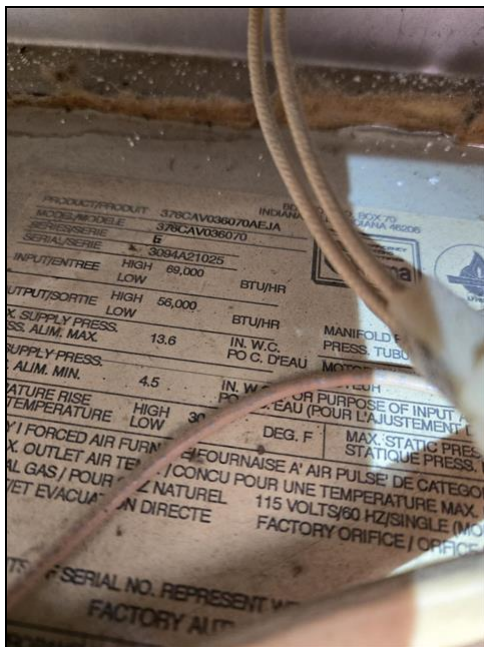
7.0 Item 1 (Picture)

Not all units were tested. Power was off to one unit. Several others had dead thermostats. One, in Unit 14, did not respond to controls. Four, in Units 11-14 had flues that were improperly sloped which is a significant life safety hazard.

All of the furnaces are substantially beyond a normal service life. Replacement is recommended. Recommend consulting a licensed and qualified HVAC contractor for estimates of cost.

Heating Plant Data - GAS-FIRED FURNACE; Fuel Source - NATURAL GAS; Manufacturer - BRYANT; Approximate Age - > 30 YEARS OLD; Heating Capacity/BTUs 69,000

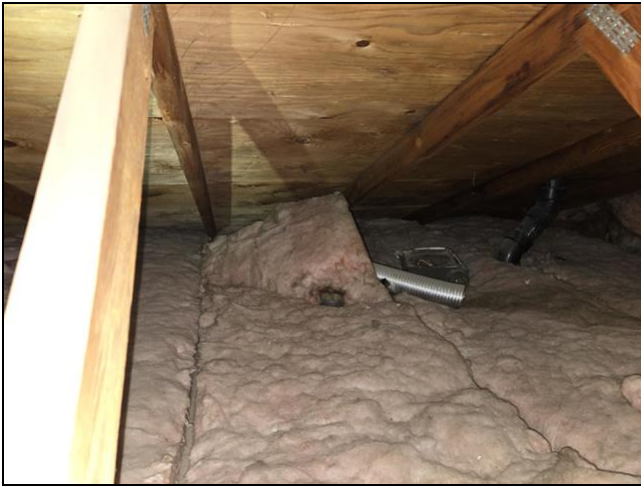
7.4 Item 1 (Picture)

(1) All of the bathroom exhaust vents terminated in the attic space. This condition is improper and will introduce excessive amounts of moisture to the attic space. Excessive moisture deposited into the attic may result in damage to building materials from decay or encourage the growth of microbes such as mold. Exhaust vents should terminate at the building exterior. Recommend repair by a licensed and qualified contractor.

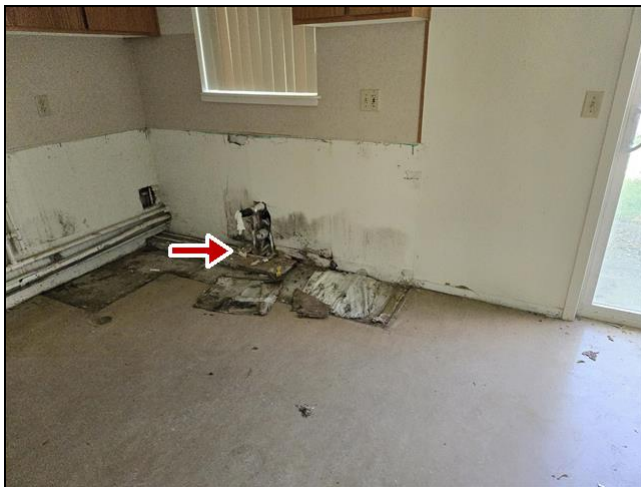
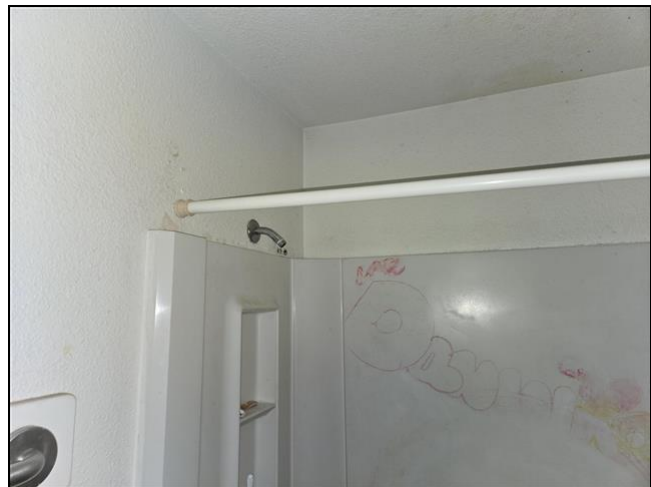
(1) Wall damage sufficient to require repair noted in approximately half of the units. The damage ranged from large holes to poorly completed wall patching and repair.

(2) Mold noted in four units with Unit 9 the worst. Recommend remediation of all such by a licensed and qualified mold remediator.

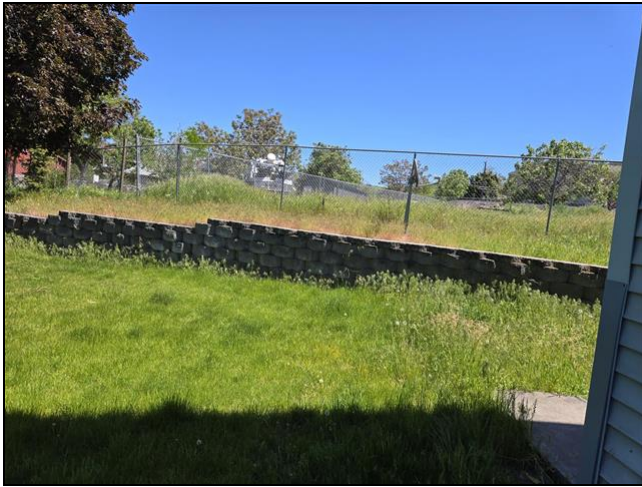
2.6 Item 1 (Picture)

The retaining wall appears serviceable, but a guardrail and should be installed to protect children or other pedestrians from an accidental fall. This is a significant liability issue. Recommend repair by a licensed and qualified contractor.

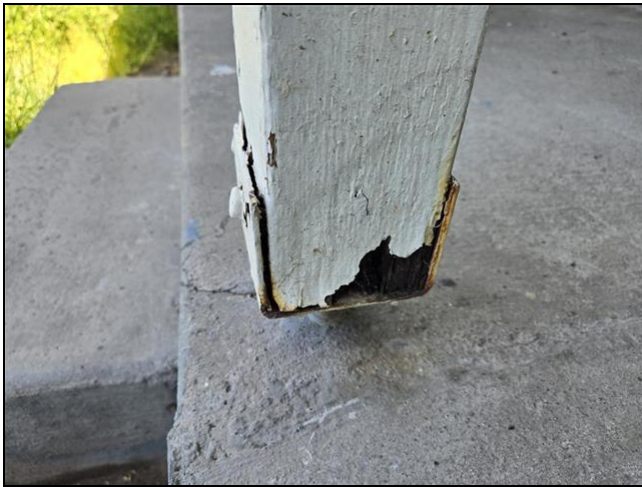
3.1 Item 1 (Picture)

(2) The column supports for the front porch overhangs have rot at the bases. This was observed on six units. Hidden damage might be present on the remainder. Replacement by a licensed and qualified contractor is recommended.

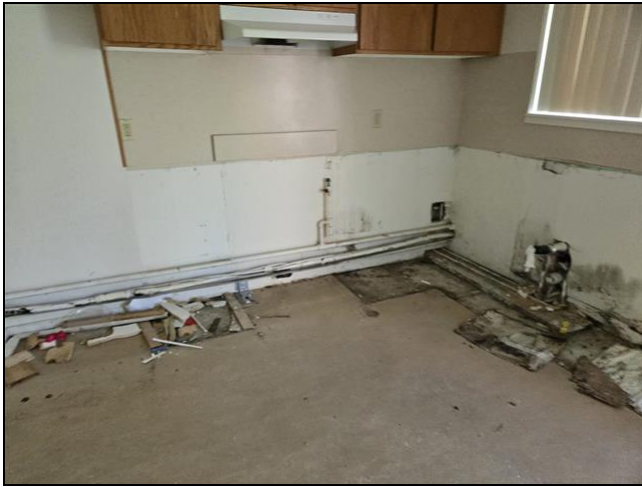
6.5 Item 1 (Picture)

Cabinets were removed in Units 6 and 9. Damage was noted in multiple other units. Cabinetry is generally worn. Recommend repairs and replacement as needed.

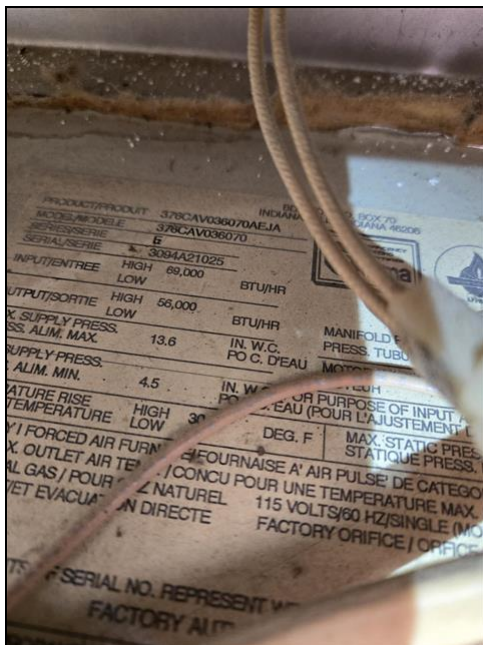
7.0 Item 1 (Picture)

Not all units were tested. Power was off to one unit. Several others had dead thermostats. One, in Unit 14, did not respond to controls. Four, in Units 11-14 had flues that were improperly sloped which is a significant life safety hazard.

All of the furnaces are substantially beyond a normal service life. Replacement is recommended. Recommend consulting a licensed and qualified HVAC contractor for estimates of cost.

Heating Plant Data - GAS-FIRED FURNACE; Fuel Source - NATURAL GAS; Manufacturer - BRYANT;  
Approximate Age - > 30 YEARS OLD; Heating Capacity/BTUs 69,000

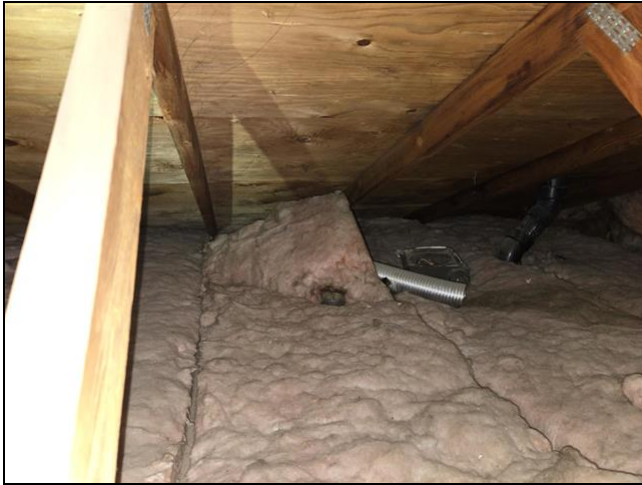
7.4 Item 1 (Picture)

(1) All of the bathroom exhaust vents terminated in the attic space. This condition is improper and will introduce excessive amounts of moisture to the attic space. Excessive moisture deposited into the attic may result in damage to building materials from decay or encourage the growth of microbes such as mold. Exhaust vents should terminate at the building exterior. Recommend repair by a licensed and qualified contractor.

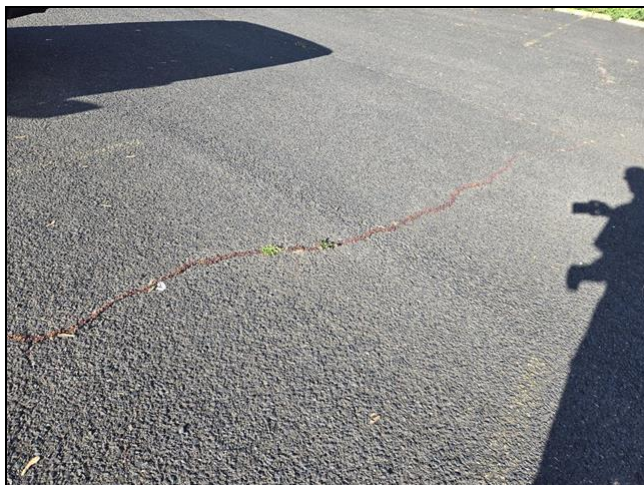
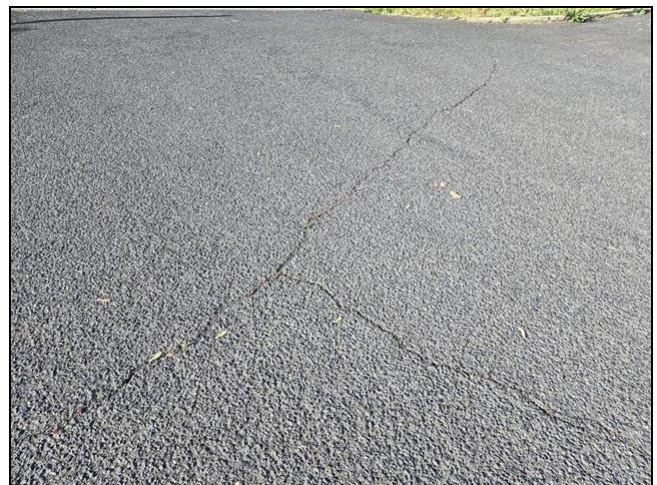
(3) Asphalt surface of the parking lot is an average condition. It is overdue for crack sealing, sealcoating, and restriping. Recommend obtaining estimates for the necessary work and setting aside reserves to complete work within the next 1 to 5 years.

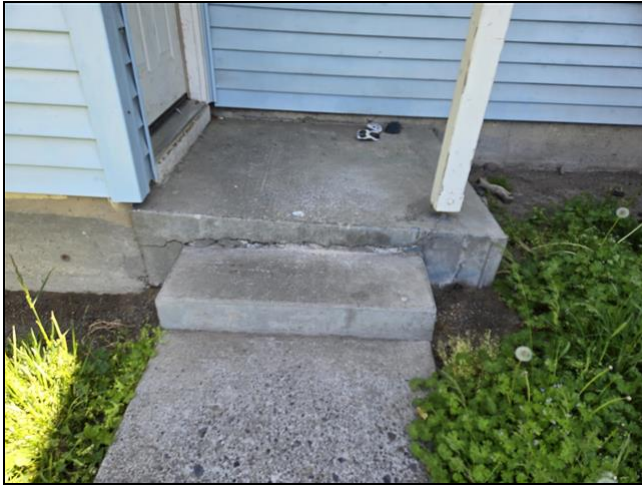
2.2 Item 1 (Picture)

(2) The steps were not constructed in a manner consistent with good construction practice. The rise and run of the steps was uneven by a greater margin than generally allowed by modern safety standards and poses a trip and fall hazard for persons traversing the steps. Repairs are recommended to bring steps into safe and useable condition. Repairs should be made by a qualified contractor.
