# Commercial Inspection Report

Property Address:

Broadway

Spokane WA 99201

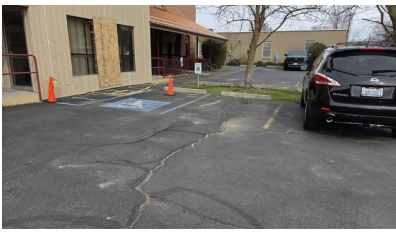
**3.3 Item 1 (Picture)**

(1) Parking lot surfaces materials included: asphalt surface. Paving materials appear to be constructed on a stabilized gravel base. A total of 50 spaces were estimated in the surface parking lot(s). Two of these were marked for accessible use.

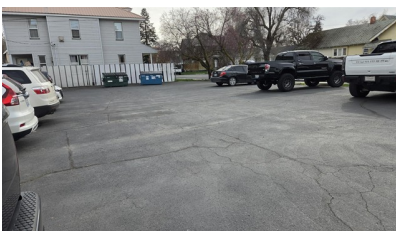
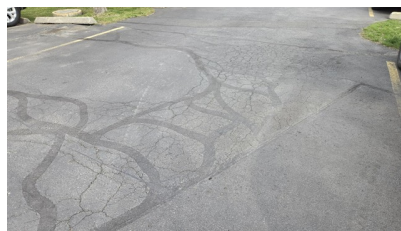
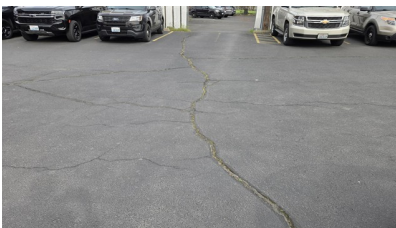
(2) Cracking in interconnected patterns resembling an alligator's skin was observed in the asphalt surface. This typically results from structural failure of the base or subgrade due to repeated loading and loss of support. Continued use under these conditions allows water intrusion, which accelerates base failure and leads to potholing. Localized low areas were observed where water collects after rainfall. These depressions may indicate localized settlement, poor compaction, or base instability. Standing water accelerates deterioration of asphalt and can create slip hazards in freezing conditions. The level of damage was best described as moderate consistent with deferred maintenance..

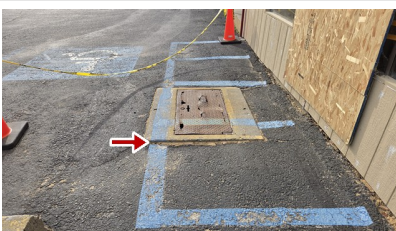
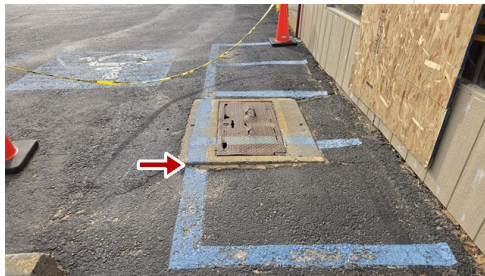
**3.3 Item 5 (Picture)**

(3) A trip hazard was present at one handicapped space in the van loading zone. This represents a liability to the building owner as well as a risk for disabled individuals.

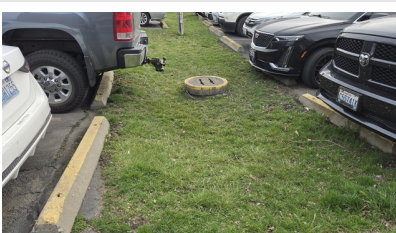
3.8 Item 1 (Picture)

Storm water drainage was accomplished by sheeting action across the parking lots to both the streets and to storm drains centrally located in landscape areas. No readily observable material deficiencies were noted.

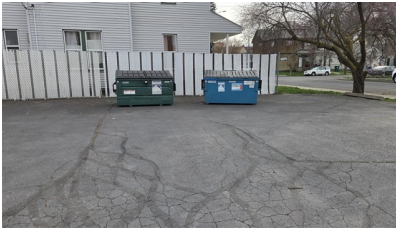
3.9 Item 1 (Picture)

Current standards requiring closures for trash dumpsters. That was not present at this location.

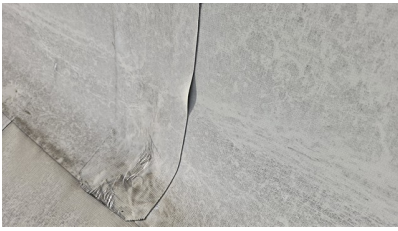
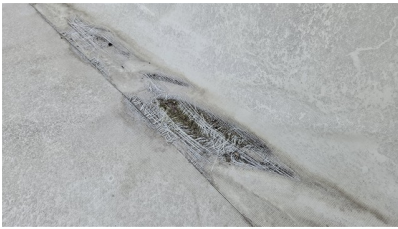
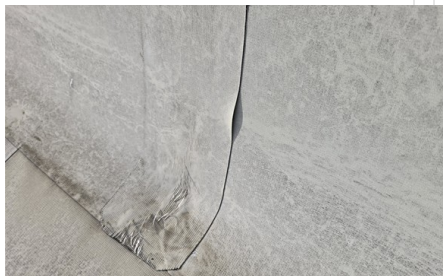
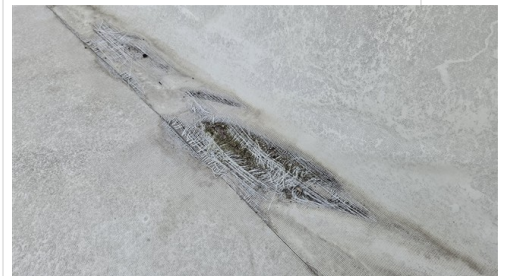
The observed roof coverings for the original building was TPO membrane. This appeared to be approximately 26–30 years old. Previous repairs were noted.

Fastener back-out and telegraphing through the membrane were observed. Backed-out or improperly seated fasteners can damage the membrane and reduce wind-uplift resistance. Flashing deficiencies were observed at curbs, parapets, or vertical transitions. Issues included incomplete welds, loose termination bars, improper detailing, or stressed transitions caused by membrane tension. Flashings are common failure points in TPO/PVC systems.

Linear section of the TPO single-ply roof membrane exhibits exposed reinforcing scrim where the top polymer coating has worn away. White fabric reinforcement is visible with frayed fibers and accumulated debris. This defect indicates membrane degradation and increases the risk of water infiltration.

Linear sections of the TPO single-ply roof membrane at the northwest corner exhibited exposed reinforcing scrim where the top polymer coating has worn away. White fabric reinforcement is visible with frayed fibers and accumulated debris. This defect indicates membrane degradation and increases the risk of water infiltration.

The roof covering is beyond a normal service life. Recommend replacement.

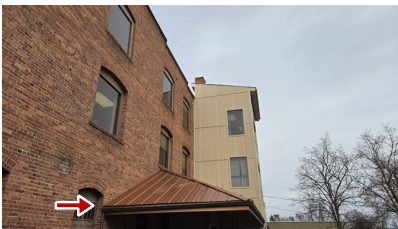
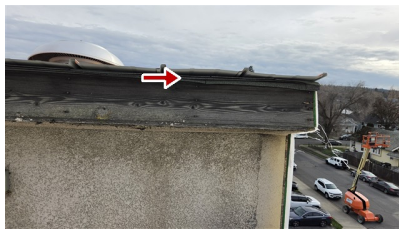
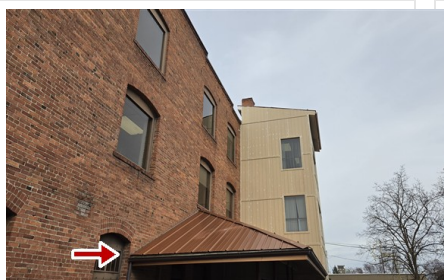
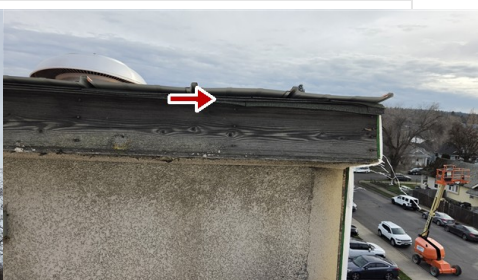
Missing kick-out flashing at the addition. This allows water from the roof to bypass the gutters and can cause siding damage or water intrusion problems. Diverting the water with kick-out flashing will minimize this and lower the risk of water intrusion.

The upper roof of the addition was missing a drip edge which will allow water intrusion under the roofing materials.

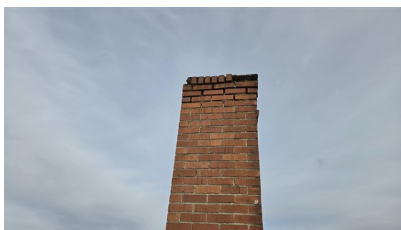
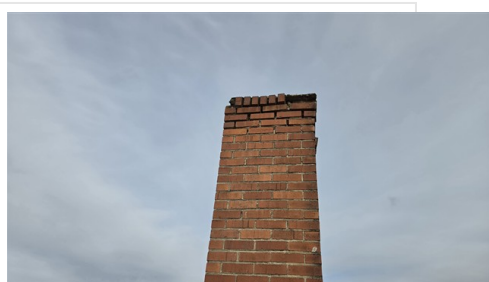
4.10 Item 1 (Picture)

The furnaces exhaust flues were routed into a brick chimney which had a missing or inadequate flue liner. This condition can cause deterioration of the chimney interior from the corrosion actions of condensation.

The chimney had extensive deterioration at the mortar joints of the chimney and/or significant spalling of the brick/block. This will tend to make the chimney unstable over time. The chimney caps had moderate to severe deterioration which should be repaired to avoid moisture intrusion of the chimney structure.

The furnaces exhaust flues were routed into a brick chimney which had a missing or inadequate flue liner. This condition can cause deterioration of the chimney interior from the corrosion actions of condensation. The chimney had extensive deterioration at the mortar joints of the chimney and/or significant spalling of the brick/block. This will tend to make the chimney unstable over time. The chimney caps had moderate to severe deterioration which should be repaired to avoid moisture intrusion of the chimney structure.

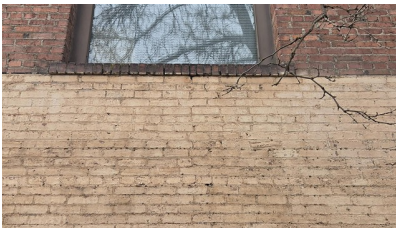
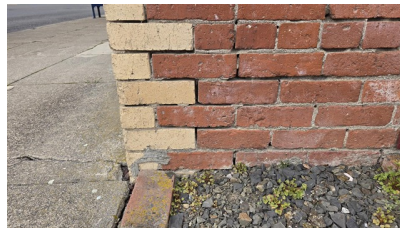
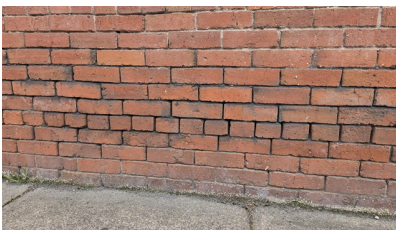
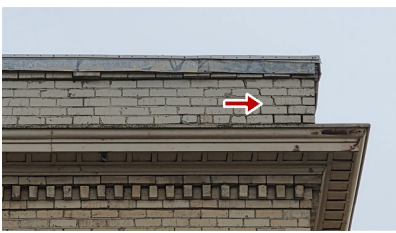
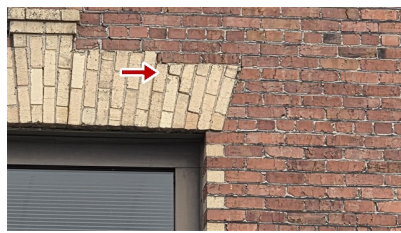
(1) The exterior wall coverings were brick for the original building. The brick serves as both as the wall covering and the structural system. The addition that was built to house the elevator shaft appear to be wood framed with hardboard siding.

(2) In general, the fields of the walls were in average condition. Extensive damage was noted to mortar joints at various locations on the walls where water runoff has occurred. This is typical of deferred maintenance of masonry systems. Periodic repointing of mortar joints is a normal part of maintenance on masonry walls. The process of repointing involves removal of damaged mortar, cleaning up the joints between the masonry pieces, and replacing the old mortar with new product. Minor cranking was noted at several locations on the wall. A substantial crack was noted over one window on the west side of the building where it appeared that a lintel has failed. The upper grout corners of the parapet wall were cracked. Damaged brick was noted along the parapet wall.

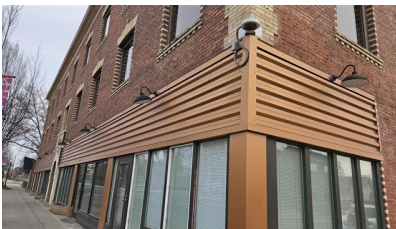
5.1 Item 1 (Picture)

A metal facade was added to the front of the building. No readily observable material deficiencies were observed.

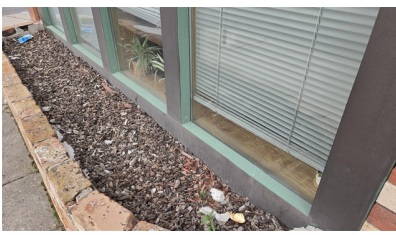
5.3 Item 1 (Picture)

(1) The installed windows appeared to be thermally paned assemblies set in wood frames. Condensation marks were noted on the interior sills which is consistent with this type of window. No readily observable material deficiencies were noted. Please note that these windows are likely 40 years old or older. Reserves should be held for eventual replacement.

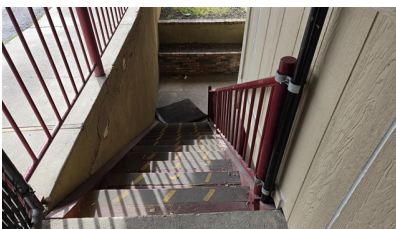
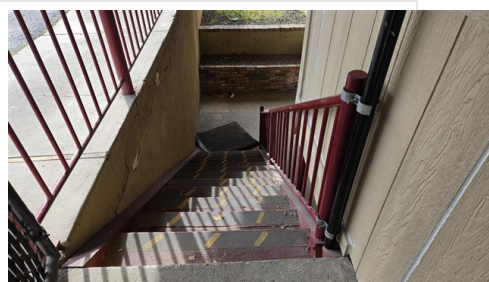
5.6 Item 1 (Picture)

There were four exterior stairwells for the property. These appeared to be in serviceable condition. Issues were observed with the installed guard- and handrails. While they met the standard at the time of construction, current safety standards mandate handrails on both sides of the stairwell and a maximum baluster spacing of 4 inches on guard rails.

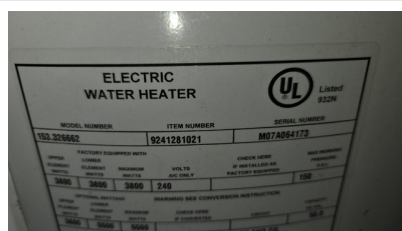
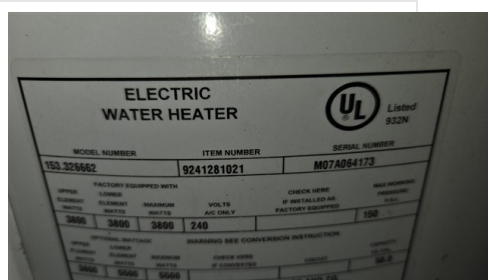
7.3 Item 1 (Picture)

The water heater was missing the following elements: seismic strapping and an expansion tank.

A single water heater was present for the building. This unit was a Sears water heater manufactured in 2007 and rated at 50 gallons of capacity. It is a residential model from a manufacturer that is no longer in business. The water heater was missing the following elements: seismic strapping and an expansion tank.

This piece of equipment is beyond a normal service life. Recommend replacement.

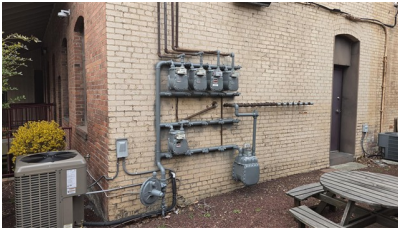
### 8.3 Item 1 (Picture)

(1) The gas meters are located at the east side of the building.

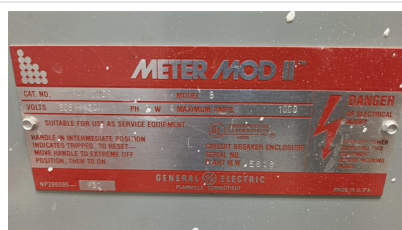
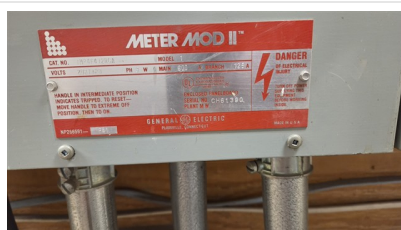
(1) The primary cabinet is a General Electric cabinet rated at 1000 amps and 208Y/120 volts. This cabinet was connected to, and supplied power to, six meter packs with 22 separate meters. Each meter pack was rated at 600 amps. Individual breakers for each meter on these were rated at 100amps.

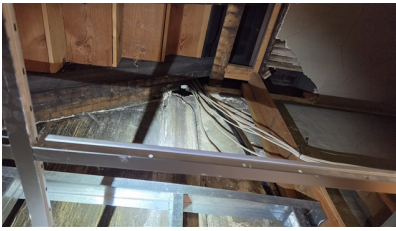
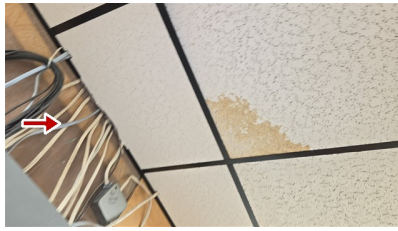
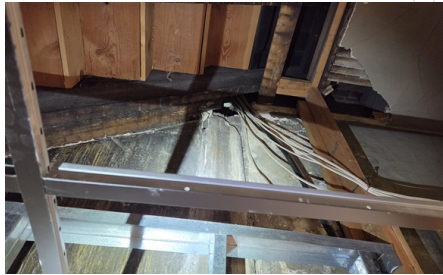
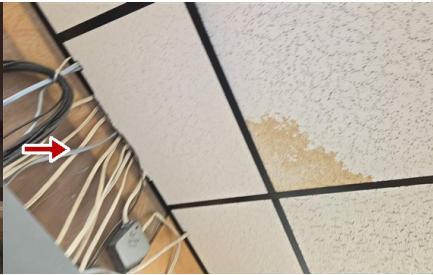
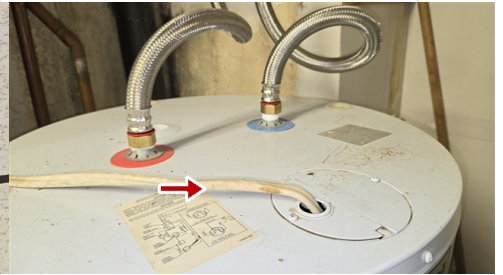
The visible portions of the branch wiring (including conductors, cables, raceways, and wiring methods) were inspected throughout the accessible areas of the property. Wiring was not enclosed in conduit. Electrical wiring observed run exposed in areas remodeled circa 1984. Under the standards in effect at the time of the remodel, commercial building wiring methods were required to utilize approved raceways (conduit), MC cable, or equivalent protected systems in most occupancies. Open/individual exposed conductors and unprotected NM cable were generally prohibited. Current observed exposed wiring does not appear to meet the wiring-method requirements that were in force during the remodel and does not comply with present-day standards for commercial installations.

The visible portions of the branch wiring (including conductors, cables, raceways, and wiring methods) were inspected throughout the accessible areas of the property. Wiring was not enclosed in conduit. Electrical wiring observed run exposed in areas remodeled circa 1984. Under the standards in effect at the time of the remodel, commercial building wiring methods were required to utilize approved raceways (conduit), MC cable, or equivalent protected systems in most occupancies. Open/individual exposed conductors and unprotected NM cable were generally prohibited. Current observed exposed wiring does not appear to meet the wiring-

method requirements that were in force during the remodel and does not comply with present-day standards for commercial installations.

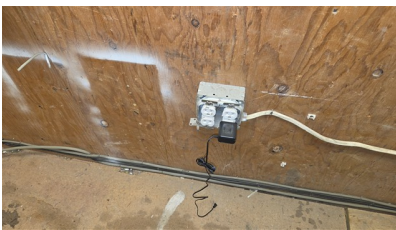
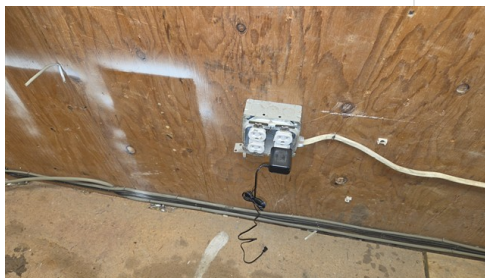
9.4 Item 1 (Picture)

(2) Missing cover plates were observed in several areas. This is a shock and fire hazard.

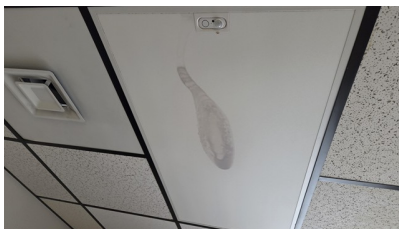
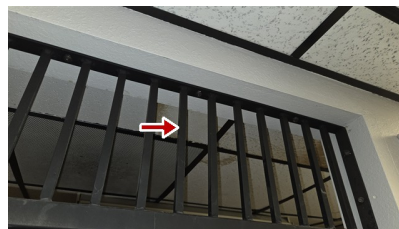
(2) Water stains on the ceiling were observed at all four levels of the building. These were tested either with a moisture meter or imaged with IR. No active leaking was noted.

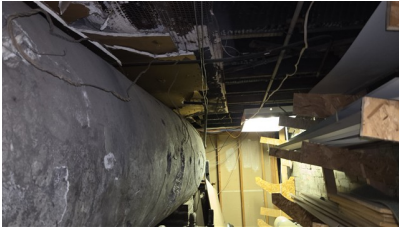
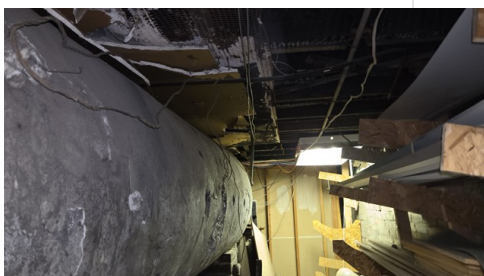
13.0 Item 1 (Picture)

There was an abandoned boiler present that appeared to have an asbestos covering installed. I strongly recommend an Asbestos Inspection by an AHERA accredited inspector. All-West Testing Provides these types of services.
