INSPECTION REPORT  
Spokane Valley WA 99206

INSPECTED BY  
Paul Duffau CCPIA  
001011  
Calibre Commercial  
Inspections, LLC

INSPECTION DATE  
📅 11/7/2024  
🕒 07:00 AM

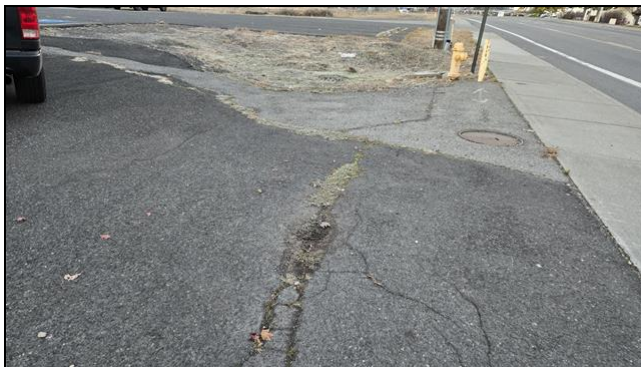
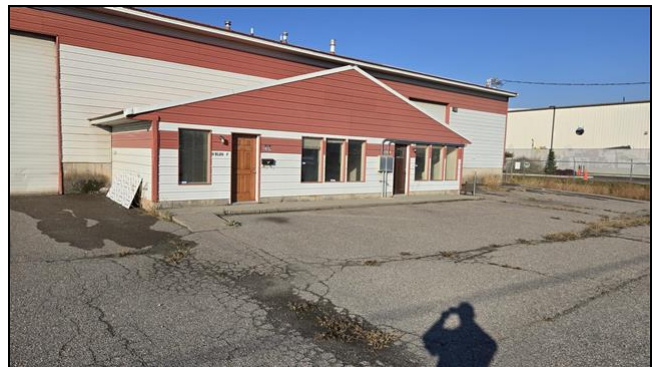
The following maintenance related issues were noted: the asphalt is due for seal-coating to preserve the surface and extend the service life and vegetation should be removed from parking lot surfaces to minimize future damage

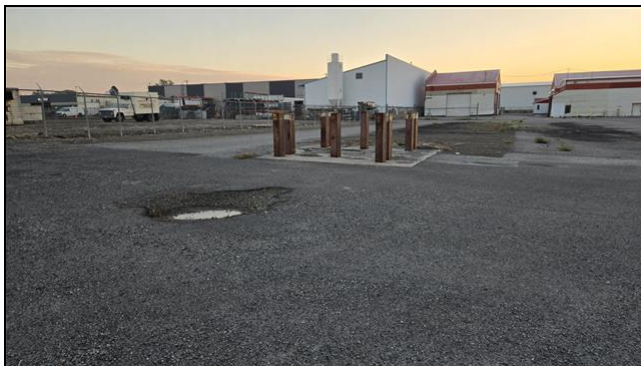
3.1 Item 3 (Picture)

(2) The asphalt surface in multiple locations throughout the yard was damaged as evident by localized alligator cracking suggesting a localized structural failure of the surface, potholes, and possibly the subsurface structure.. Recommend evaluation by a licensed and qualified paving contractor to determine the full scope of the necessary work.

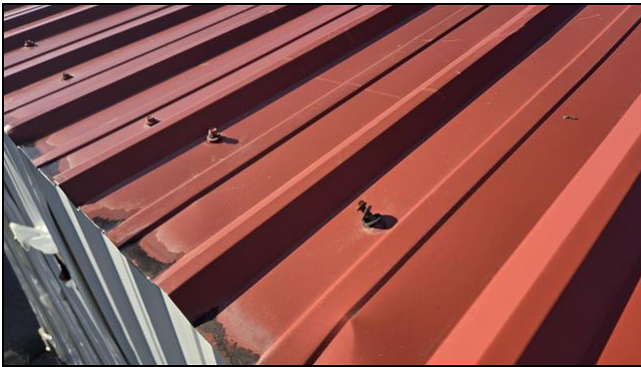
4.1 Item 4 (Picture)

(2) Buildings B-F had metal roofs. The re-roofing of these structures appears to have occurred at the same time as the materials are similar and the degree of fading consistent. Roofs appear to be approximately 20 years old. Numerous loose fasteners noted across all these buildings. Routine maintenance has not been performed. Recommend completion.

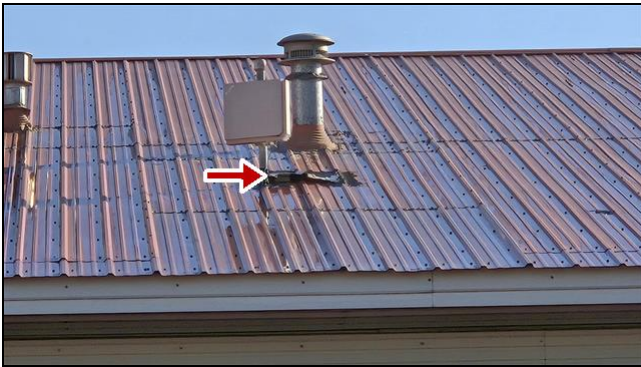
4.2 Item 1 (Picture)

- (1) No readily observable material deficiencies were noted except on Building F
- (2) Flashing lifting on Building F. Recommend repair to prevent water entry.

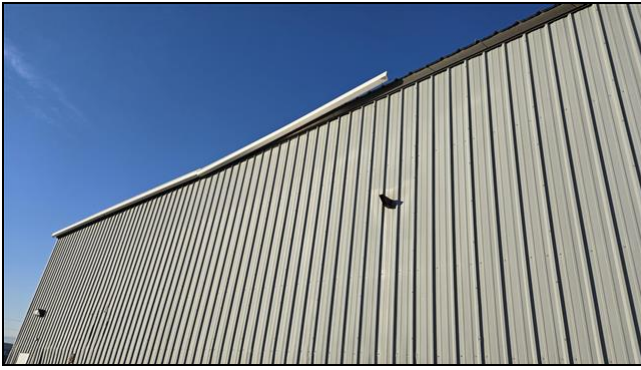
4.4 Item 1 (Picture)

The gutters on Building A were damaged. Recommend repair.

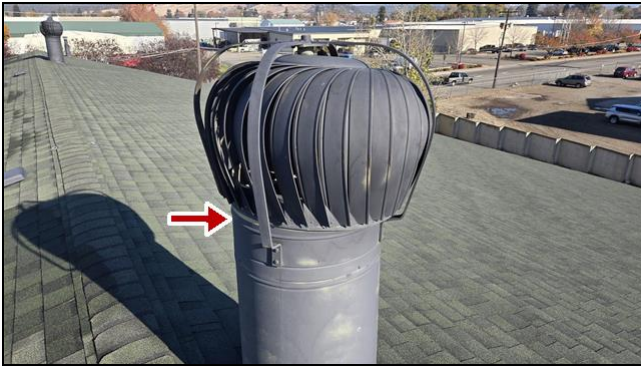
4.7 Item 1 (Picture)

Building A had two turbine vents installed. One is damaged. Recommend repair.

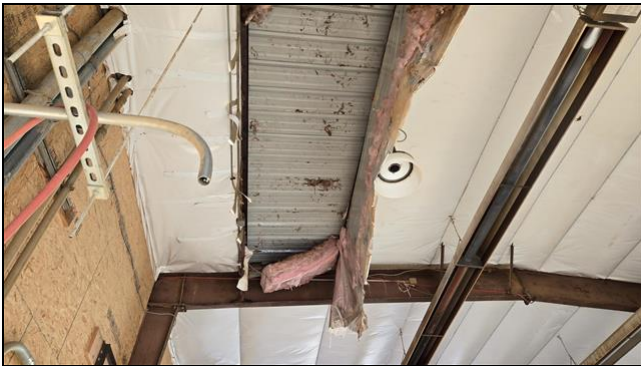
4.8 Item 1 (Picture)

- (1) Building A, D1, D2, E, and F had fiberglass batt insulation.
- (2) Insulation in D1 and D2 was damaged and falling from ceiling cavities. Recommend repair.

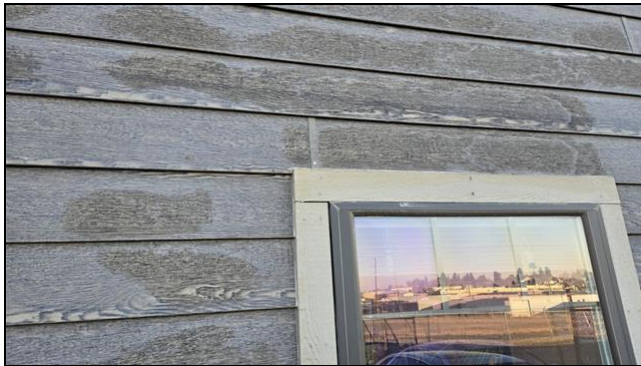
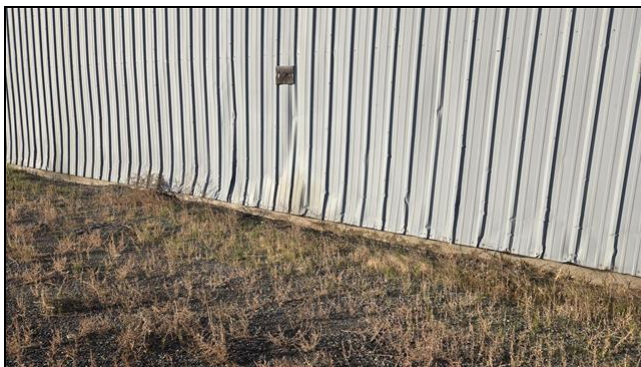
(2) Building A had some minor siding damage to the metal portions of siding. The cement hardboard was improperly installed with poor clearance to grade and hardscape as well as missing head flashing over windows and doors. The cement fiber siding is overdue for painting.

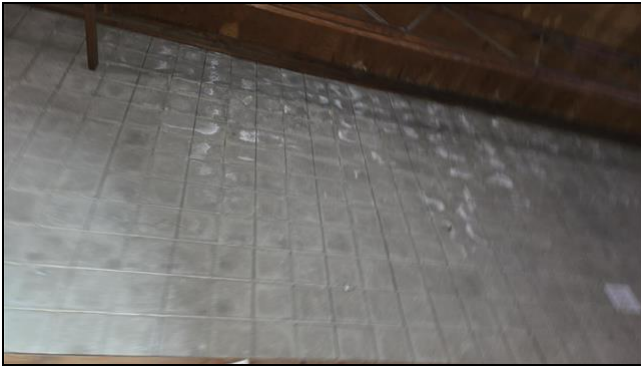
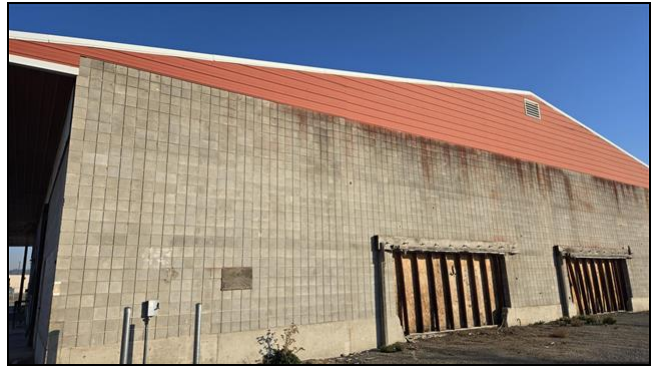
Building C had considerable efflorescence from apparent leakage from the roof assembly. Flashing was missing. Recommend repair.

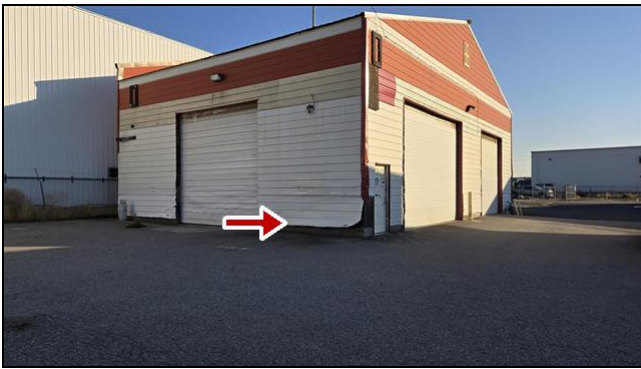
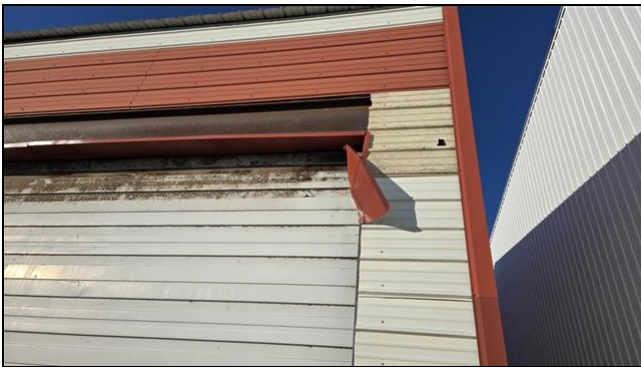
(4) Both D buildings had substantial siding damage that significantly impacts the integrity of the system. Water intrusion noted in multiple locations. Repairs are recommended.

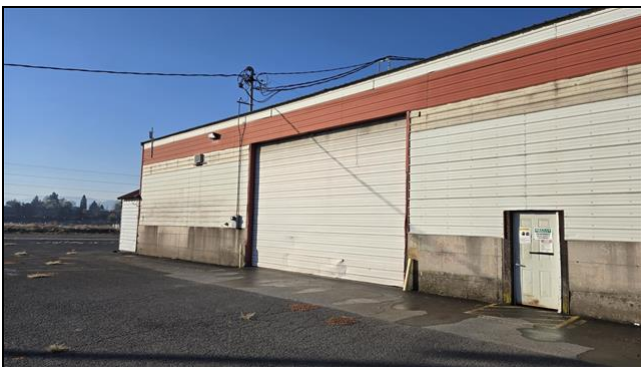
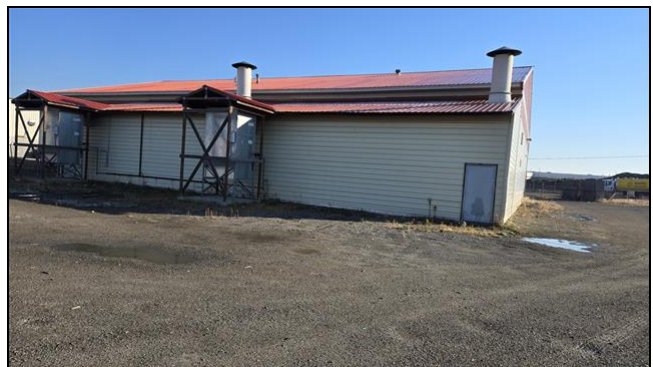
(5) Buildings E and F had minor siding damage.

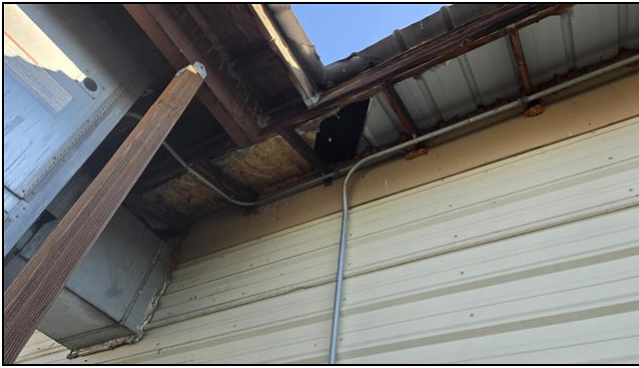
5.0 Item 11 (Picture)

(6) Birds are entering into Buildings E and F through soffits and holes in the siding. Recommend correction.

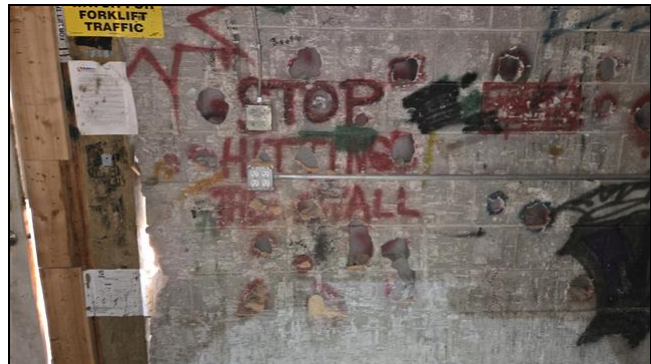
6.2 Item 4 (Picture)

(2) Buildings B and C had concrete masonry wall systems. Substantial opening were made in the walls, especially on Building B, without adequate reinforcement. Building C has substantial damage to individual cells of the block. Recommend repair.

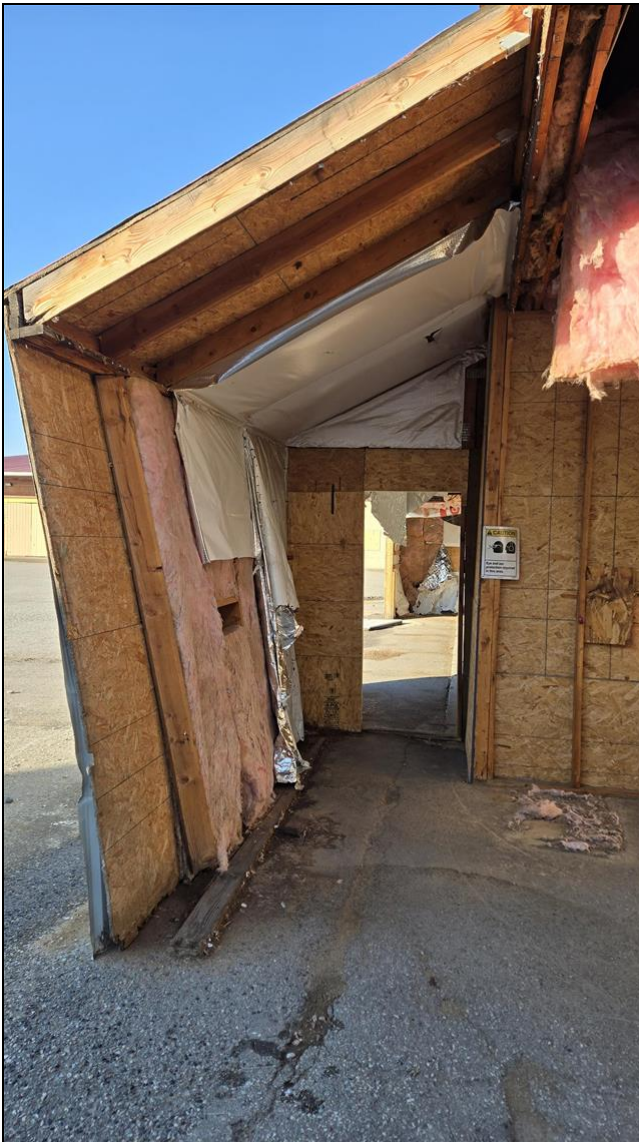
6.2 Item 5 (Picture)

(3) Building D2 had multiple lean-to and shed additions made. These are in very poor repair and collapse is possible. Recommend repair or removal at the earliest opportunity.

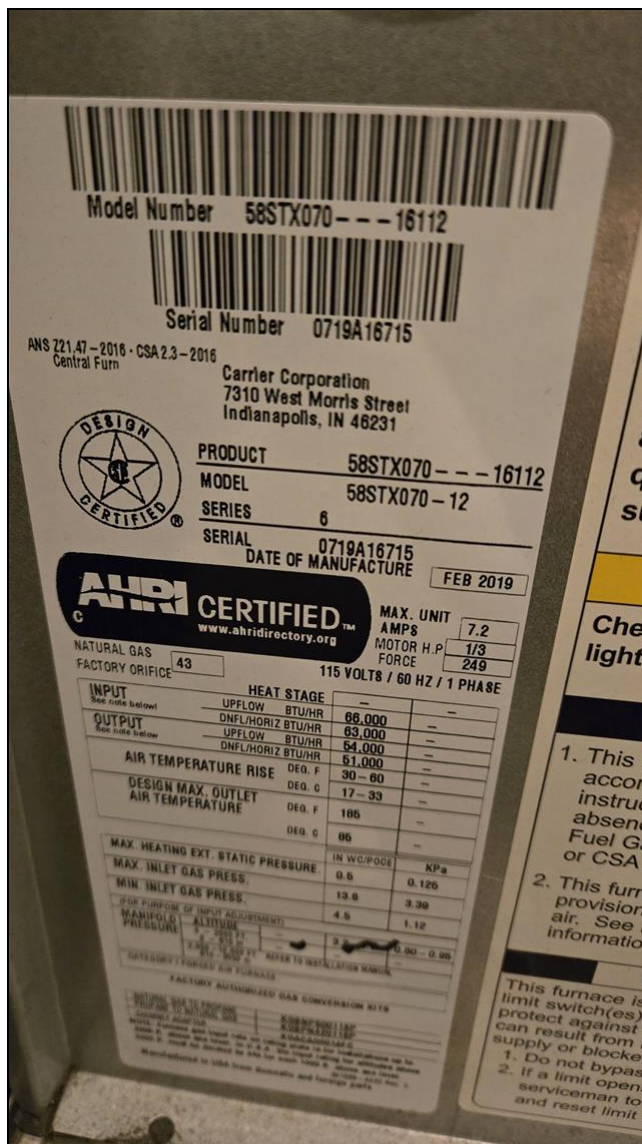
7.0 Item 1 (Picture)

(1) Building A had four gas-fired, forced air furnaces present and readily observable. Two furnaces were manufactured by Carrier Corporation and were located in a mechanical room in the office spaces. These units were each rated at 70,000 BTUs and were manufactured in 2019. These pieces of equipment are well within a normal service life. Recommend continuing with routine maintenance.

The other two furnaces were located in the mezzanine section. These were manufactured by Goodman in 2009. The data plates were not very legible but it appeared that the units were rated for 100,000 BTUs. These are in the final third of a normal service life. Recommend continuing with routine maintenance.

The warehouse had three gas-fired radiant heaters manufactured by Reflect\_O-Ray installed. These were rated at 130,000 BTUs (where the tag was visible) and are 35 years old. These are beyond a normal service life. Replacement is recommended.

Based on available records, inspections stickers, or the lack thereof, routine maintenance appears to be overdue. Recommend maintenance for this unit at this time.

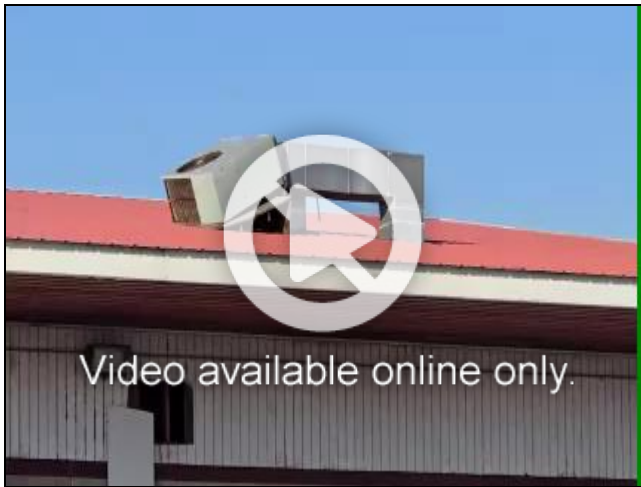
7.0 Item 5 (Video)

(2) Building C had a unitary heating system that was roof mounted. The stand for that unit has collapsed. The unit does not appear operational. Recommend replacement.

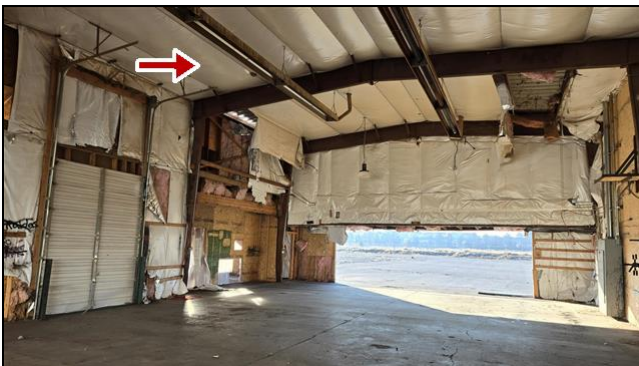
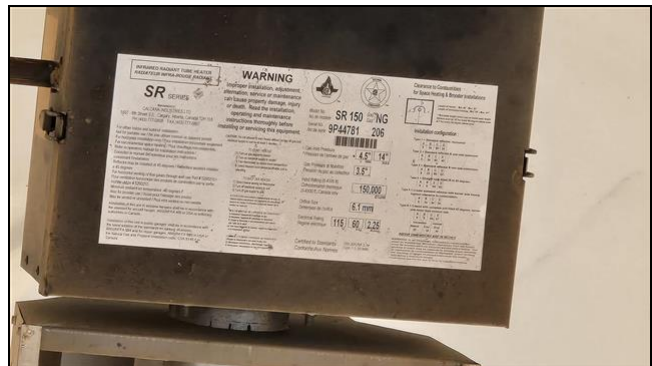
(3) Building D2 had a pair of infrared heaters. Data tags were not fully legible. They were manufactured by Calcana Industries and rated at 150,000 BTUs. These appeared to be approximately 15 years old. Recommend service.

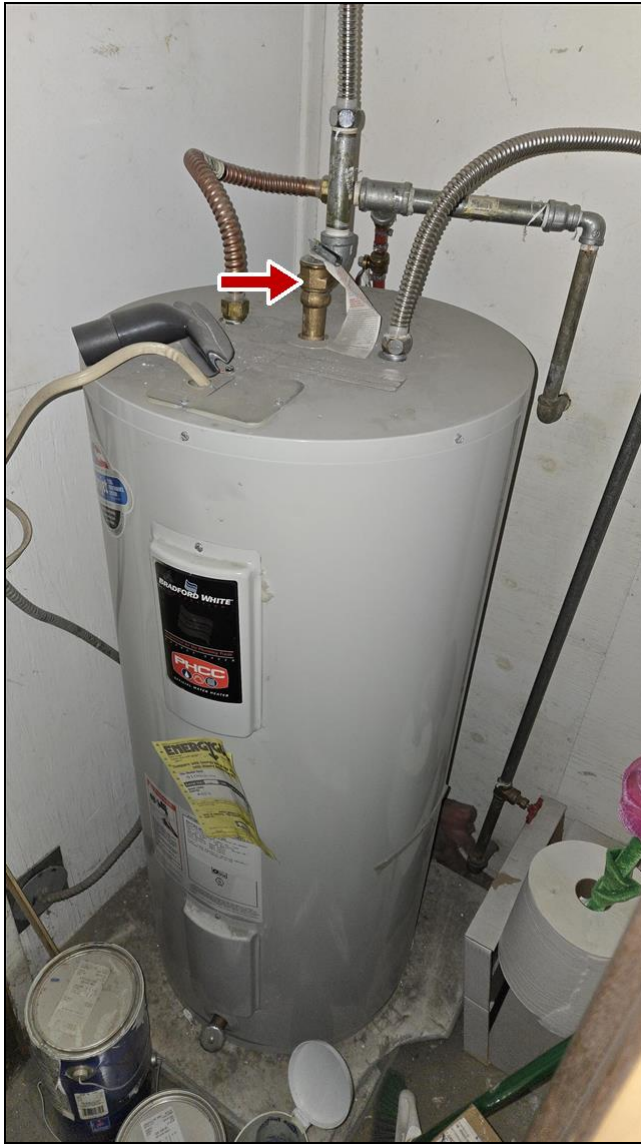
7.3 Item 1 (Picture)

This piece of equipment is at the end of a normal service life. Recommend continuing with routine maintenance and developing cash reserves for eventual replacement. Based on available records, inspections stickers, or the lack thereof, routine maintenance appears to be overdue. Recommend maintenance for this unit at this time.

\The water heater's temperature-pressure relief valve drain line is routed upward. This valve is an emergency device, but periodically small amounts of water could be discharged. If the drain is routed up, water can collect near the valve and that can lead to corrosion and impair the operation of the valve during an emergency. Therefore, drain line must be routed either down or horizontally. It cannot be routed up, even over a short distance. Recommend having a qualified plumbing contractor fully evaluate and repair so the drain line is properly routed down or horizontally.

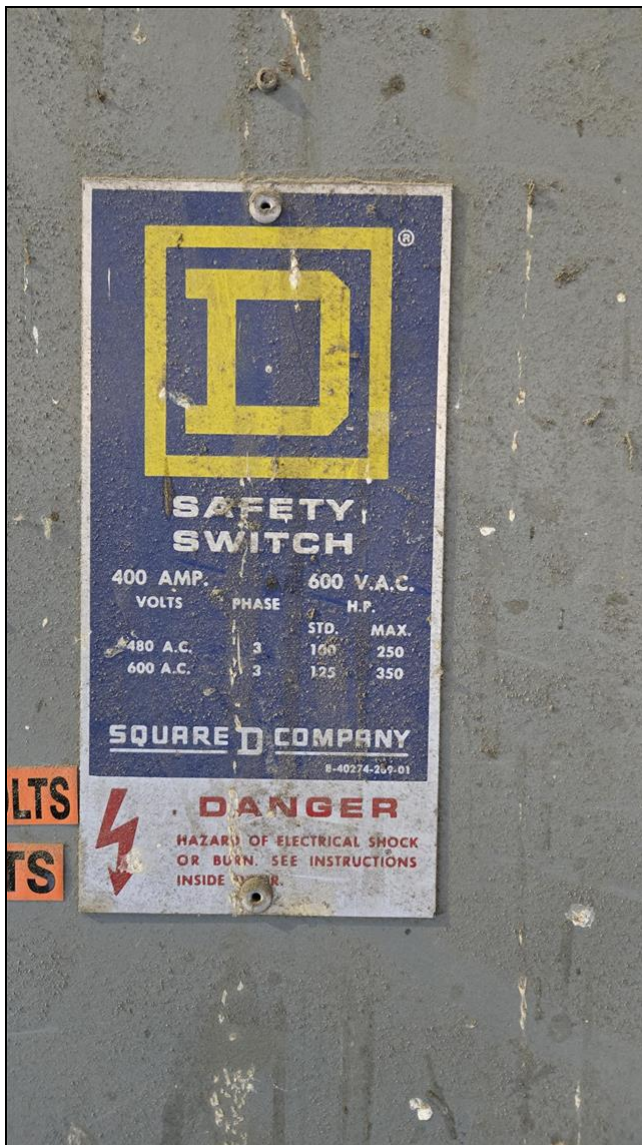
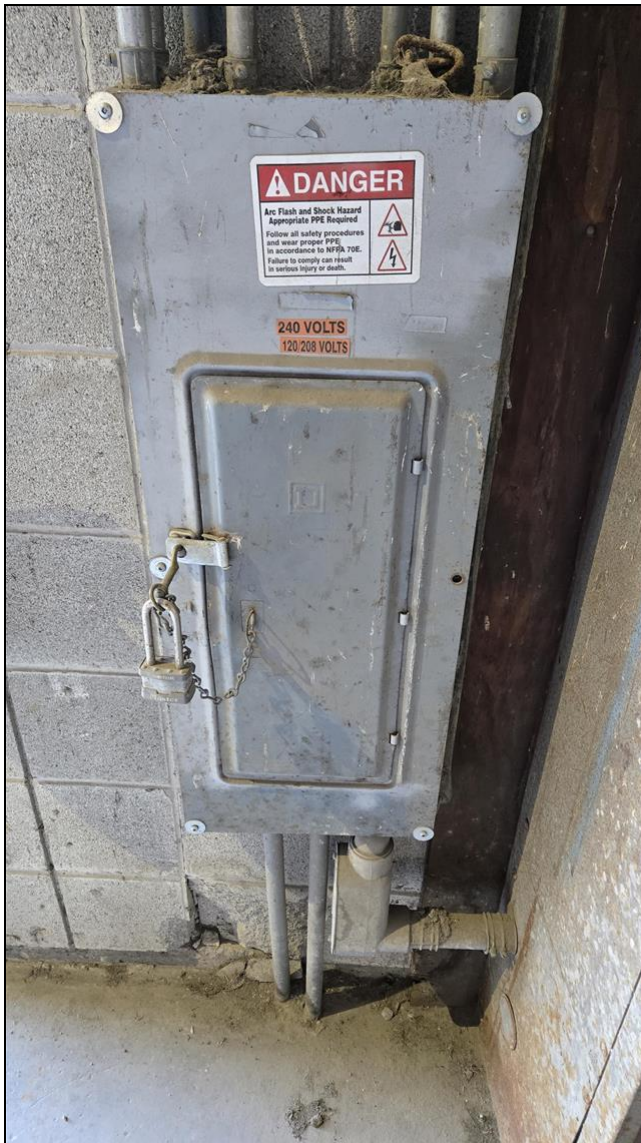
(3) Building B had a 400 amp Square D service. A transformer was located in this building. The main fuse and panel system is aging and due for replacement. The main panel was locked.

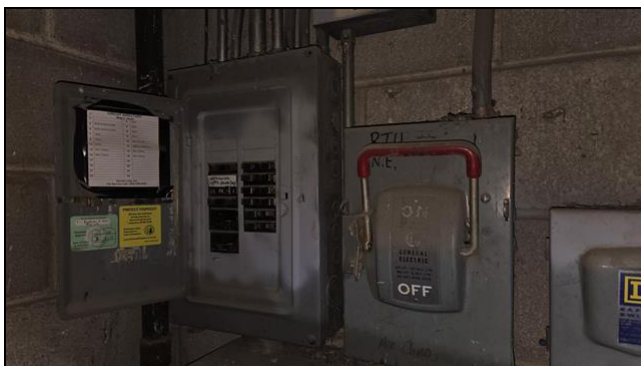
9.2 Item 13 (Picture)

(4) Building C had antiquated main fuses. A transformer was located in this building. The main fuse and panel system is aging and due for replacement. Power appeared to be 120/208v. The main fuse was rated at 200amps. Multiple switches and secondary panels were present, almost all aging.

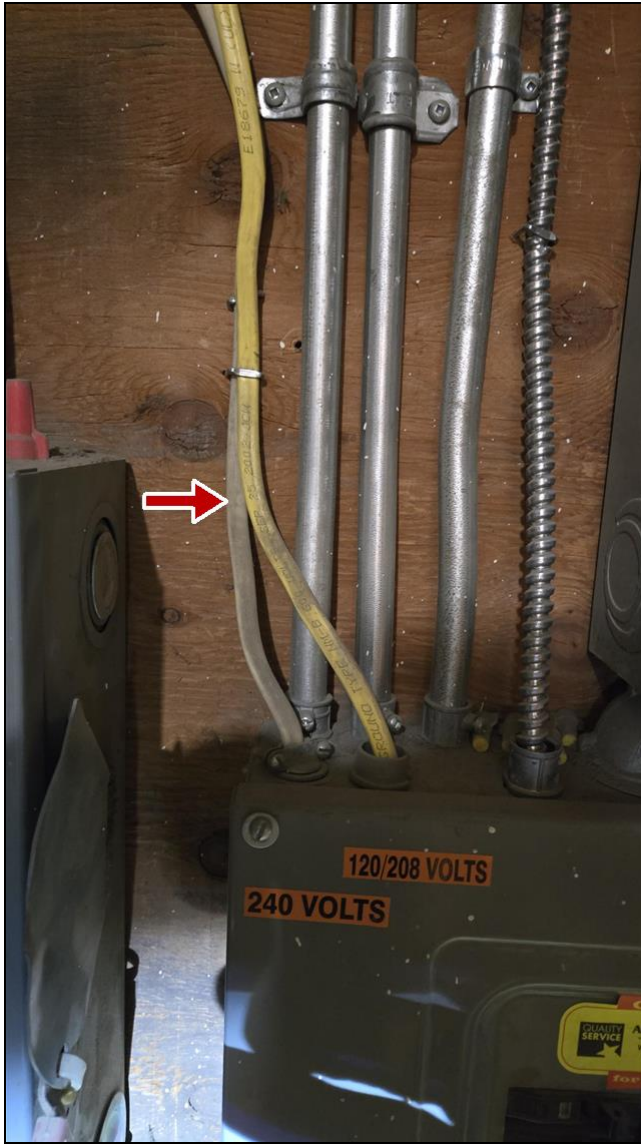
9.3 Item 1 (Picture)

Newer wiring in Building A did not conform to current safety standards. It was installed without conduit. Recommend repair by a licensed and qualified electrical contractor.

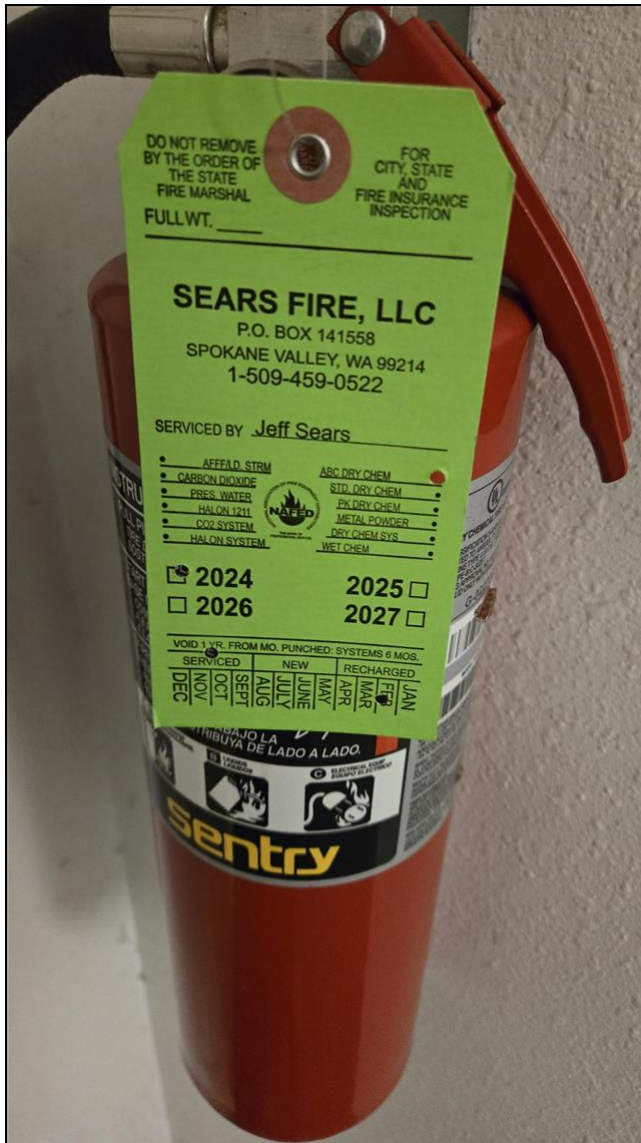
#### 10.4 Item 1 (Picture)

Present but universally out-of-date or missing for all the buildings except Building A. Recommend correction.

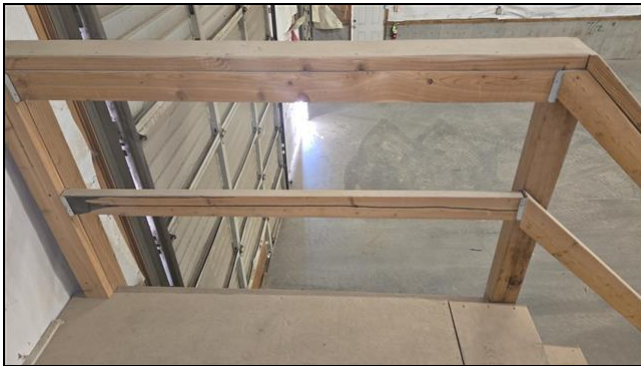
11.4 Item 1 (Picture)

Stair railings to loft/mezzanines in Buildings E and F do not have proper baluster spacing. Recommend repair.
