| <b>Property Address</b> | <b>Date of Inspection</b><br>8/30/2024 | <b>Report ID</b><br>20240830-12003-Vancouver-WA |

| <b>Building Use:</b><br>OFFICE | <b>Number of Buildings:</b><br>ONE | <b>Approximate building size:</b><br>5000+ square feet |

This is a Commercial Building Inspection Report developed using the Standards of Practice for the CCPIA.

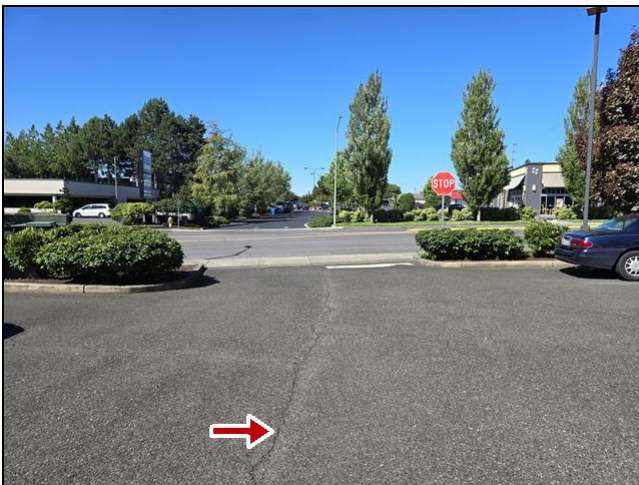
2.1 Item 3 (Picture)

(2) The following maintenance related issues were noted: the asphalt is due for crack seal-coating to preserve the surface and extend the service life. Recommend consulting a licensed and qualified paving contractor for an estimate of costs.

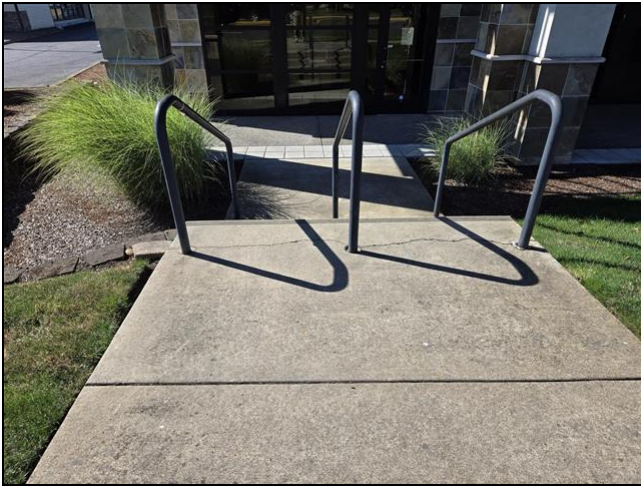
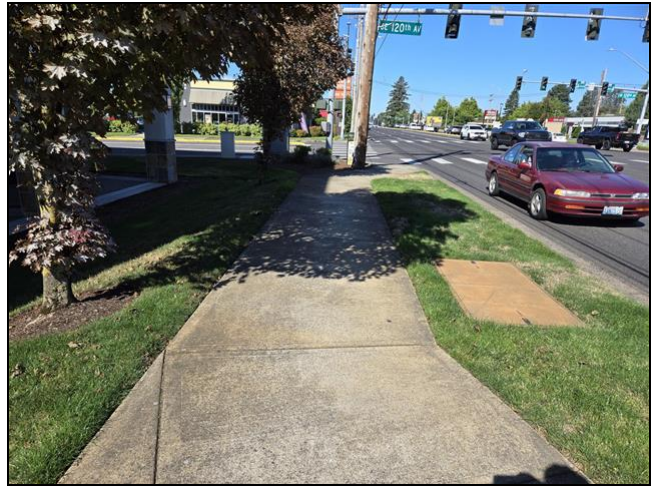
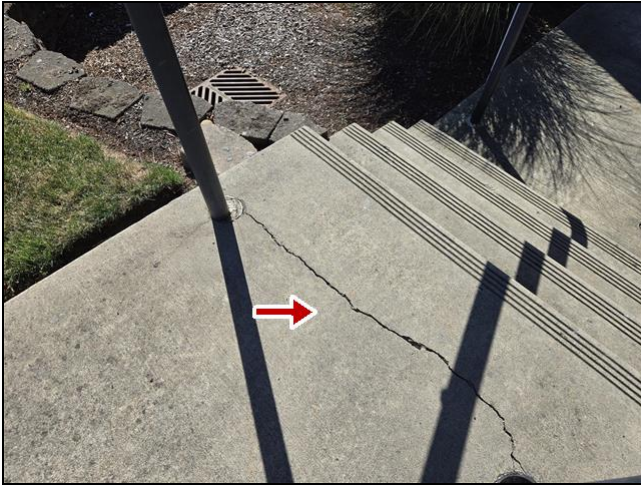
Cracking at the top of the steps should be sealed to prevent water intrusion/damage.

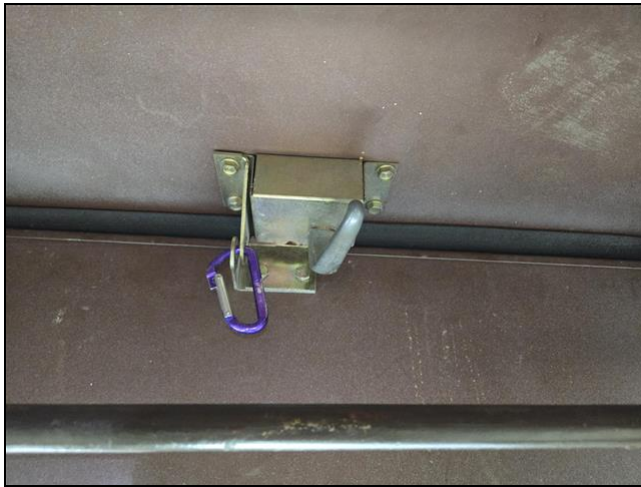
3.0 Item 1 (Picture)

There was a roof access scuttle located in a hall closet. Scuttle locking mechanism appeared damaged and did not engage. Hatch was held shut with a carabineer. Recommend repair.

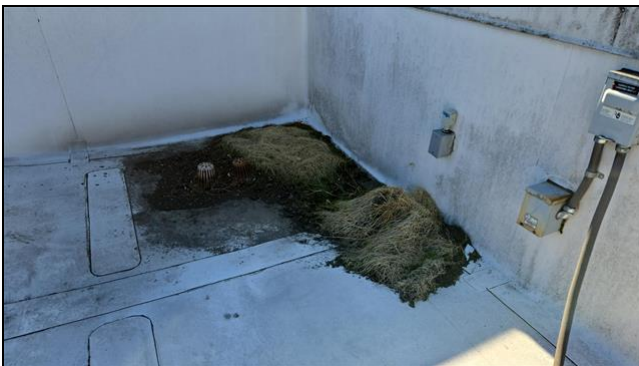
3.4 Item 1 (Picture)

Roof drainage is accomplished by use of scuppers located in the rear corners of the building. These Skippers have not been recently maintained and will pose a point of potential water intrusion. Recommend repair at earliest opportunity.

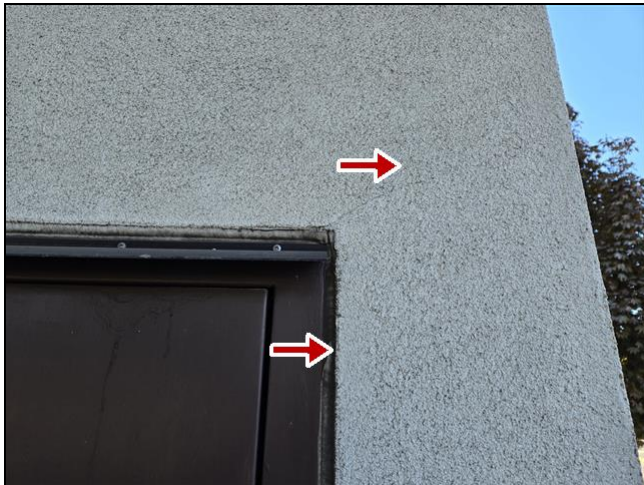
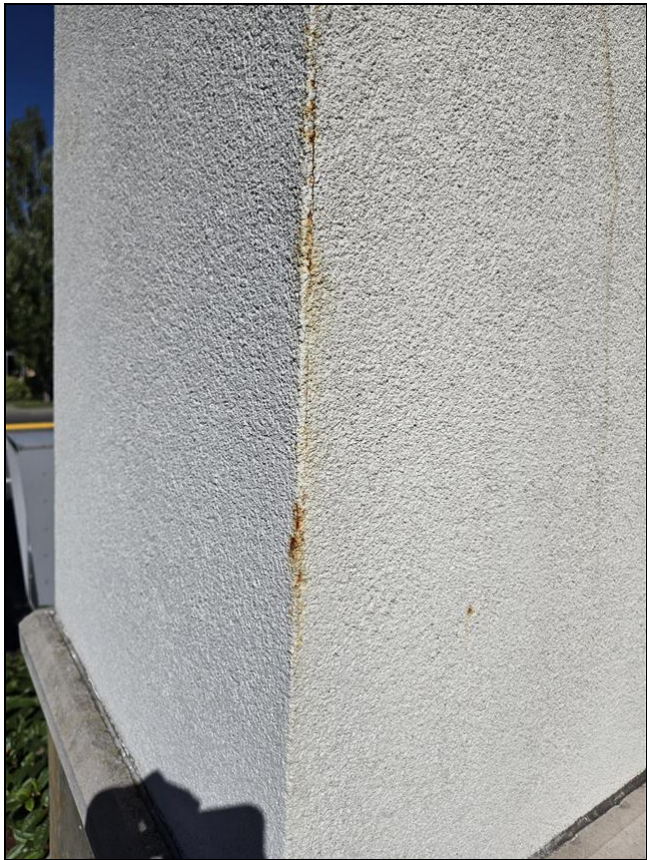
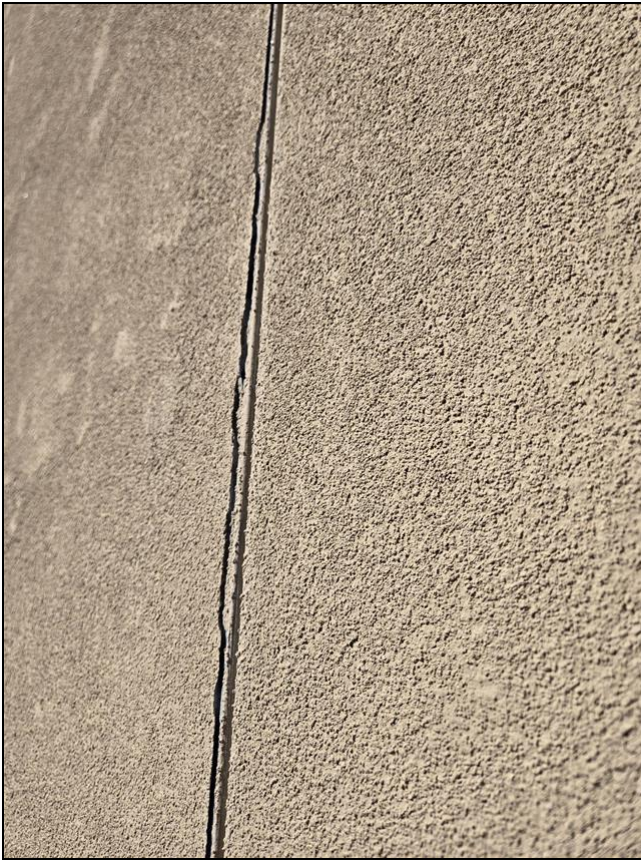
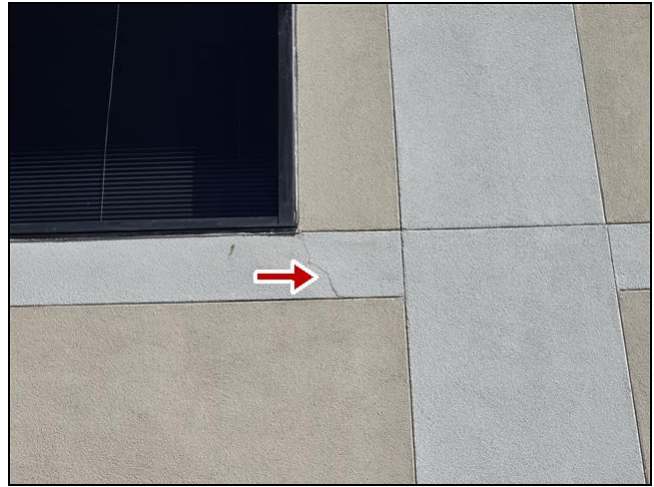
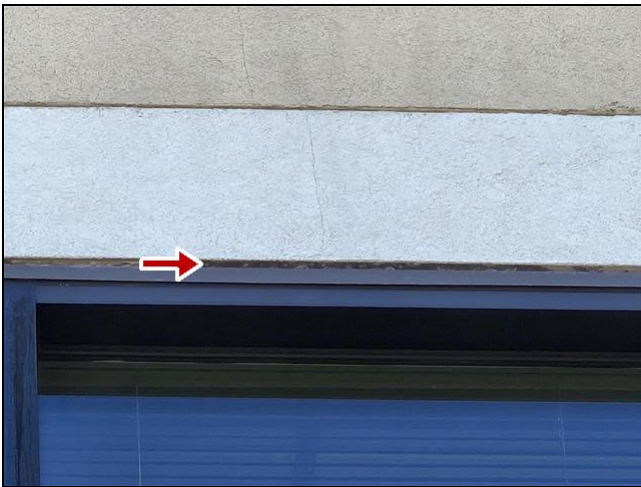
(2) Inspection of the EIFS siding revealed significant concerns. This siding requires very specific installation practices. The surface of the siding has numerous cracks, none of which appeared to have ever been repaired/sealed. Minor differential movement was noted between sections. Water intrusion was noted in multiple locations. In at least one location, rust staining was visible suggesting that water intrusion and damage was occurring. It appeared that the caulking around windows, doors, and penetrations was degrading.

I strongly recommend having the siding inspected by a certified EIFS specialist to determine the full scope of the issues and the costs of any necessary repairs.

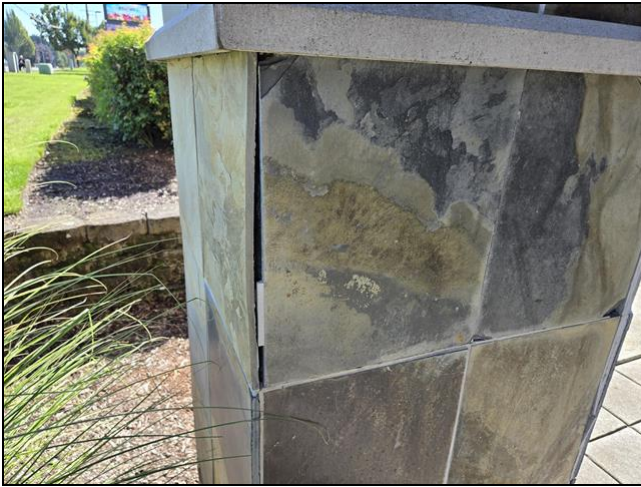
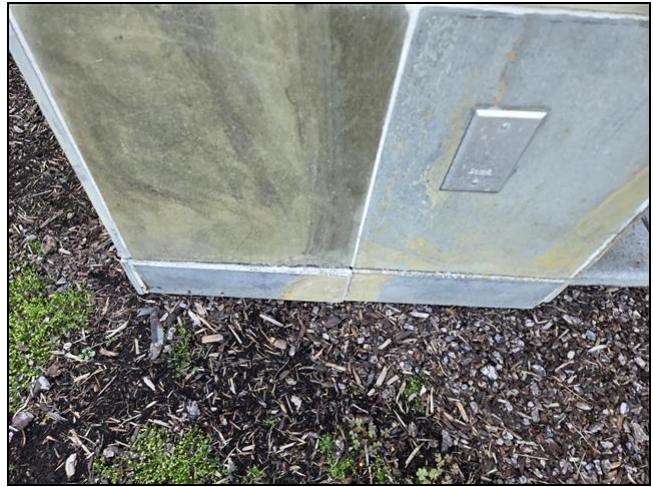
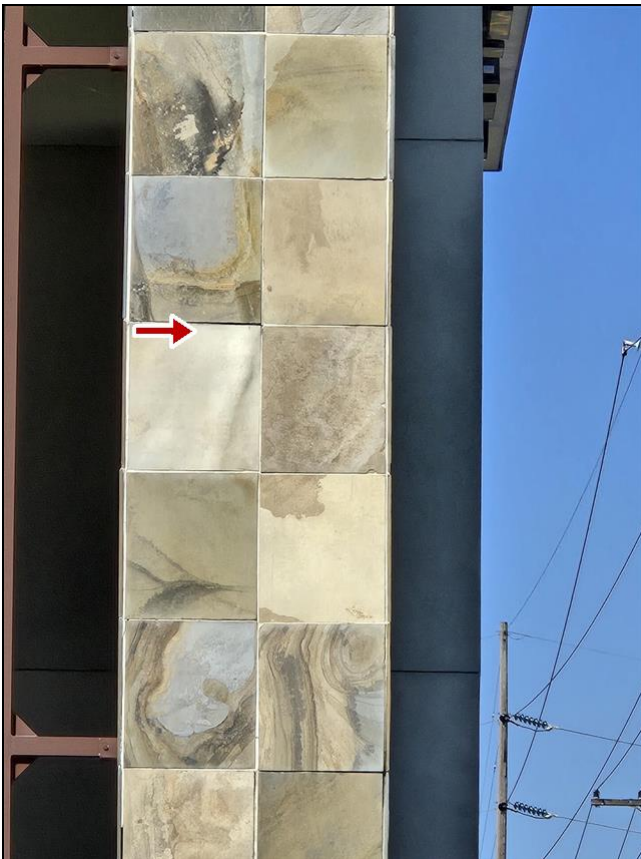
(3) Slate was applied as a architectural veneer at the front of the building. The attachment of the veneer is failing. Three pieces of slate are already missing and many more are loose and in danger of falling. Should falling pieces strike a pedestrian, the liability could be significant. Recommend consulting a contractor with expertise in these materials and their installation in this environment to determine the best course of action moving forward, either repair or full replacement.

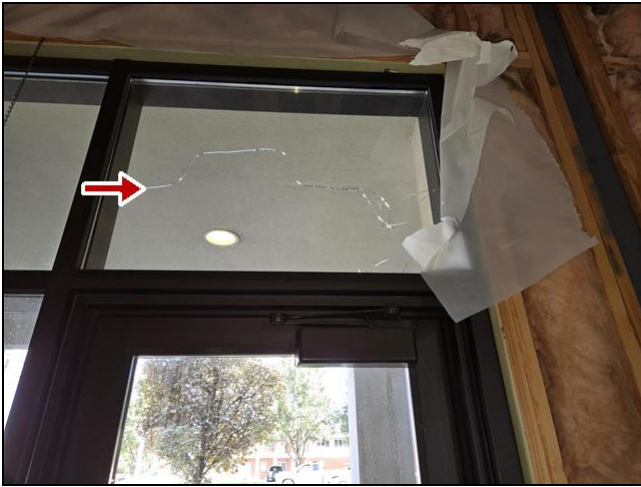
4.1 Item 1 (Picture)

- (1) Windows were thermal-panel glazing set in anodized metal frames.
- (2) One window on the front of the building was broken. Recommend repair.

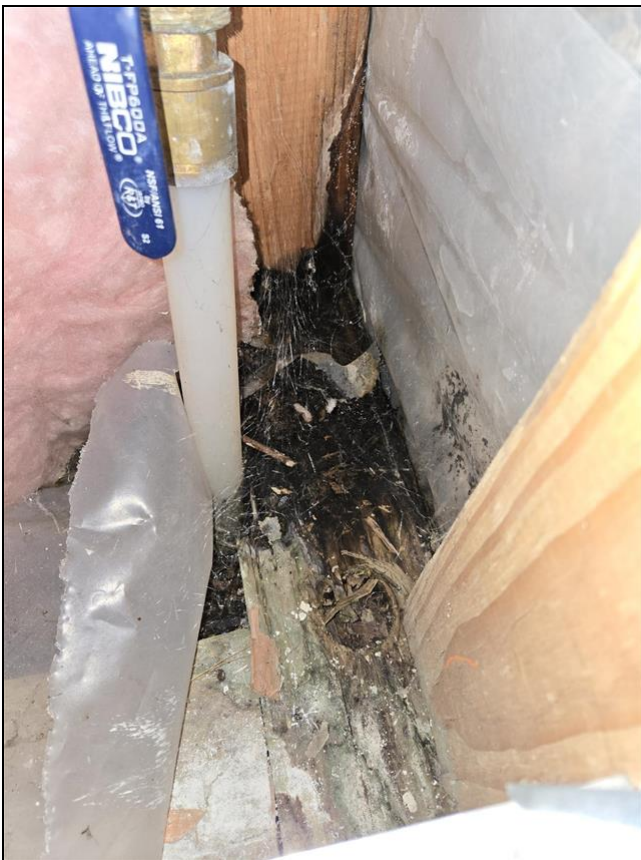
5.1 Item 2 (Picture)

(2) The sill plate at the water main appears to have wood rot/wood-destroying fungus present. Recommend repair.

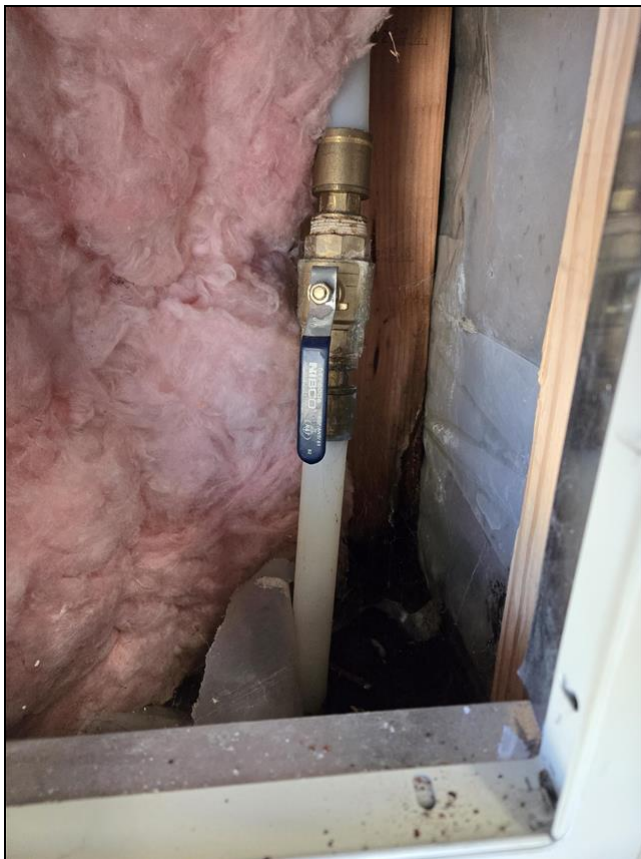
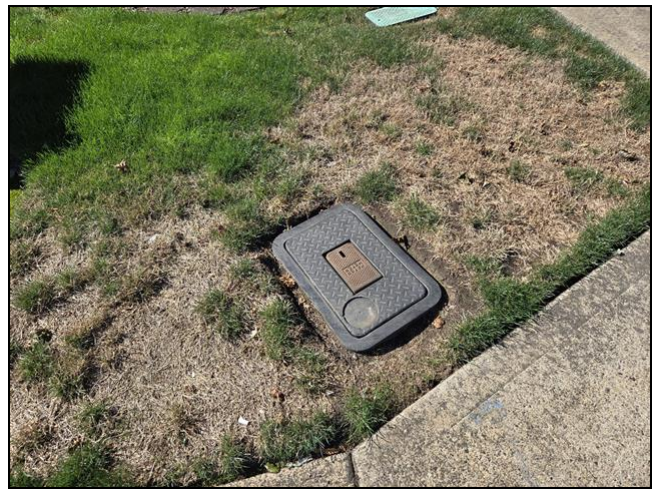
The water main line is located at the front of the building in the corner by the staircase. It was leaking at the valve. This led to mold and wood-destroying fungus issues. Recommend repair at earliest opportunity.

Wall damage present at the point of the leaking water main.

Fungal growth was noted on the front wall of the first floor at the leaking water main. Recommend evaluation by a mold remediation specialist to determine the best treatment plan and to implement same. Recommend work be completed at the earliest opportunity.

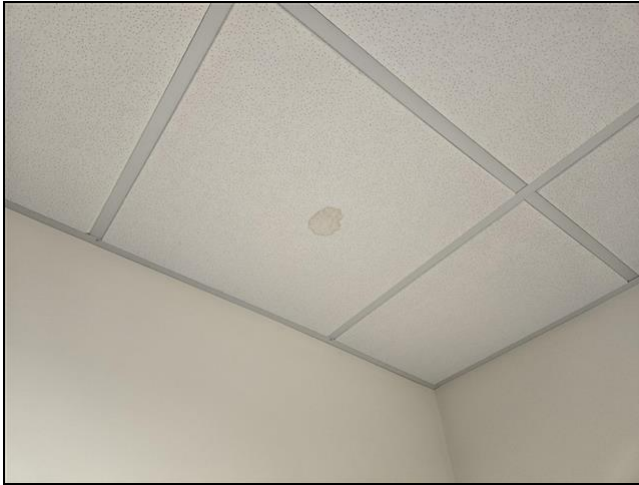
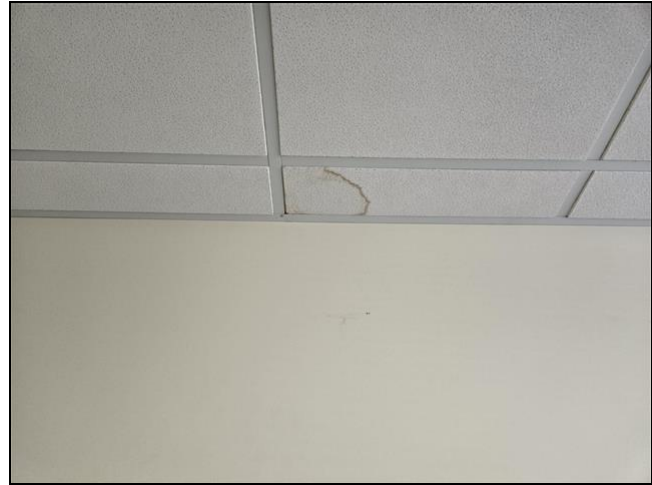
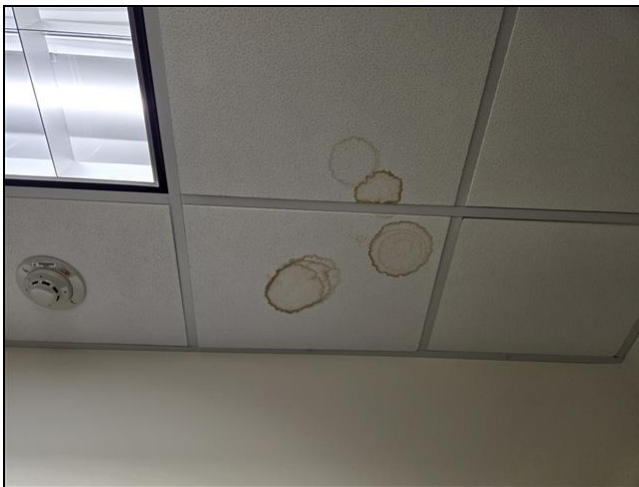
Water stains were noted in four separate locations in the upper suite. These tested as dry at the time of inspection. Recommend monitoring.

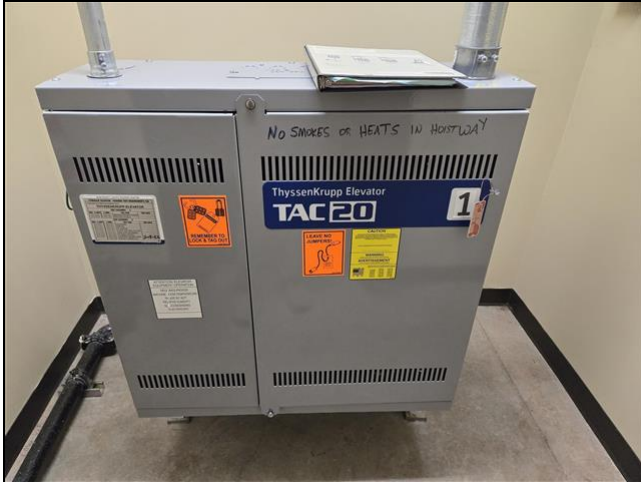
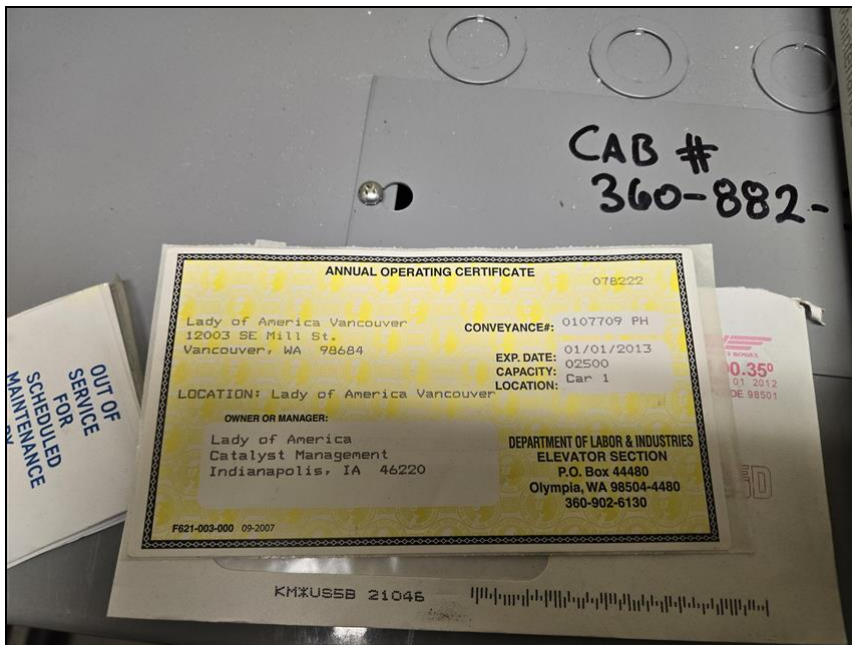
Unable to locate a current license or inspection report for the elevator. Recommend obtaining these documents. If not up-to-date, I recommend that these be brought current prior to the transfer of the property to new owners.

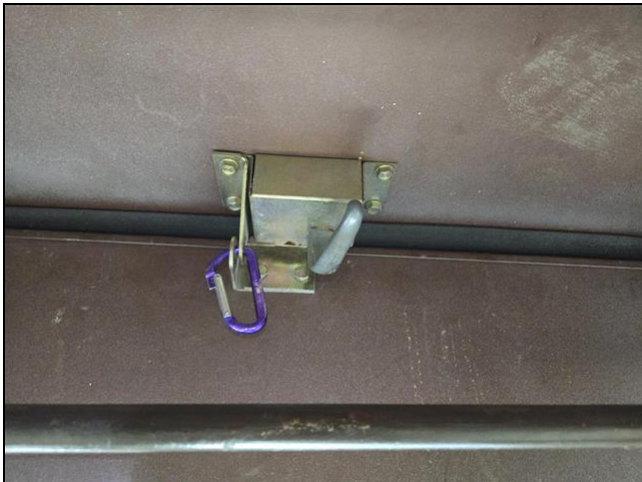
3.0 Item 1 (Picture)

There was a roof access scuttle located in a hall closet. Scuttle locking mechanism appeared damaged and did not engage. Hatch was held shut with a carabiner. Recommend repair.

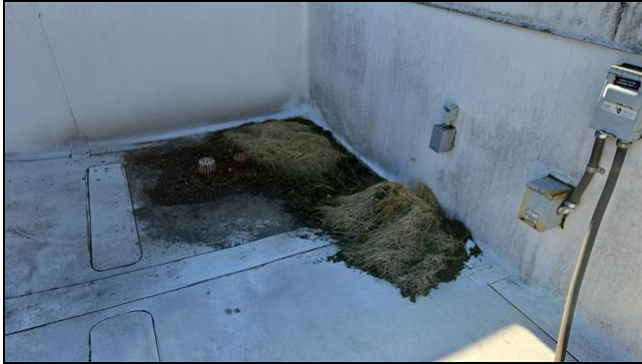
3.4 Item 1 (Picture)

Roof drainage is accomplished by use of scuppers located in the rear corners of the building. These Skippers have not been recently maintained and will pose a point of potential water intrusion. Recommend repair at earliest opportunity.

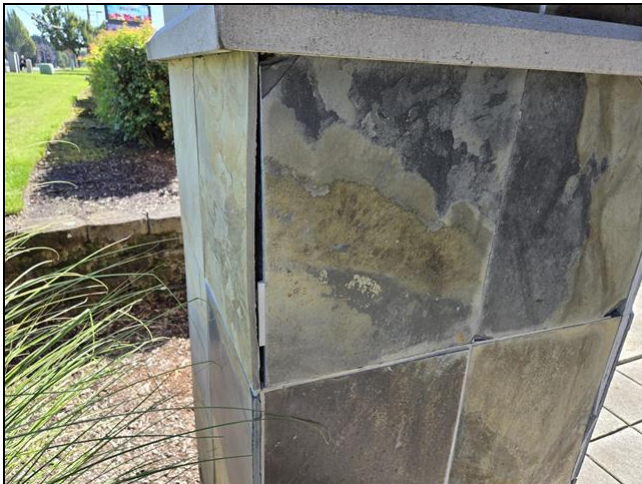
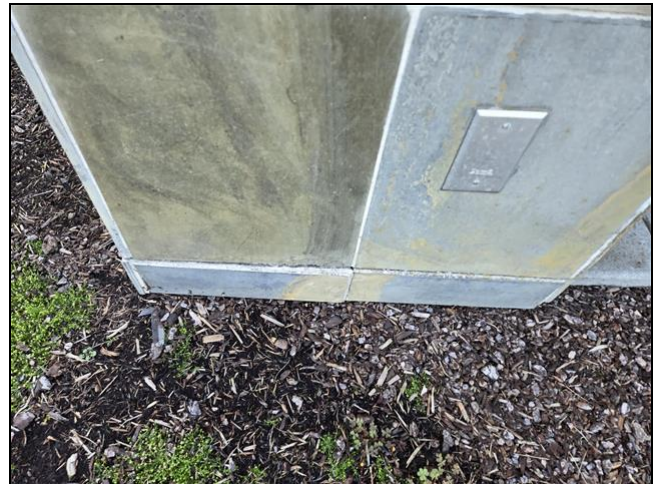
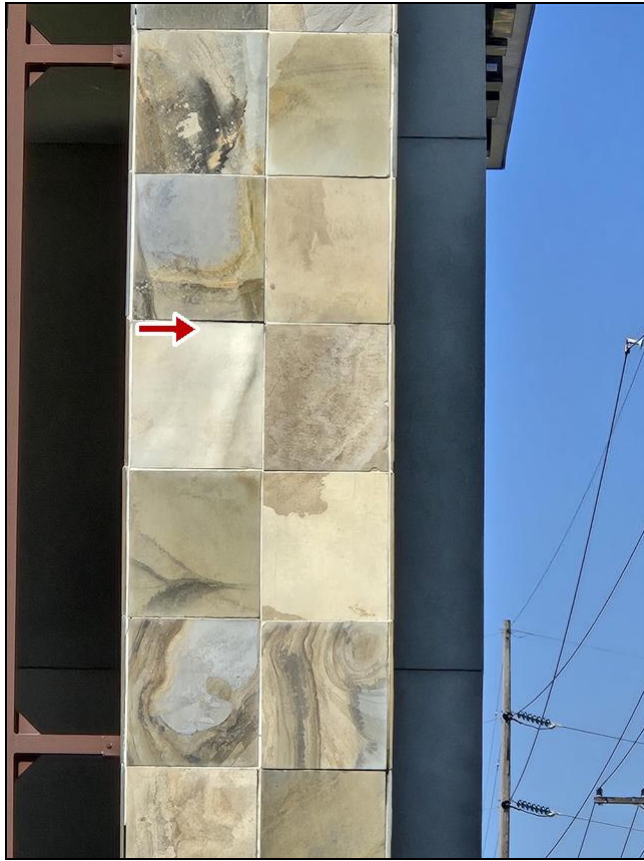
(3) Slate was applied as an architectural veneer at the front of the building. The attachment of the veneer is failing. Three pieces of slate are already missing and many more are loose and in danger of falling. Should falling pieces strike a pedestrian, the liability could be significant. Recommend consulting a contractor with expertise in these materials and their installation in this environment to determine the best course of action moving forward, either repair or full replacement.

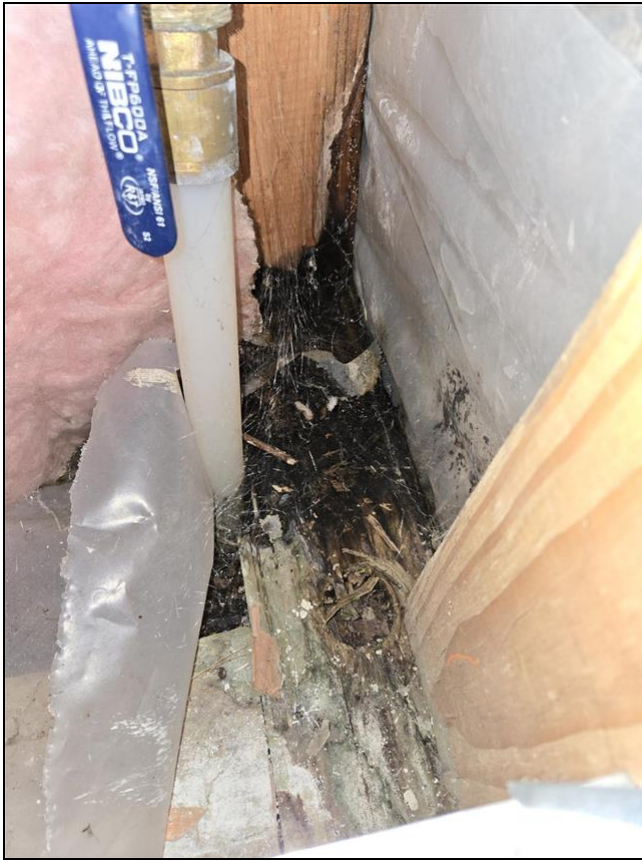
5.1 Item 2 (Picture)

(2) The sill plate at the water main appears to have wood rot/wood-destroying fungus present. Recommend repair.

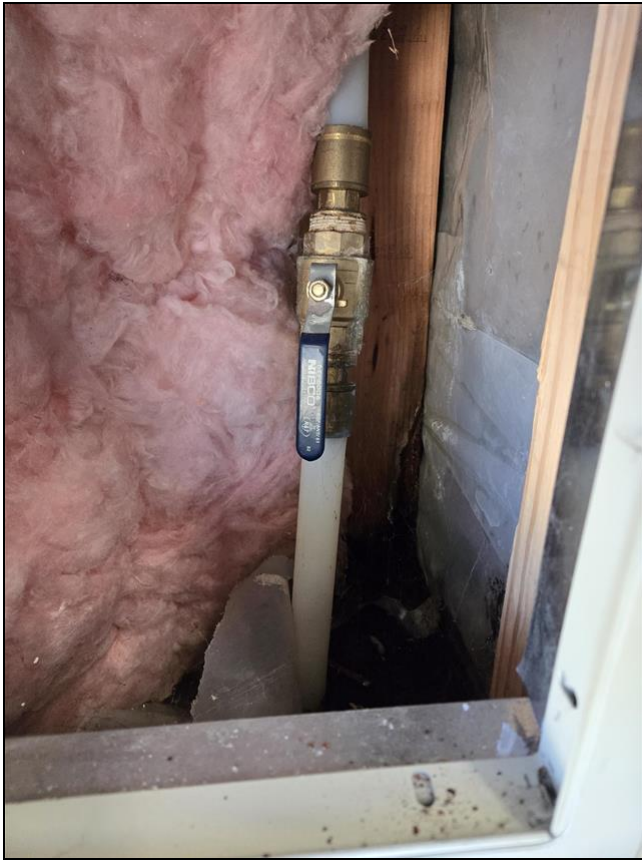
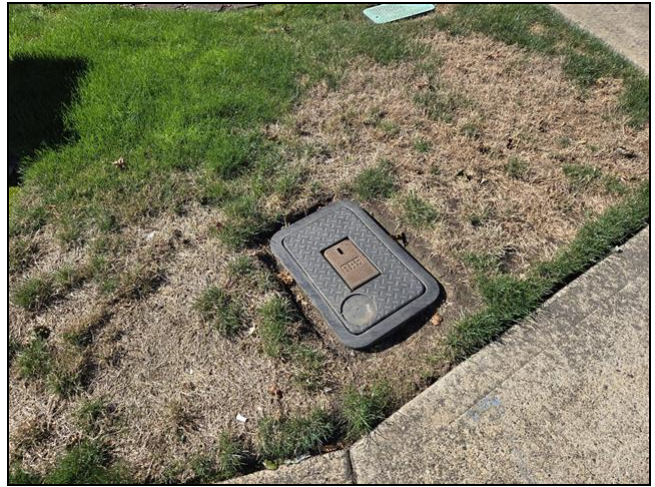
The water main line is located at the front of the building in the corner by the staircase. It was leaking at the valve. This led to mold and wood-destroying fungus issues. Recommend repair at earliest opportunity.

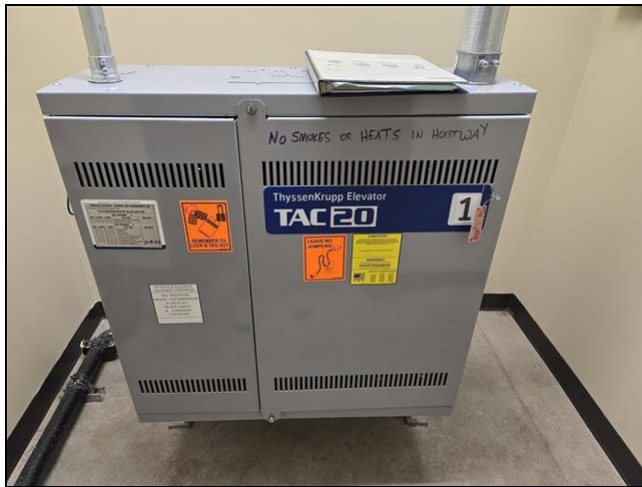
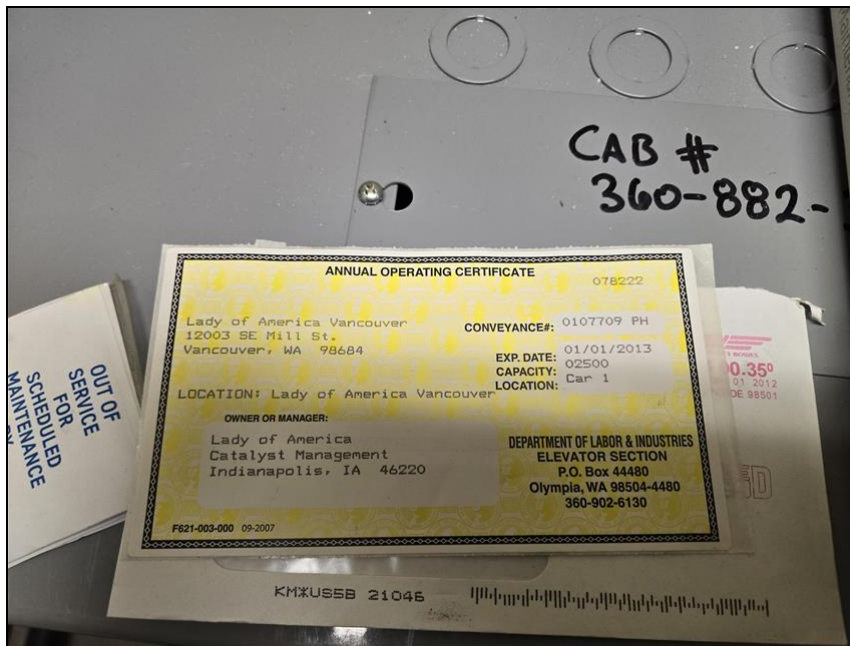
Unable to locate a current license or inspection report for the elevator. Recommend obtaining these documents. If not up-to-date, I recommend that these be brought current prior to the transfer of the property to new owners.

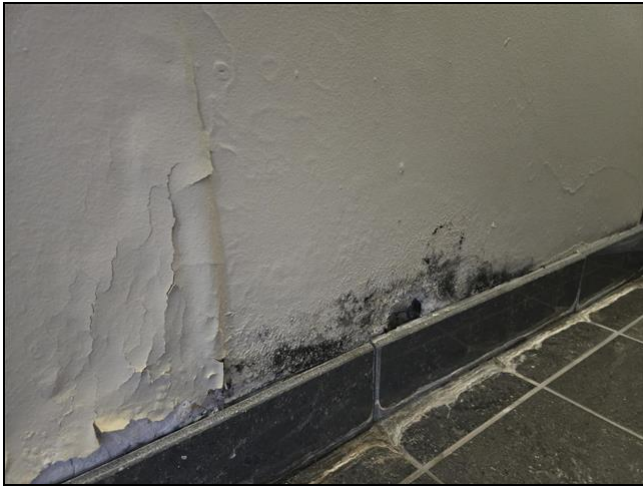
12.0 Item 1 (Picture)

Fungal growth was noted on the front wall of the first floor at the leaking water main. Recommend evaluation by a mold remediation specialist to determine the best treatment plan and to implement same. Recommend work be completed at the earliest opportunity.

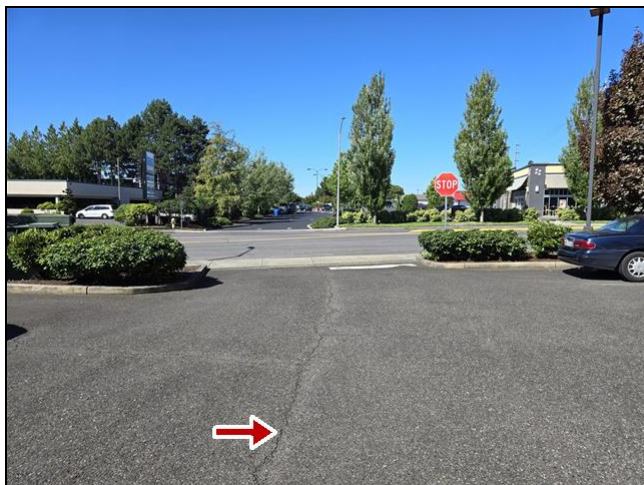
2.1 Item 3 (Picture)

(2) The following maintenance related issues were noted: the asphalt is due for crack seal-coating to preserve the surface and extend the service life. Recommend consulting a licensed and qualified paving contractor for an estimate of costs.
