INSPECTION REPORT  
Walla Walla WA 99362

INSPECTED BY  
Paul Duffau, CCPIA  
081041  
Calibre Commercial  
Inspections, LLC

INSPECTION DATE  
9/24/2022  
08:00 AM

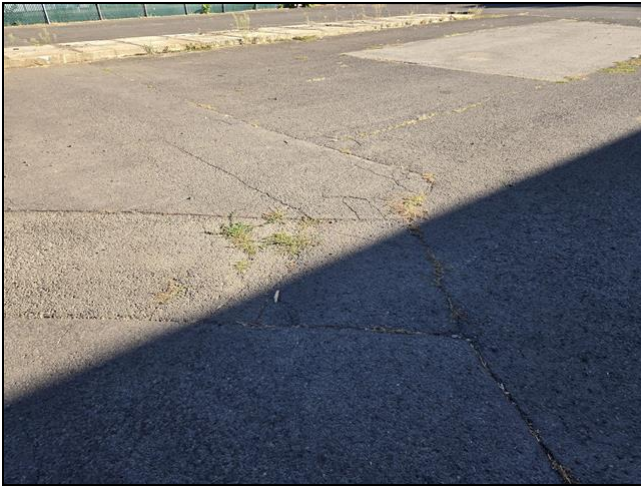
3.1 Item 2 (Picture)

(2) The asphalt surface in several locations in the lumber yard was damaged as evident by localized alligator cracking suggesting a localized structural failure of the surface and possibly the subsurface structure.. Recommend evaluation by a licensed and qualified paving contractor to determine the full scope of the necessary work.

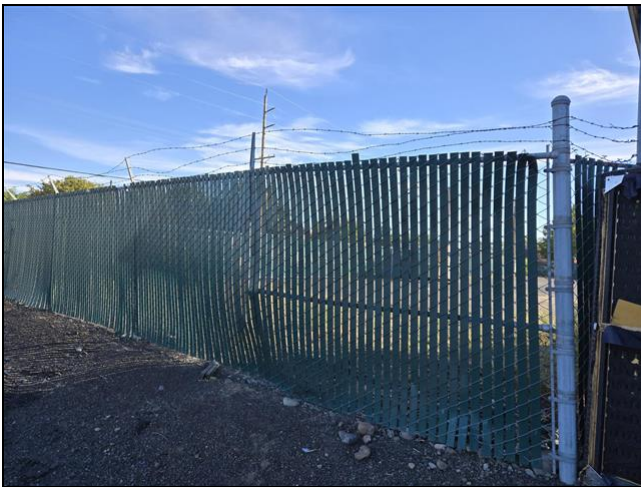
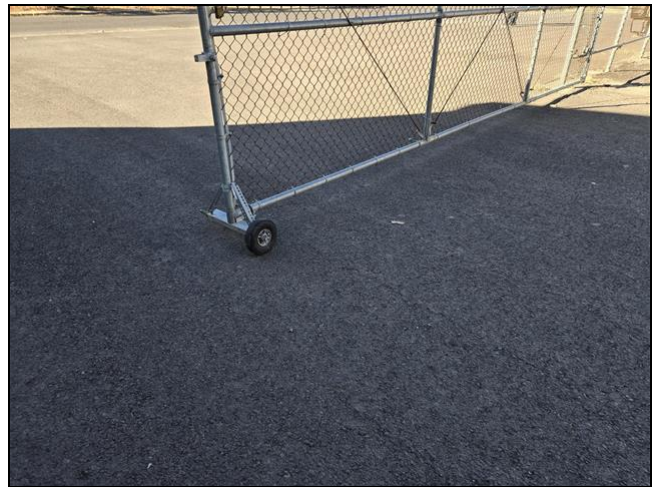
3.5 Item 1 (Picture)

A chain link fence with barbed wire strands at the top provided protection along the perimeter of the property. Minor damage was noted on the fencing. There were three vehicle gates in the fencing and one pedestrian gate. The rear gate had an automatic opener. This was not tested.

One vehicle gate (right side, between the primary building and the lumber shed, was missing a wheel.

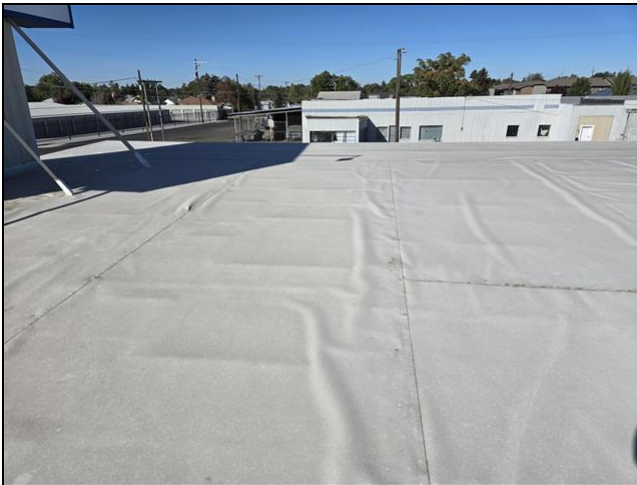
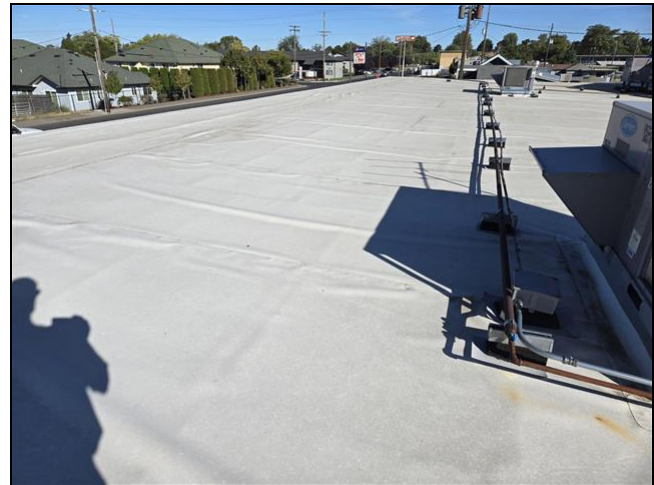
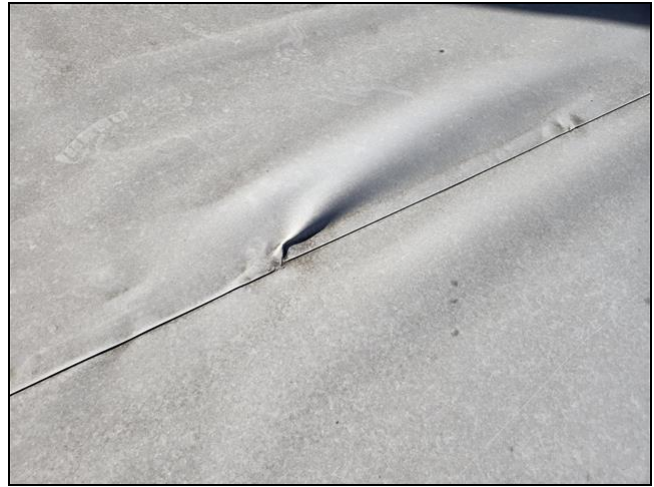
4.1 Item 1 (Picture)

Installation of the roofing appeared generally poor with substantial rippling present. While TPO products typically do have expansion/contraction properties, the size of these, on a day that was relatively moderate in temperature, suggests that the normal range of movement has been exceeded. In addition, ponding is occurring at the junction of the flat roof to the gable roof assembly. Sidewall installation was sealed with adhesives which will leak over time.

Recommend evaluation by a licensed and qualified roofing contractor to determine the best means of correction and to obtain estimates of associated costs.

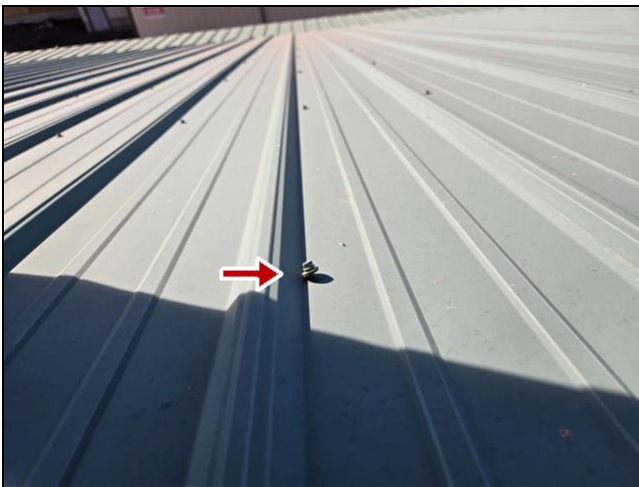
4.1 Item 5 (Picture)

(2) The remaining roof of the primary building was metal with exposed fasteners.

Loose fasteners were observed in multiple locations.

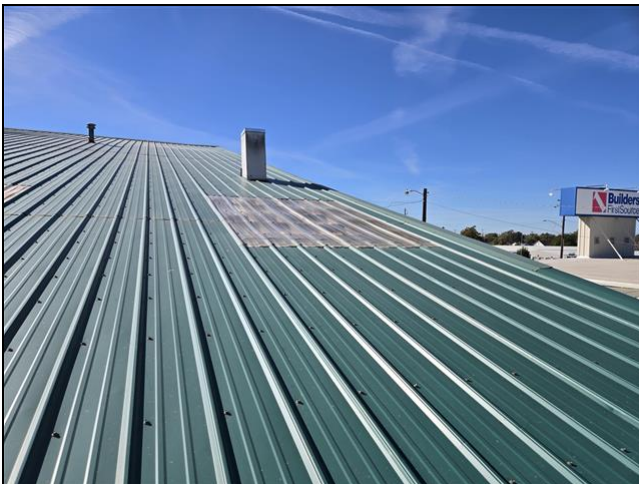
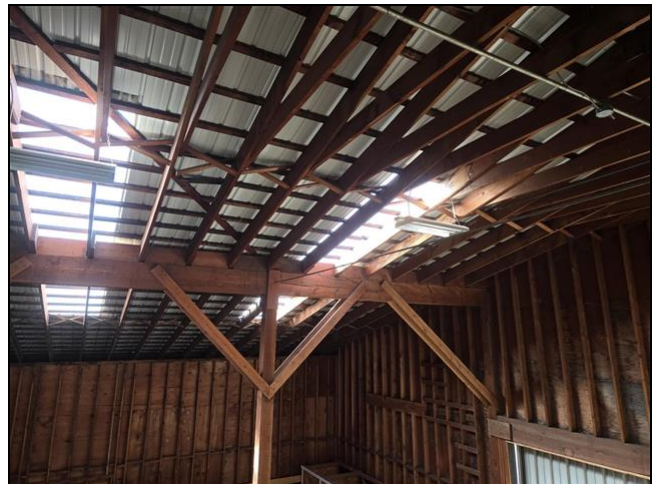
4.1 Item 6 (Picture)

(3) The roof of the lumber shed was metal with exposed fasteners. This roof does not have sheathing. Leakage is evident. Roof was inspected from a ladder as the slope and material made traversing hazardous.

Loose fasteners were observed in multiple locations.

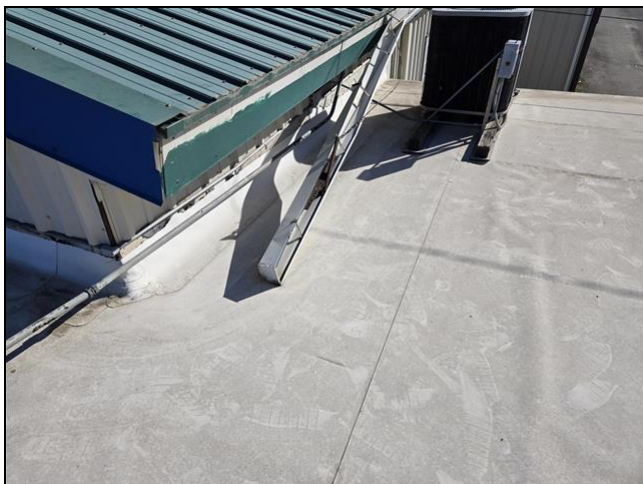
4.4 Item 1 (Picture)

Damage was noted gutters on the gable portion of the primary building. Other gutters did not appear securely attached and may be prone to separation. Recommend repair.

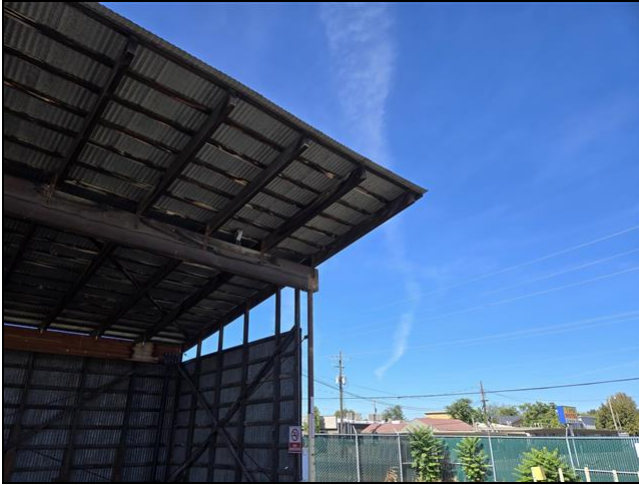
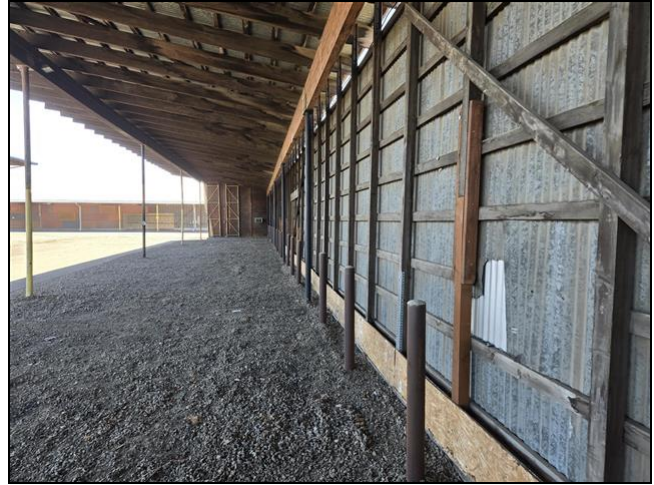
4.6 Item 1 (Picture)

(2) The older lumber rack cover used a beam and rafter system for the roof support. Sagging was noted at the end of the rafters at the open end. A newer beam was installed to provide support along the rear wall.

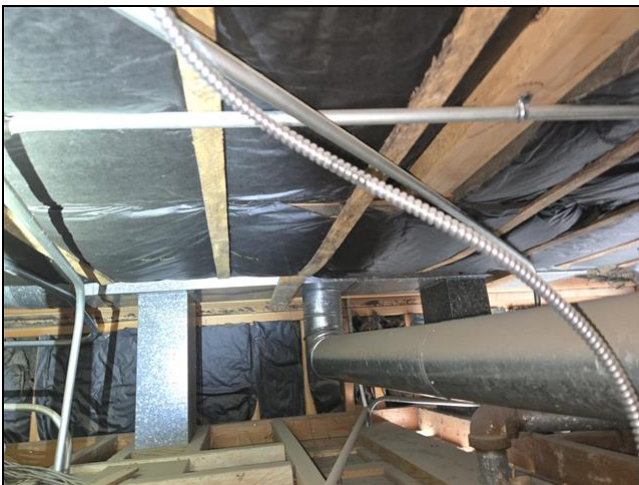
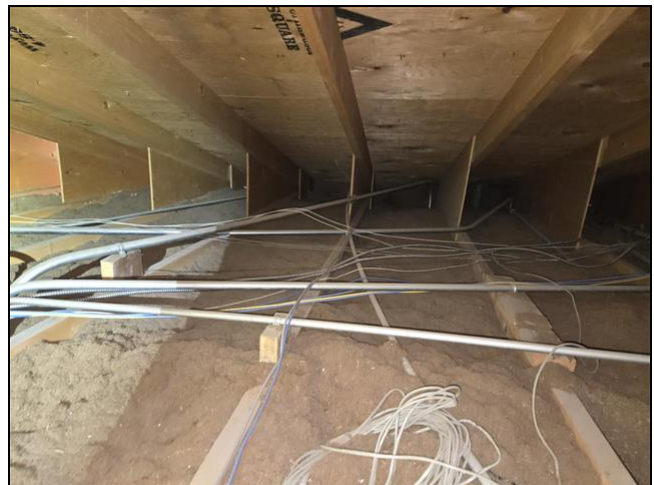
4.8 Item 1 (Picture)

Approximately 4-6 inches of sawdust insulation was observed in the attic space of the gable section of the primary building. Fiberglass batts were observed in the attic spaces above the bathrooms in the flat roof section that appeared to be of similar depth. This is well below modern standards and will greatly increase the cost of operating the building

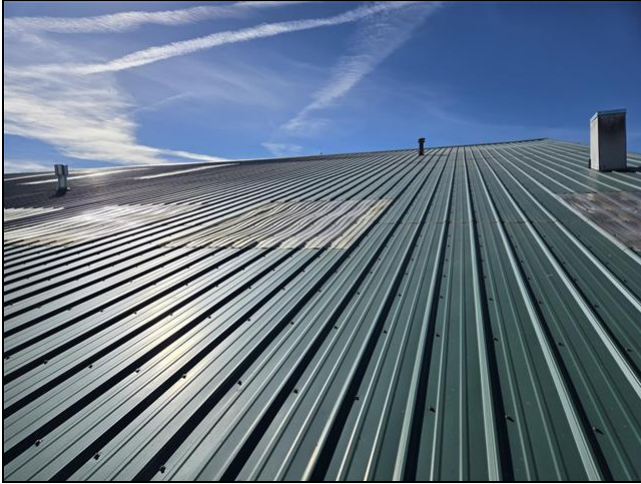
4.9 Item 1 (Picture)

The plexiglass skylights at the lumber shed appear to be leaking. Recommend repair.

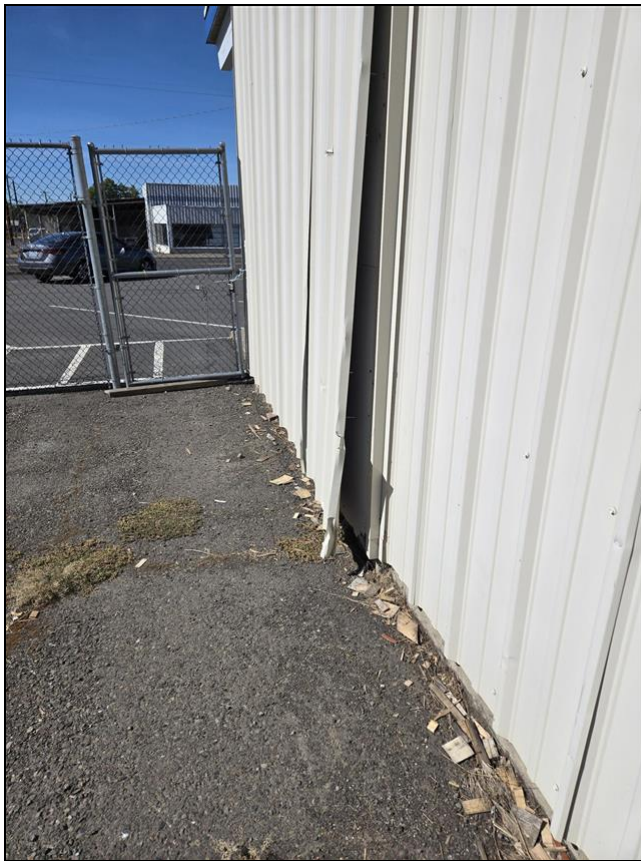
5.0 Item 1 (Picture)

(2) Minor damage noted in several locations of the exteriors. The signage system had detaching siding at the base of the system as fasteners were not attached to solid materials but to insulated foam board. Impact damage noted in the same general area and at the corner of the lumber shed.

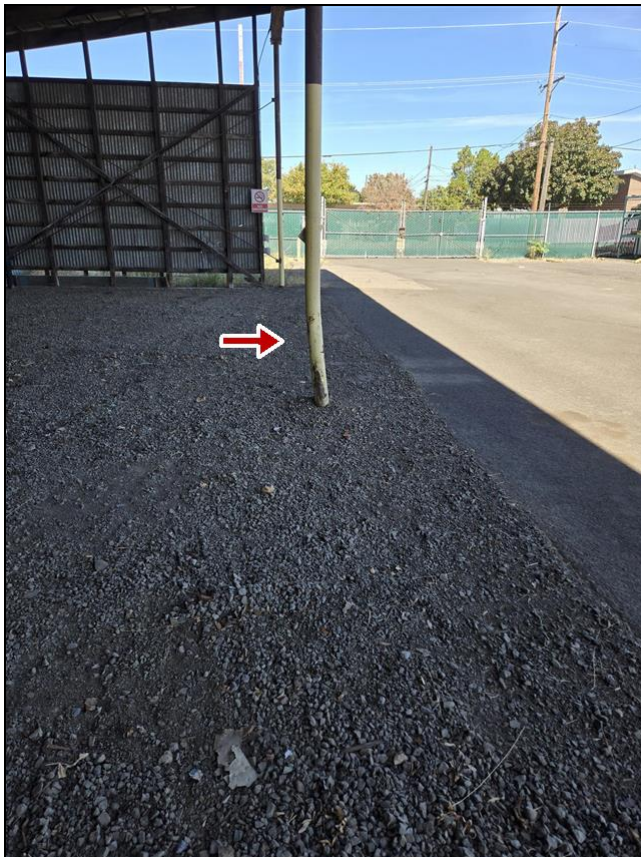
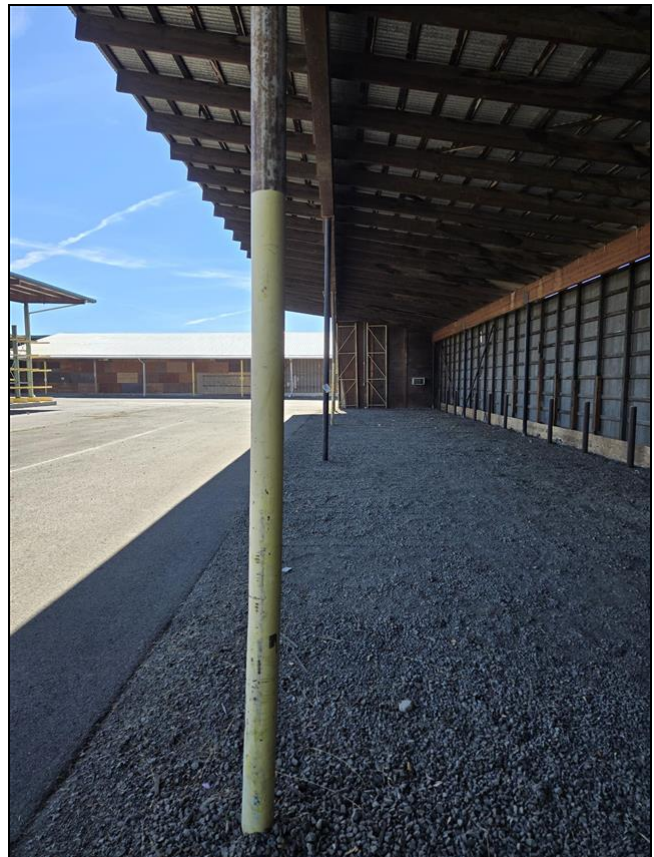
6.0 Item 1 (Picture)

(3) The older lumber rack cover used a pole-and-beam structural system with the original rear wall bearing load to a concrete foundation wall. It appears that this system was failing as a new beam system was installed to carry the load at the rear.

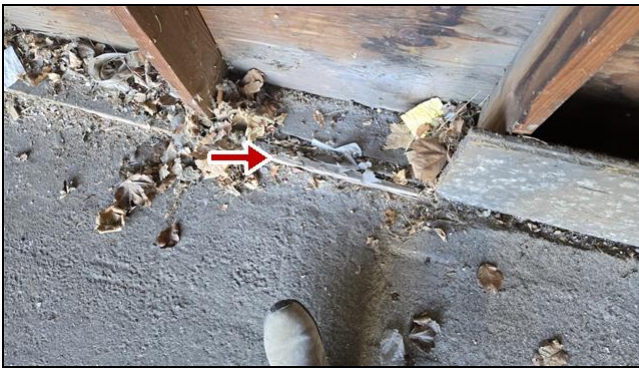
6.2 Item 1 (Picture)

(2) The exterior walls of the lumber shed was framed using 2x6 wood studs with plywood sheathing. Anchor bolts were missing from much of the structure but were present at the lean-to.

Extensive water staining noted throughout the structure, likely from the roof.

A damaged sill plate was noted at the rear lean-to structure near the site of a previous repair. Recommend repair.

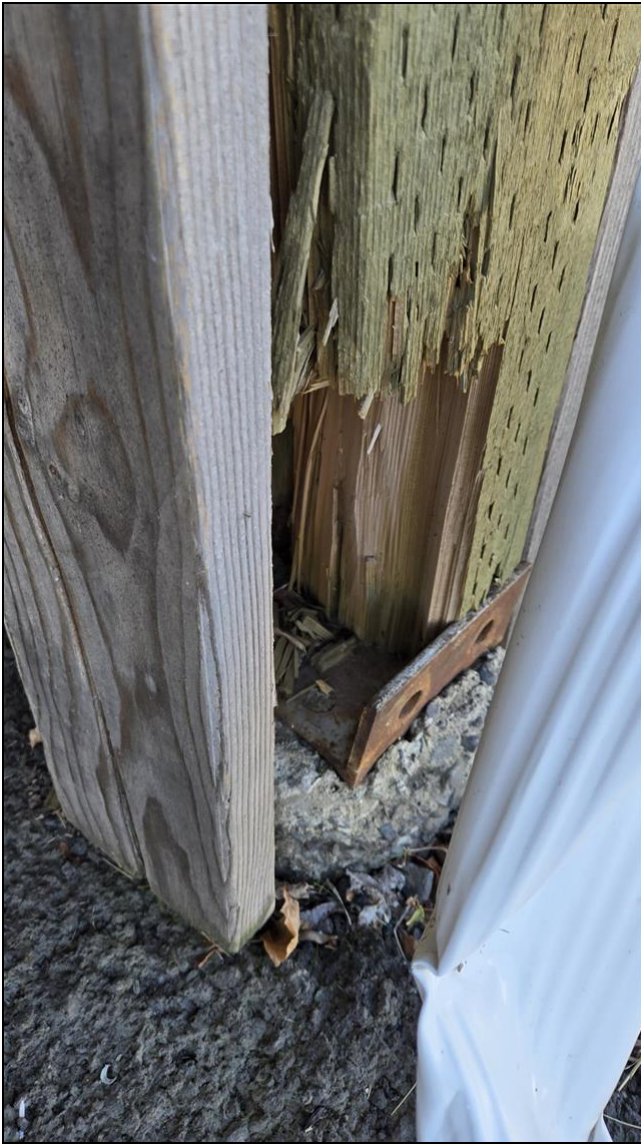
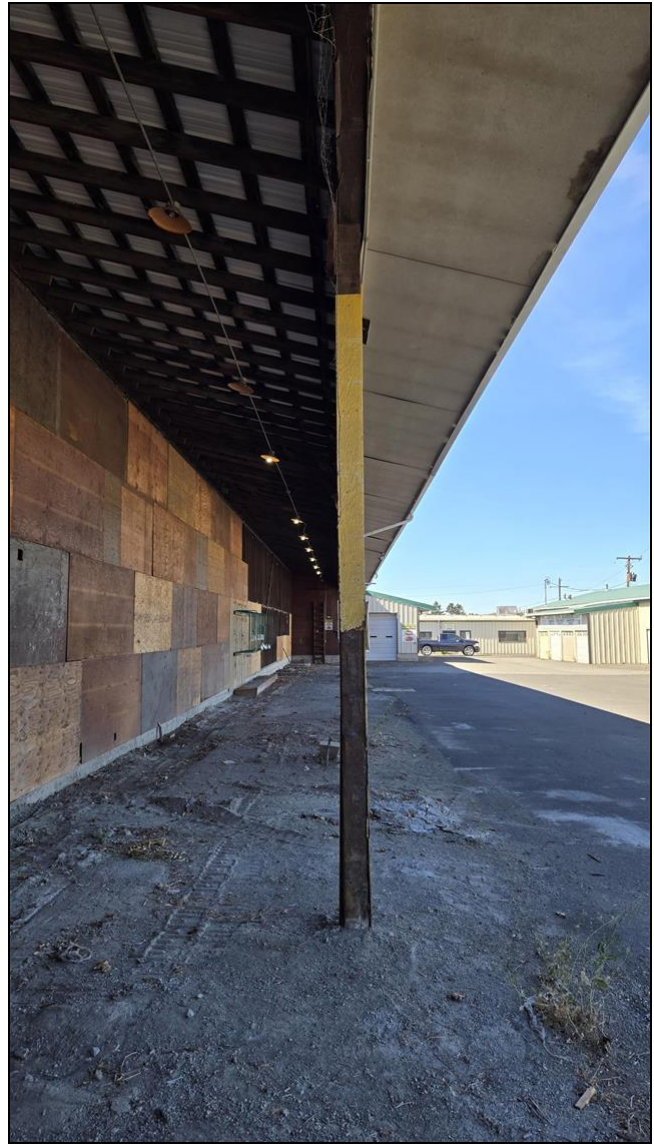
6.3 Item 1 (Picture)

Damage was noted at the base of two columns and the corner support for the roof assembly was approximately 2 inches off the footing. Columns are not plumb. Recommend repair to ensure continued structural stability.

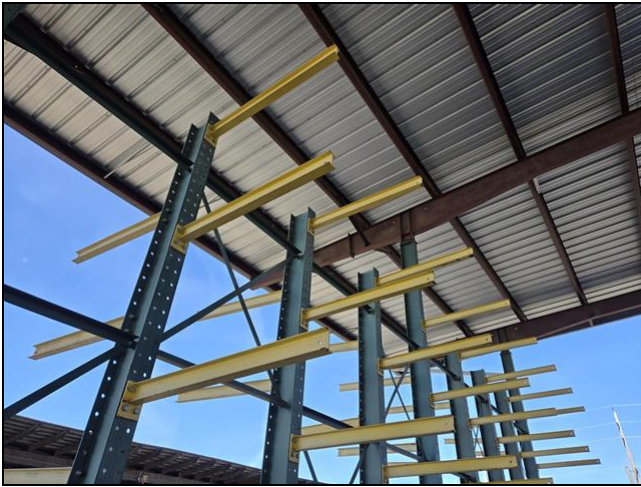
6.3 Item 5 (Picture)

(3) Structural columns for the prefabricated lumber rack appeared to be in satisfactory conditions. Several of the shelf arms were damaged. No recommendation.

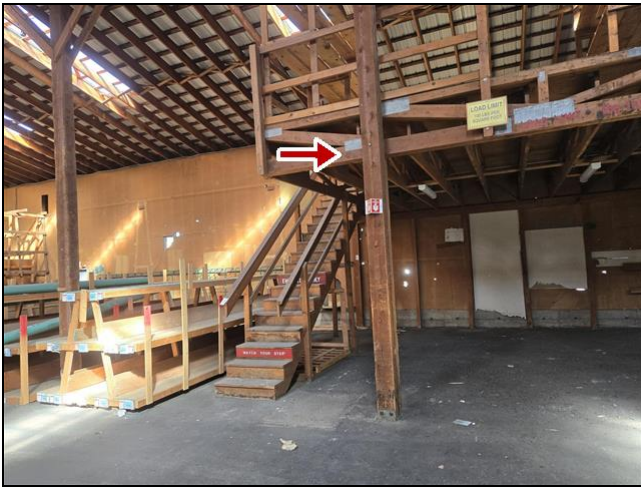
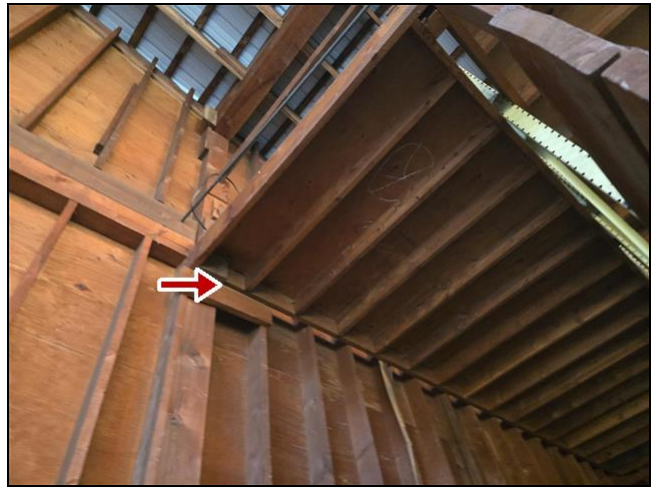
6.4 Item 1 (Picture)

- (1) No readily observable material deficiencies were noted with the ground floor systems..
- (2) The mezzanines framing did not meet current standards. The joists were not connected with hangers and beams did not bear to columns. Recommend repair.

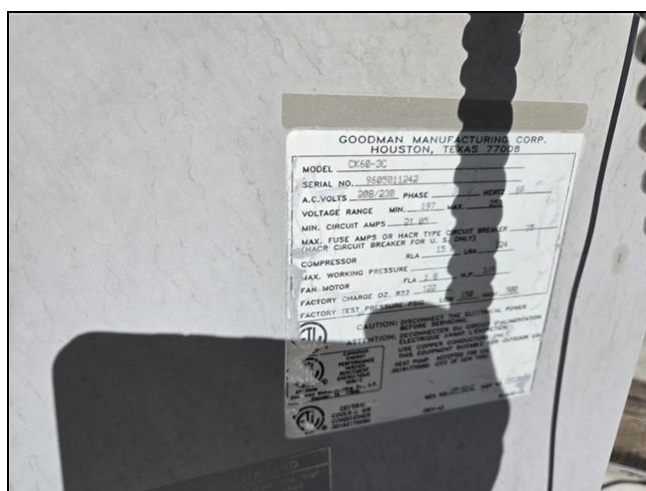
7.1 Item 1 (Picture)

(4) Cooling plant four is a Goodman Manufacturing split-system air conditioner that is 28 years old.

This piece of equipment is beyond a normal service life. Recommend replacement..

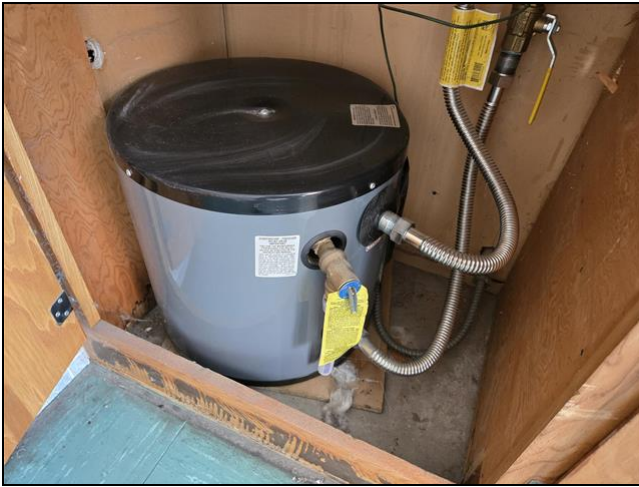
7.3 Item 1 (Picture)

This piece of equipment appeared to be at the end of a normal service life. Recommend continuing with routine maintenance and developing cash reserves for eventual replacement.

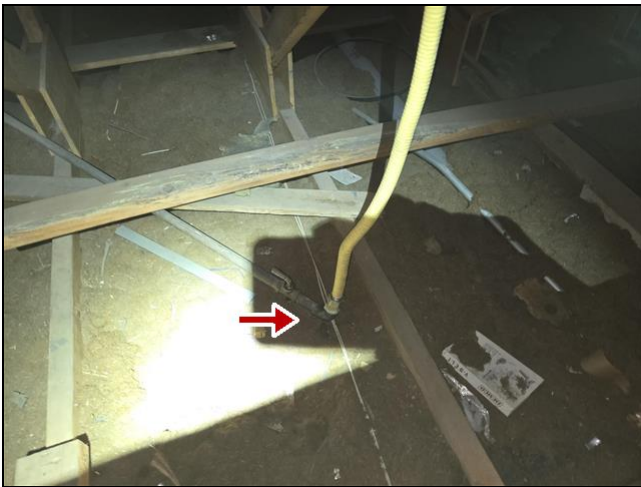
8.3 Item 2 (Picture)

(2) A sediment trap was missing to the Coleman gas-fired furnace in the attic. This trap is intended to collect any debris in the gas line to prevent harm to equipment. Recommend installing.

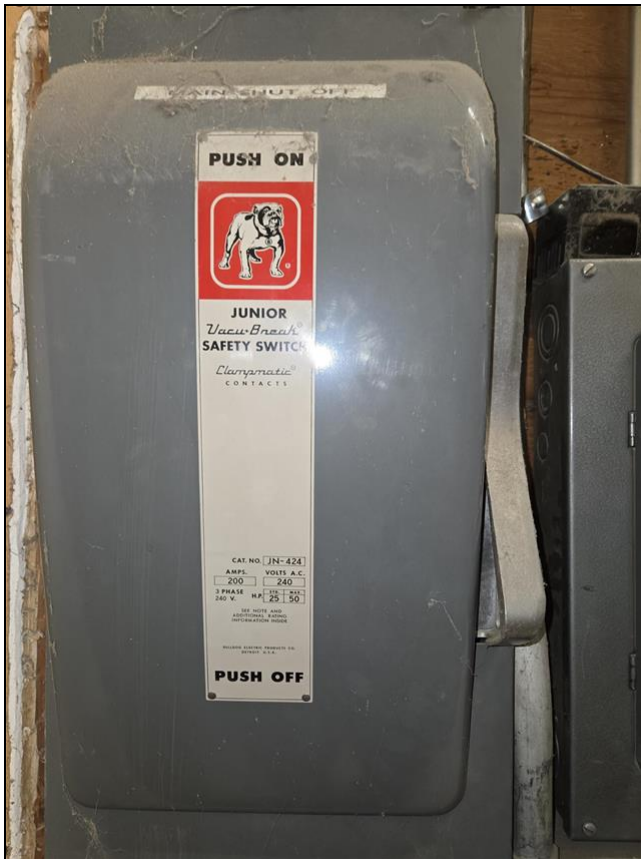
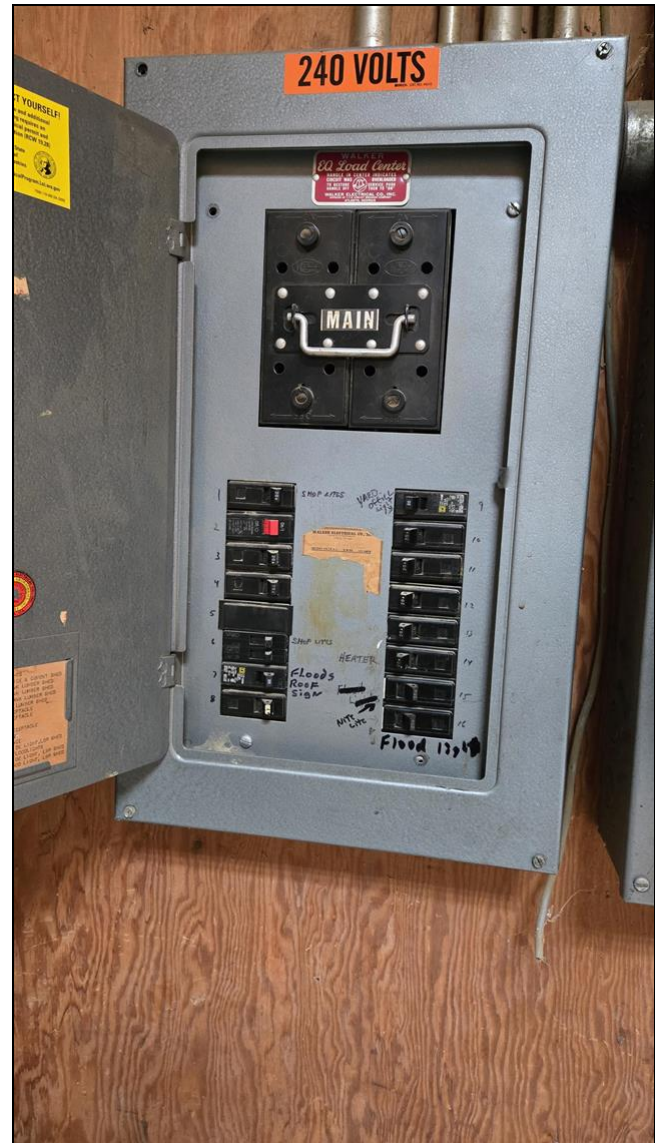
9.2 Item 1 (Picture)

(1) There were a mix of panels. The oldest of these are Walker EQ panels that are original and are fed by Bulldog fused mains.. These panels are combined breaker and fuse systems are antiquated. Replacement is recommended.

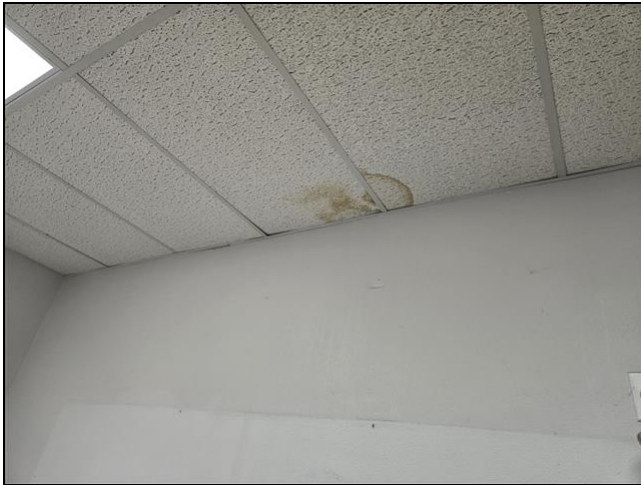
11.0 Item 1 (Picture)

(1) Multiple water stains noted in both the shop and the primary building. Recommend monitoring in wet weather for re-activation of the leaks. Those in the shop are likely still active due to the type and manner of roofing materials. Those in the primary building may be older damage that predates the newer roof.

(2) Stained and damage ceiling tiles should be replaced.

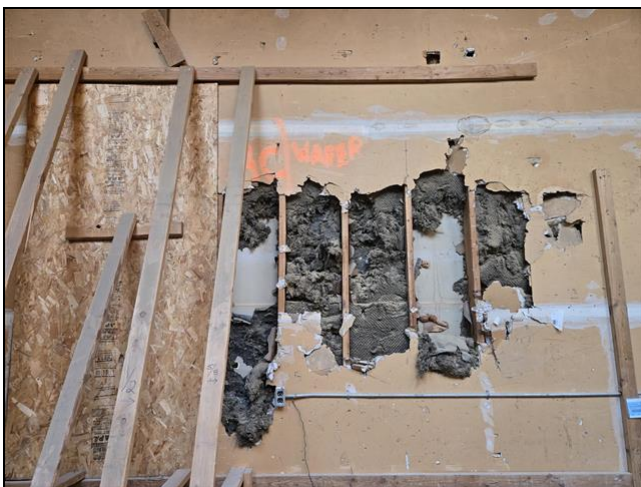
11.1 Item 1 (Picture)

(1) Extensive damage, consistent with the property's use, noted on drywall systems for the walls, especially the lumber shed. Interiors at the primary building show wear but are in better condition.

(2) Substantial drywall repairs will be necessary to bring the walls into normal condition.

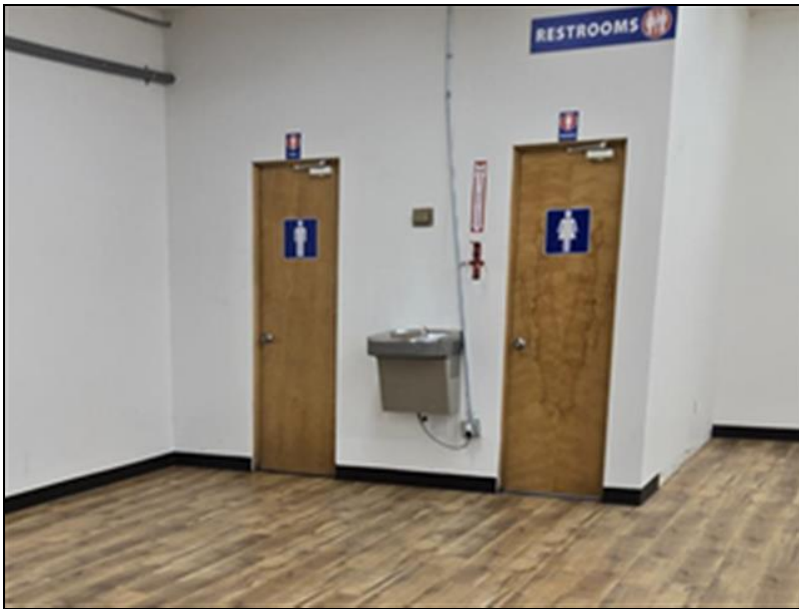
11.3 Item 1 (Picture)

The doors for the bathrooms are substantially undersized. Recommend upgrading.

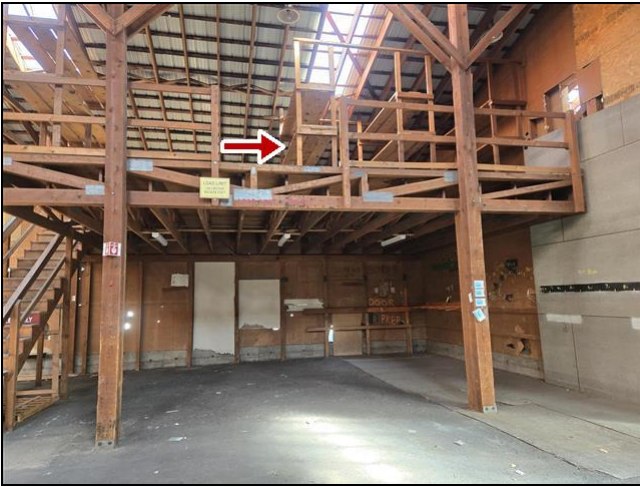
11.4 Item 1 (Picture)

Hand- and guard-rails had baluster spacing greater than 4" which creates a potential fall hazard. Recommend repair.

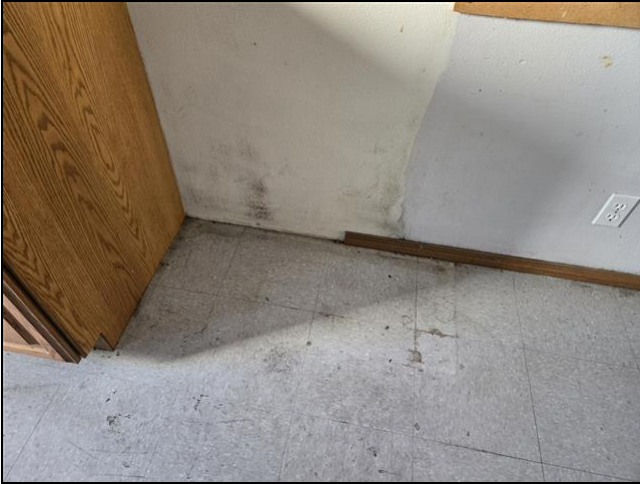
12.0 Item 1 (Picture)

Fungal growth was observed on the wall of the breakroom. This appears to be surface growth.

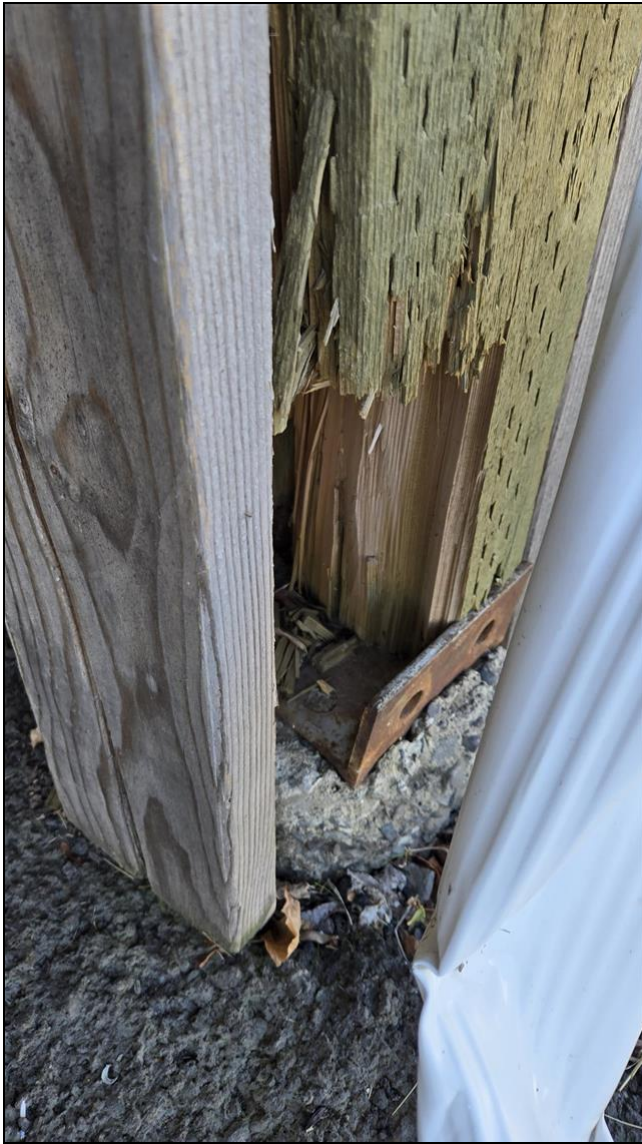
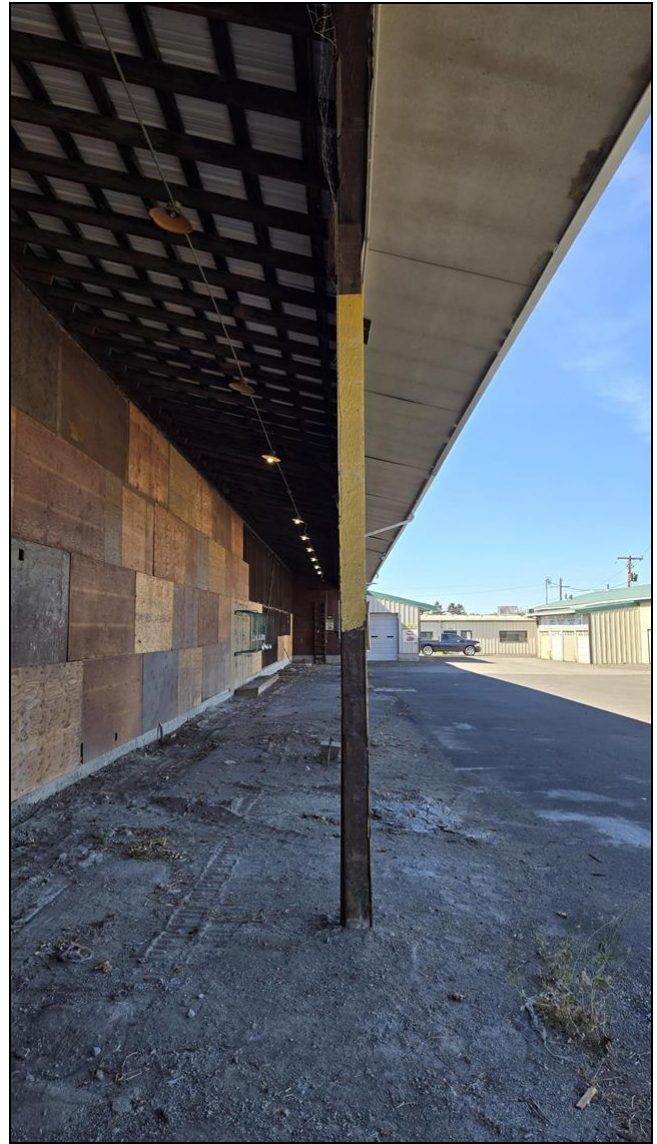
6.3 Item 1 (Picture)

Damage was noted at the base of two columns and the corner support for the roof assembly was approximately 2 inches off the footing. Columns are not plumb. Recommend repair to ensure continued structural stability.

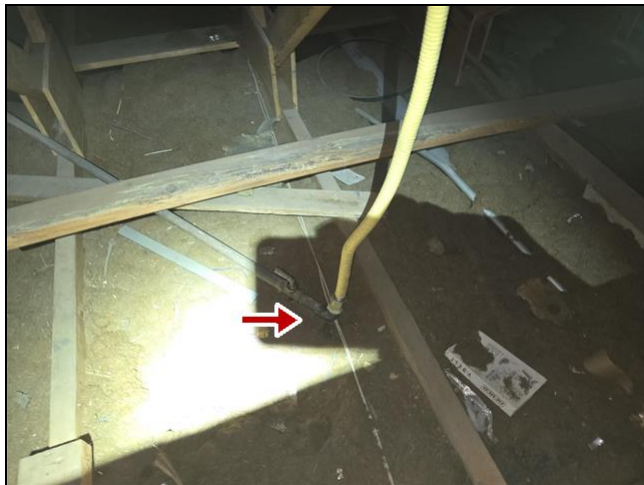
8.3 Item 2 (Picture)

(2) A sediment trap was missing to the Coleman gas-fired furnace in the attic. This trap is intended to collect any debris in the gas line to prevent harm to equipment. Recommend installing.

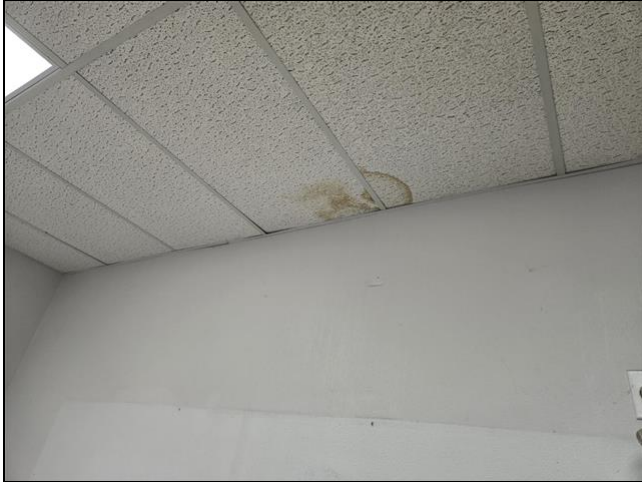
11.0 Item 1 (Picture)

(1) Multiple water stains noted in both the shop and the primary building. Recommend monitoring in wet weather for re-activation of the leaks. Those in the shop are likely still active due to the type and manner of roofing materials. Those in the primary building may be older damage that predates the newer roof.

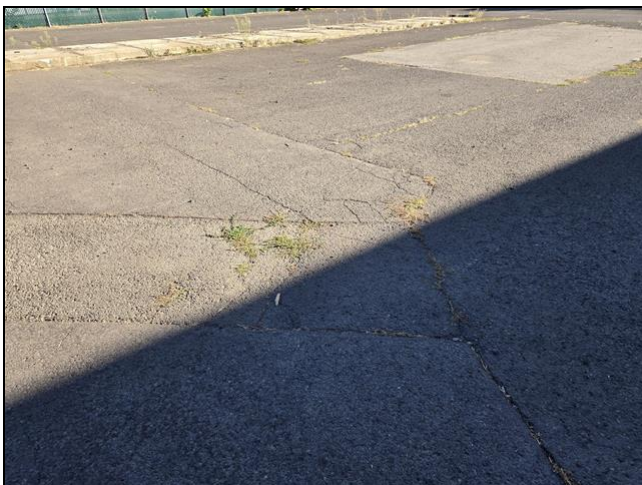
3.1 Item 2 (Picture)

(2) The asphalt surface in several locations in the lumber yard was damaged as evident by localized alligator cracking suggesting a localized structural failure of the surface and possibly the subsurface structure.. Recommend evaluation by a licensed and qualified paving contractor to determine the full scope of the necessary work.

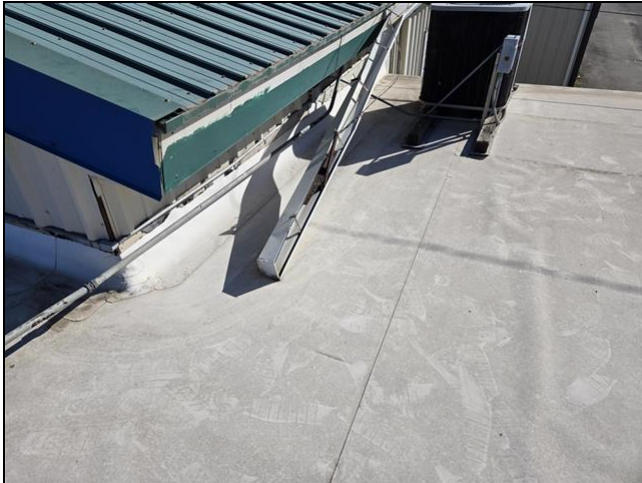
4.4 Item 1 (Picture)

Damage was noted gutters on the gable portion of the primary building. Other gutters did not appear securely attached and may be prone to separation. Recommend repair.

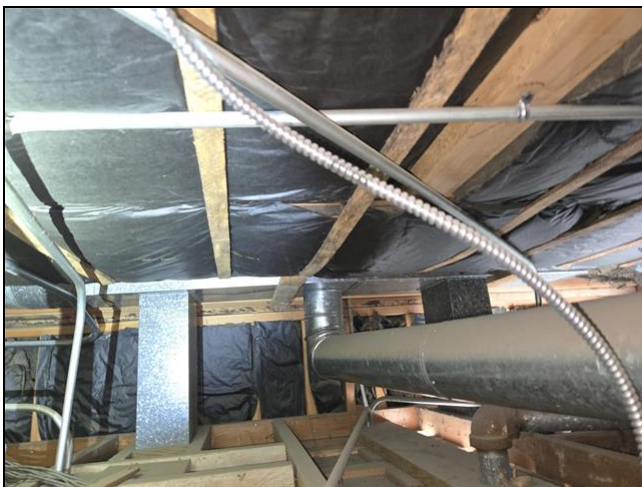
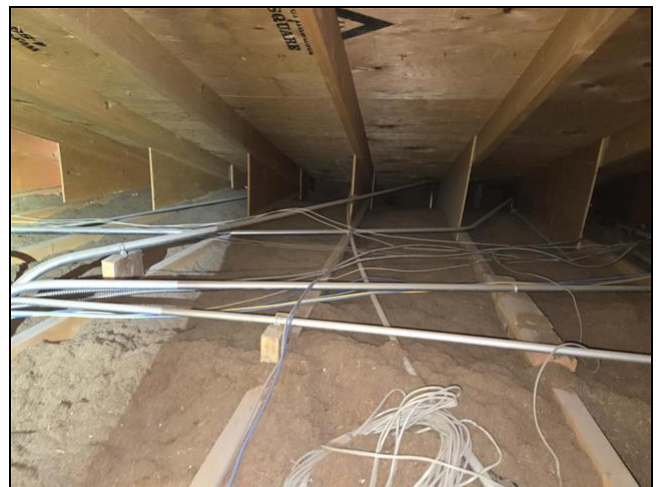
4.8 Item 1 (Picture)

Approximately 4-6 inches of sawdust insulation was observed in the attic space of the gable section of the primary building. Fiberglass batts were observed in the attic spaces above the bathrooms in the flat roof section that appeared to be of similar depth. This is well below modern standards and will greatly increase the cost of operating the building

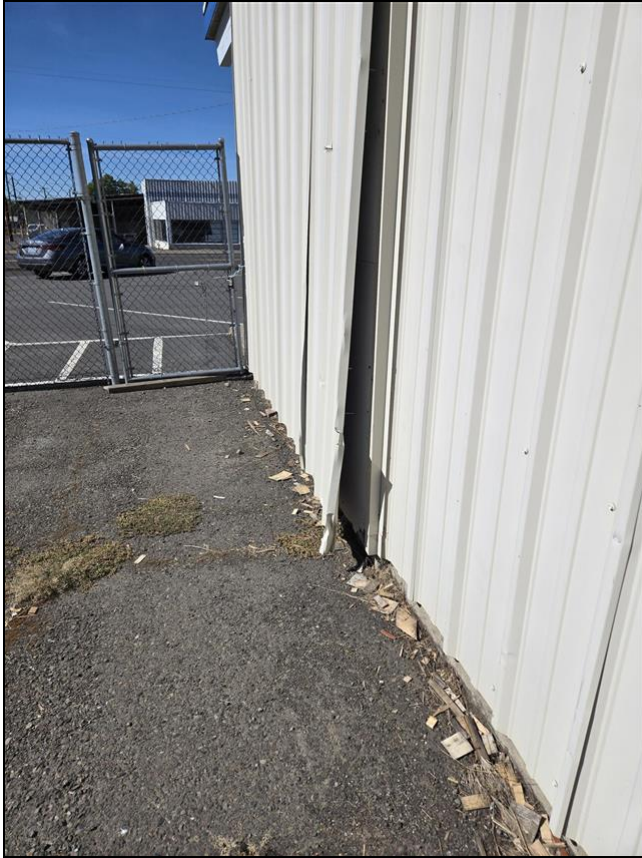
5.0 Item 1 (Picture)

(2) Minor damage noted in several locations of the exteriors. The signage system had detaching siding at the base of the system as fasteners were not attached to solid materials but to insulated foam board. Impact damage noted in the same general area and at the corner of the lumber shed.

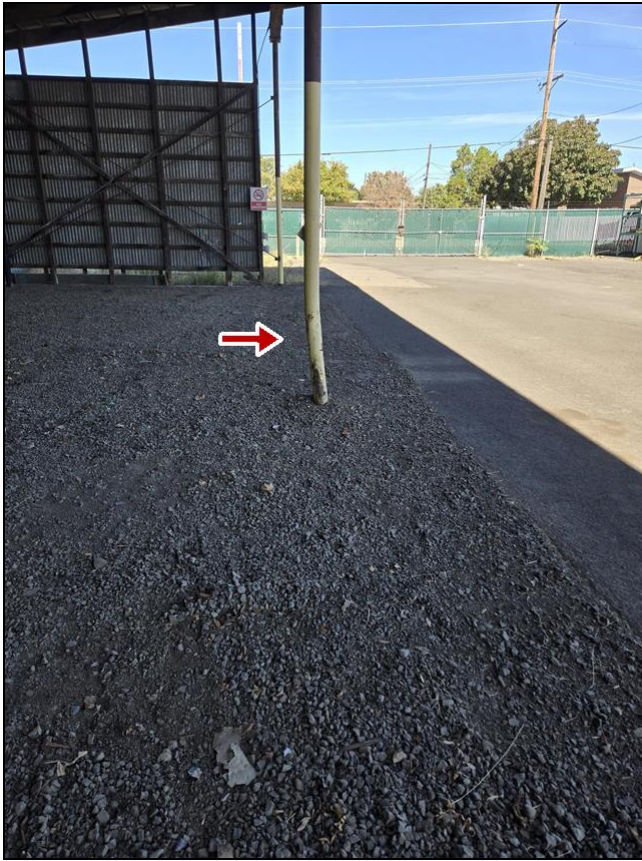
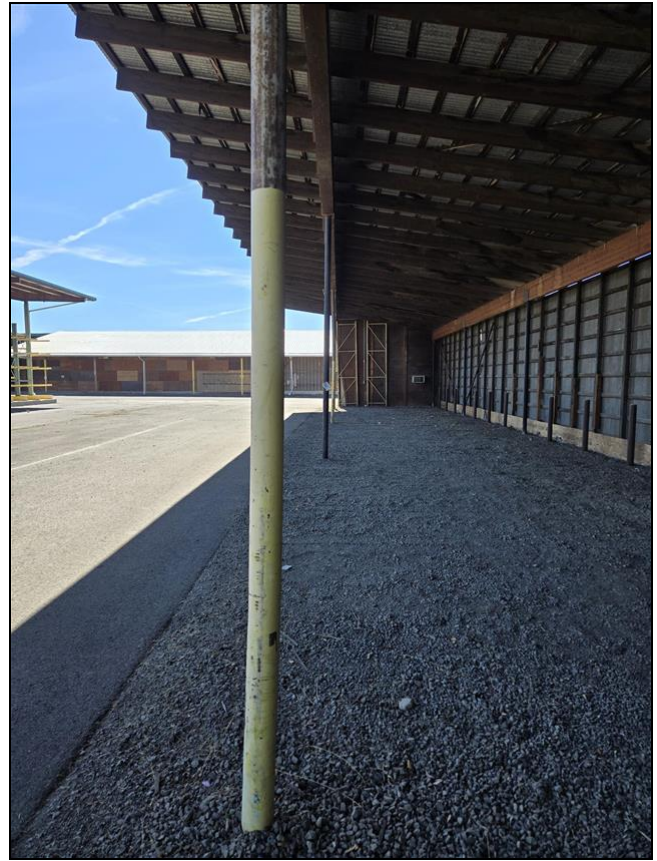
6.0 Item 1 (Picture)

(3) The older lumber rack cover used a pole-and-beam structural system with the original rear wall bearing load to a concrete foundation wall. It appears that this system was failing as a new beam system was installed to carry the load at the rear.

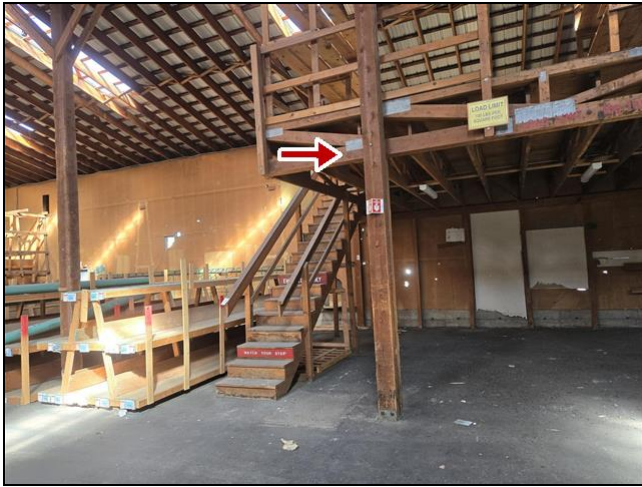
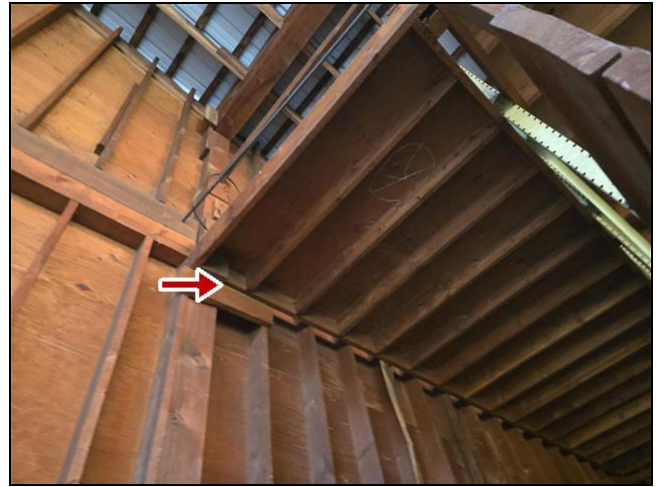
6.4 Item 1 (Picture)

(2) The mezzanines framing did not meet current standards. The joists were not connected with hangers and beams did not bear to columns. Recommend repair.

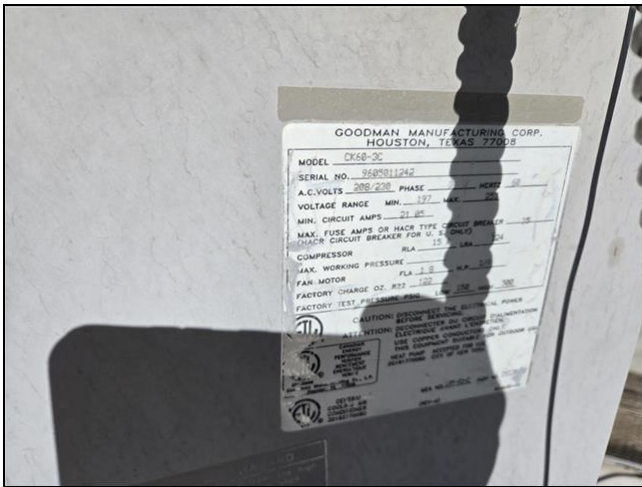
7.1 Item 1 (Picture)

This piece of equipment is beyond a normal service life. Recommend replacement..

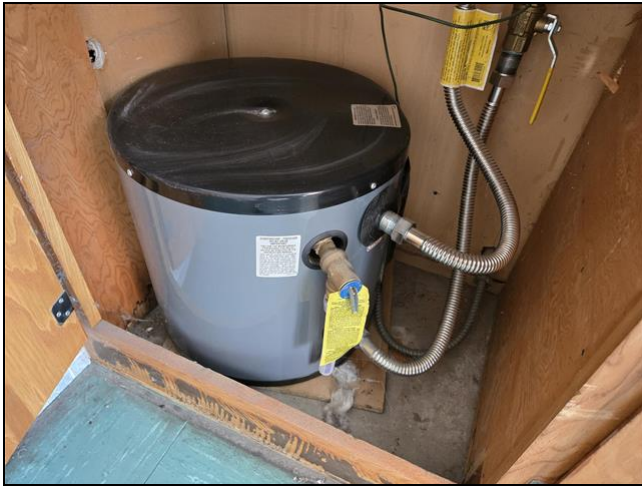
7.3 Item 1 (Picture)

This piece of equipment appeared to be at the end of a normal service life. Recommend continuing with routine maintenance and developing cash reserves for eventual replacement.
