INSPECTION REPORT  
Maple Grove Rd  
Boise ID 83709

INSPECTED BY  
Paul Duffau CCPIA  
601011  
Calibre Commercial  
Inspections, LLC

INSPECTION DATE  
📅 9/25/2024  
🕒 09:00 AM

20240925-Maple-Grove-Rd

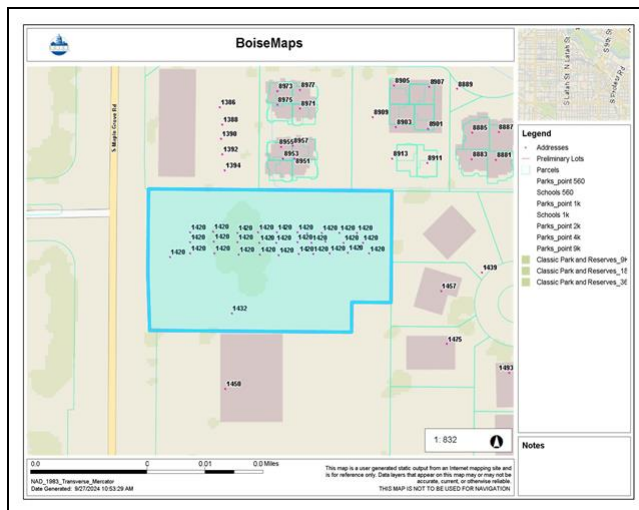
2.2 Item 1 (Picture)

The lot is irregularly shaped and level.

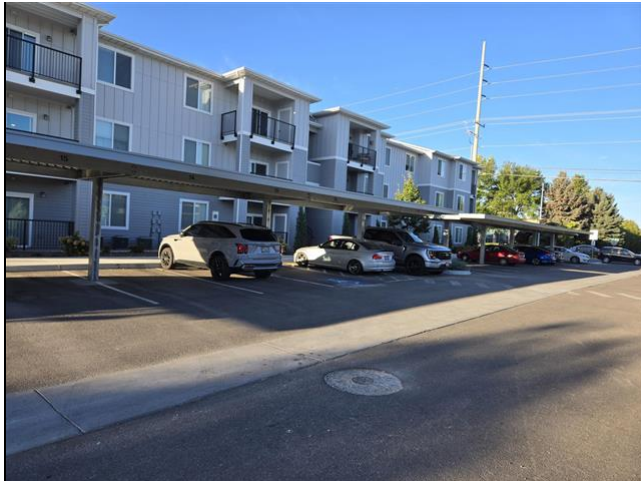
3.1 Item 1 (Picture)

Parking lot surfaces materials included: asphalt surface. Paving materials appear to be constructed on a stabilized gravel base. A total of 50 spaces were counted in a surface parking lot on the left and rear sides of the subject property. Two of these were marked for accessible use. It appeared about 29 of them were under carport covers. The covers were framed from cold formed steel with metal panel roofing. The columns bear to concrete footings.

No readily observable material deficiencies were noted.

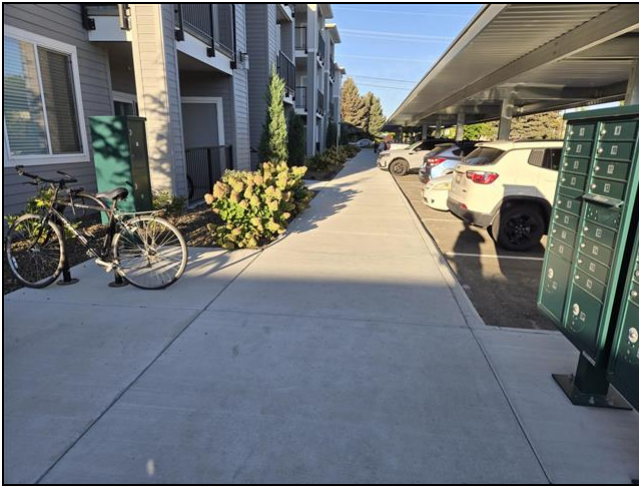
3.2 Item 1 (Picture)

There are poured in place concrete walkways for present along the right hand side of the property between the building and the parking lot. There's an additional walkway at the front of the building off the public sidewalk. The ground level units have small concrete patios with short fencing. No readily observable material deficiencies were noted.

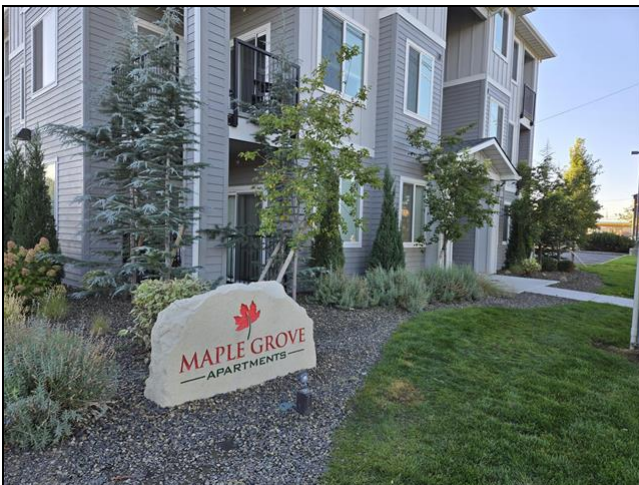
3.3 Item 1 (Picture)

Landscaping for the subject property included areas of artificial grass , low shrubs , and trees. Sprinklers were present.

No readily observable material deficiencies were noted.

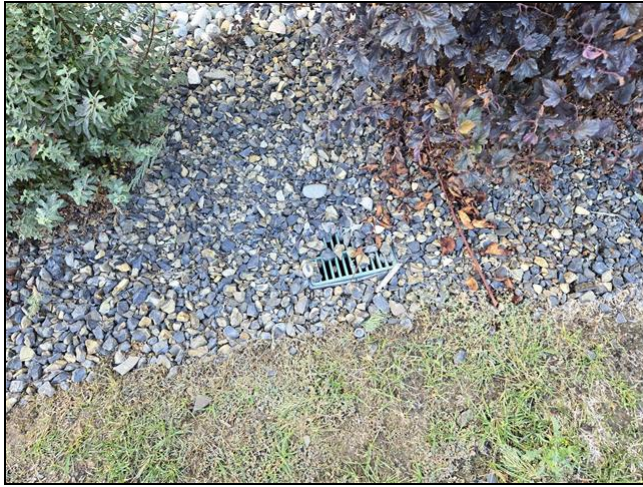
3.4 Item 1 (Picture)

Storm water management was accomplished by storm sewers in the drives with landscaping providing some absorption. A ground drain was noted on the left side of the property in the landscaping areas to provide for additional drainage.

No readily observable material deficiencies were noted.

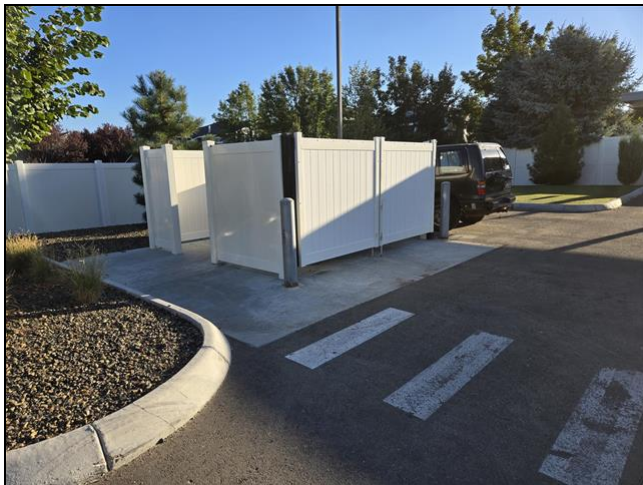
3.5 Item 1 (Picture)

Fencing was present on the perimeter of the property and around the trash enclosure.

No readily observable material deficiencies were noted.

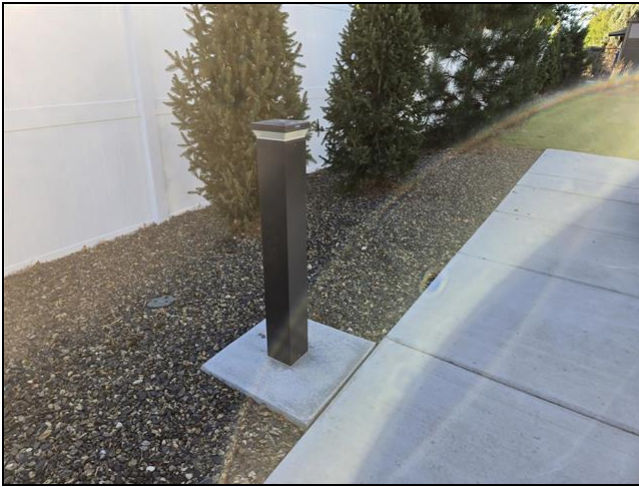
3.7 Item 1 (Picture)

Lighting was a combination of pole-mounted lighting in the parking lot, free-standing lighting along some walkways, and building mounted lighting at the stairwells and entry doors.

No readily observable material deficiencies were noted.

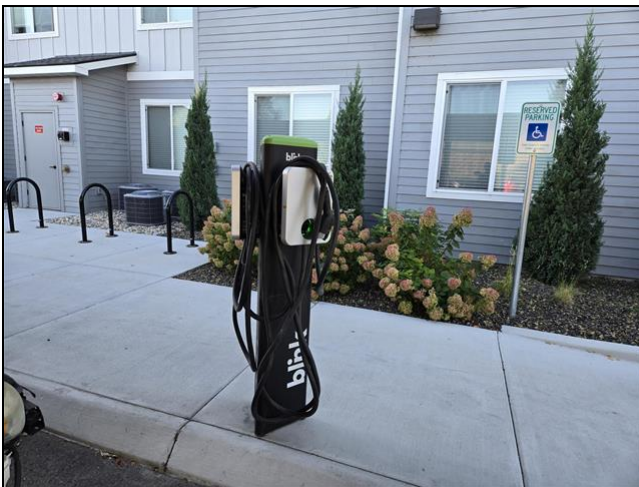
3.9 Item 1 (Picture)

The apartment complex had EV charging stations in two locations. Bike racks were available at the side of the building and in the stairwells. Mail boxes were on the left by the parking lot. There was a small putting green and an area for pet walking with a dispenser for baggies for cleanup.

No readily observable material deficiencies were noted.

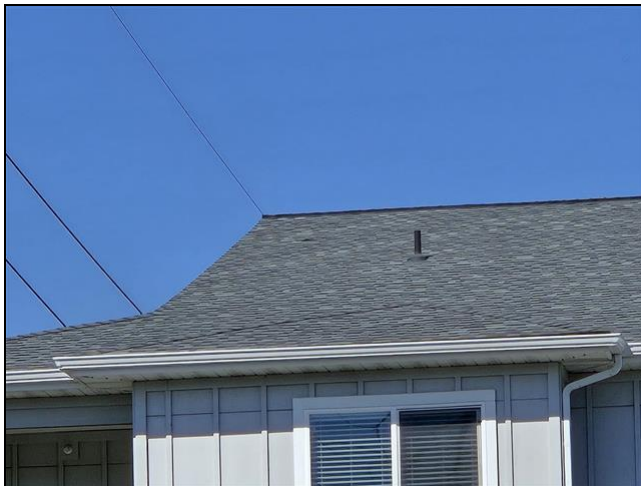
4.1 Item 1 (Picture)

The observed roof coverings are: asphalt composition shingles. They appear to be approximately 2 years old. The roof covering is well within a normal service life. Recommend continuing with routine maintenance.

No readily observable material deficiencies were noted.

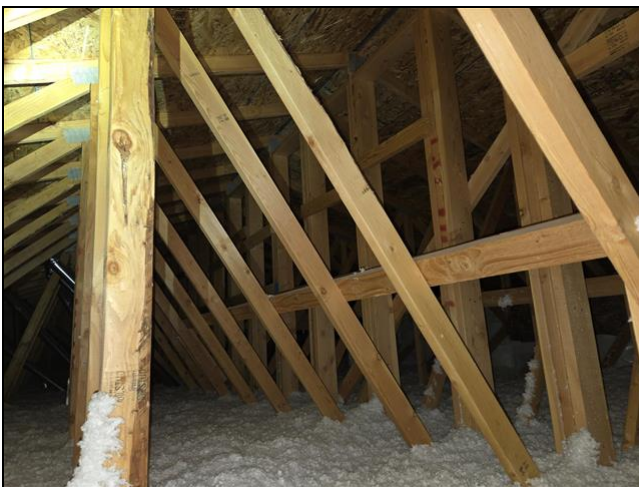
4.6 Item 1 (Picture)

The roof was framed using manufactured roof trusses. Manufactured roof trusses are designed by a structural engineer and prefabricated in a manufacturing facility under controlled conditions. Truss designs and their installation specifications are specific to individual structures.

The sheathing was OSB.

No readily observable material deficiencies were noted.

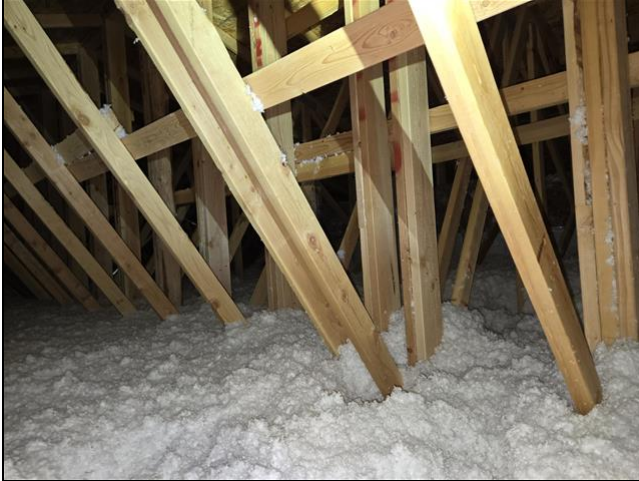
4.8 Item 1 (Picture)

Insulation was blown fiberglass and fiberglass batts.

No readily observable material deficiencies were noted.

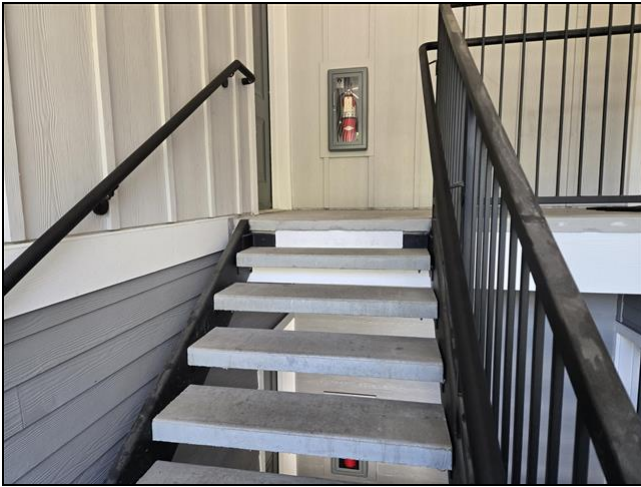
5.4 Item 1 (Picture)

No readily observable material deficiencies were noted.

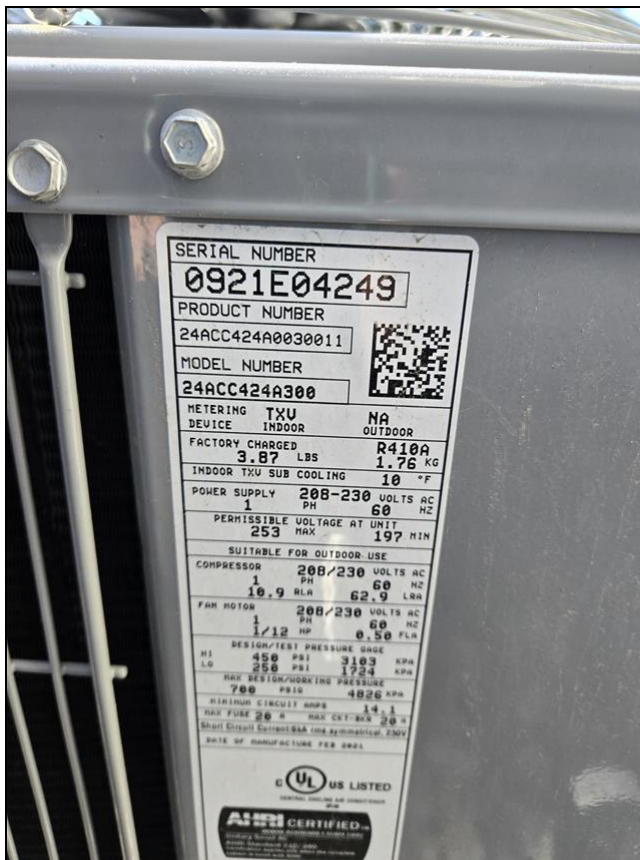
7.1 Item 1 (Picture)

There were 30 air conditioning units, Model Number 24AAC418 and 24ACC424, installed, one per unit. All were manufactured by Carrier in 2021. They are rated at 2 tons of cooling for the two-bedroom units and 1.5 tons of cooling for the one-bedroom units.

Based on available records, inspections stickers, or the lack thereof, routine maintenance appears to be overdue. Recommend maintenance for this unit at this time.

No readily observable material deficiencies were noted.

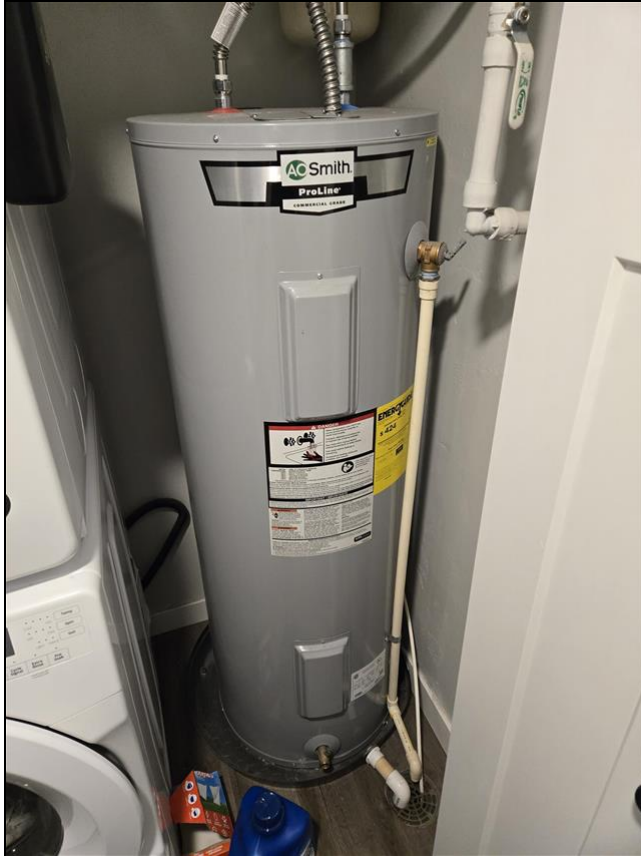
7.3 Item 1 (Picture)

Based on available records, inspections stickers, or the lack thereof, routine maintenance appears to be overdue. Recommend maintenance for this unit at this time.

No readily observable material deficiencies were noted except as follows.

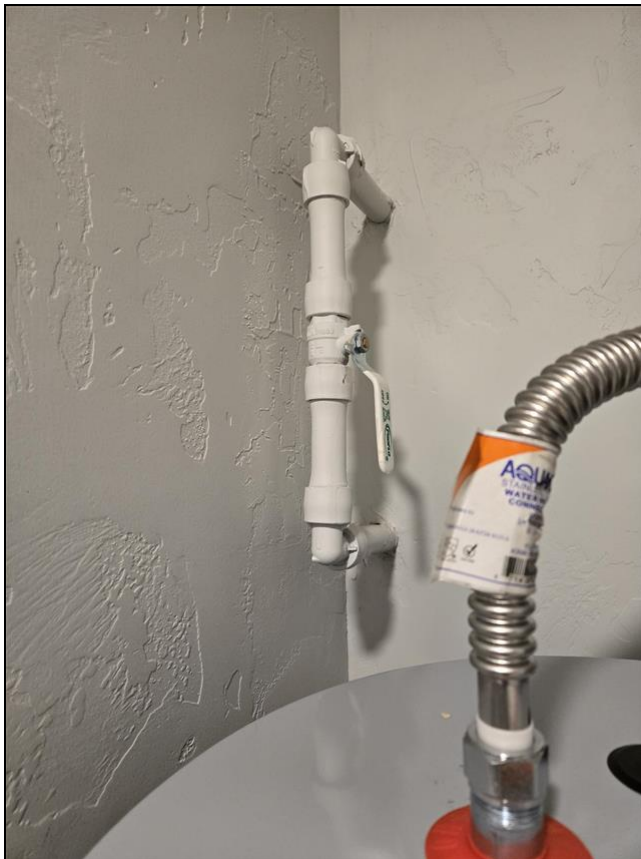
8.0 Item 1 (Picture)

Water mains for each unit were located in the same closet as the water heaters.

No readily observable material deficiencies were noted.

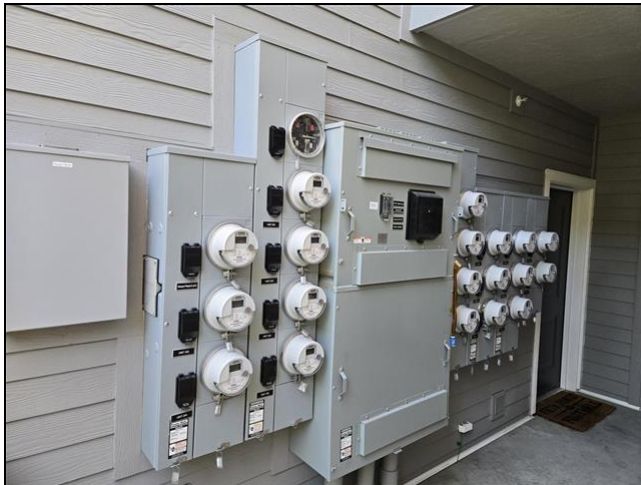
9.0 Item 1 (Picture)

The service entrance is located breezeways of the building. Power is delivered underground to a Square D Meter pack. Delivered power is 120/240v with 1200 amps of capacity per pack. No readily observable material deficiencies were noted.

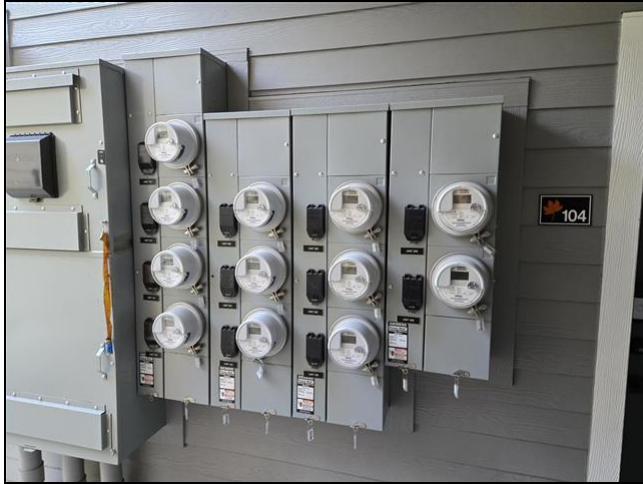
9.2 Item 1 (Picture)

(1) The main cabinets on the exterior appeared serviceable. Inspection stickers were present.

No readily observable material deficiencies were noted.

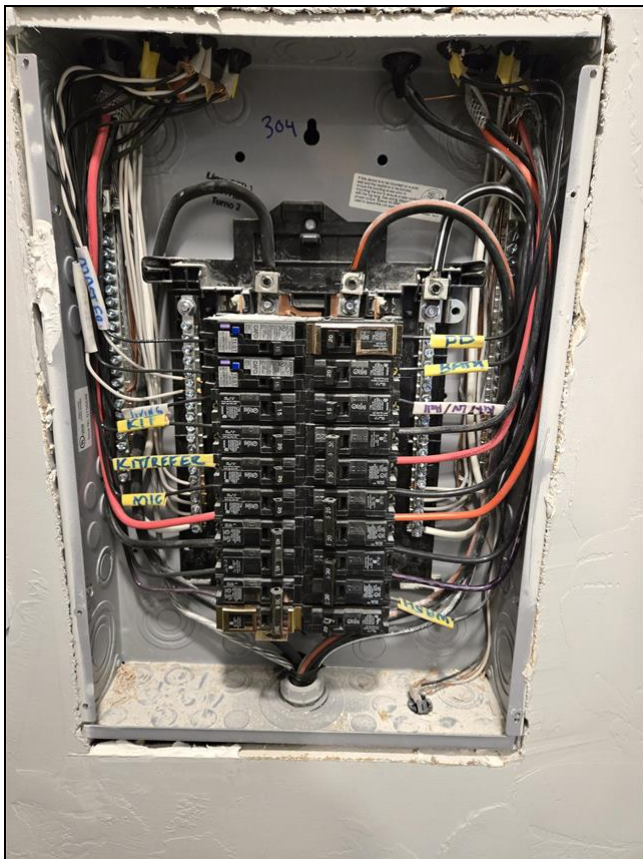
9.2 Item 2 (Picture)

(2) Each unit was equipped with a 100 amp Siemens service panel.

No readily observable material deficiencies were noted.

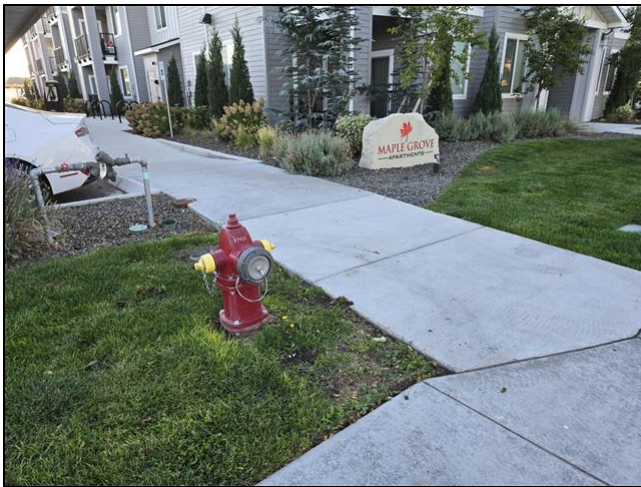
10.2 Item 1 (Picture)

Located at the front left corner of the property.

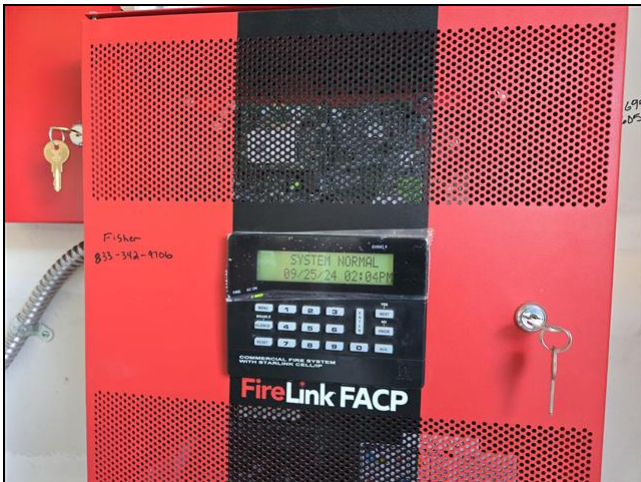
10.3 Item 1 (Picture)

No readily observable material deficiencies were noted.
