INSPECTION REPORT  
1736 S Broadway Ave  
Boise ID 83706

INSPECTED BY  
Paul Duffau CCPIA  
001011  
Calibre Commercial  
Inspections, LLC

INSPECTION DATE  
📅 9/3/2025  
🕒 08:25 AM

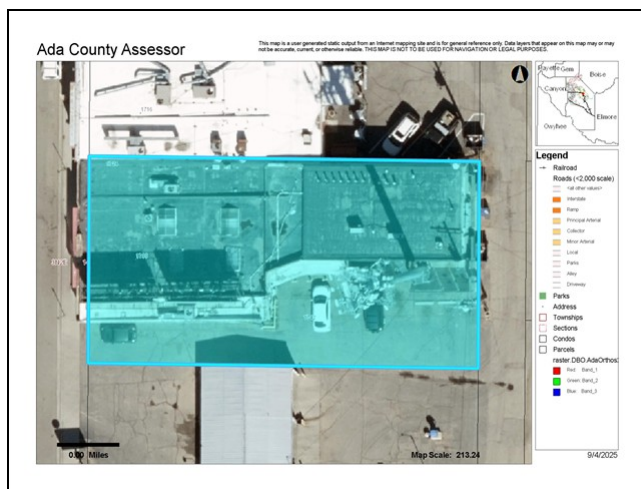
2.2 Item 1 (Picture)

The property is rectangular in shape and is approximately .18 acres. The frontage is along S. Broadway with businesses to either side and an alley to the rear.

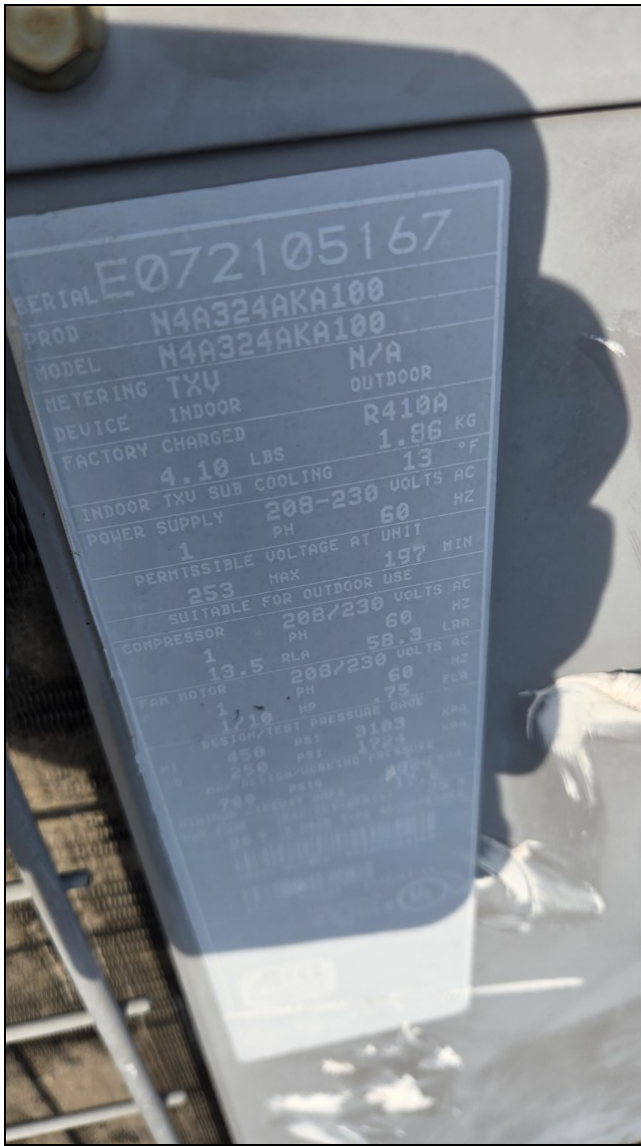
7.1 Item 4 (Picture)

No readily observable material deficiencies were noted.

Based on available records, inspections stickers, or the lack thereof, routine maintenance appears to be overdue. Recommend maintenance for this unit at this time.

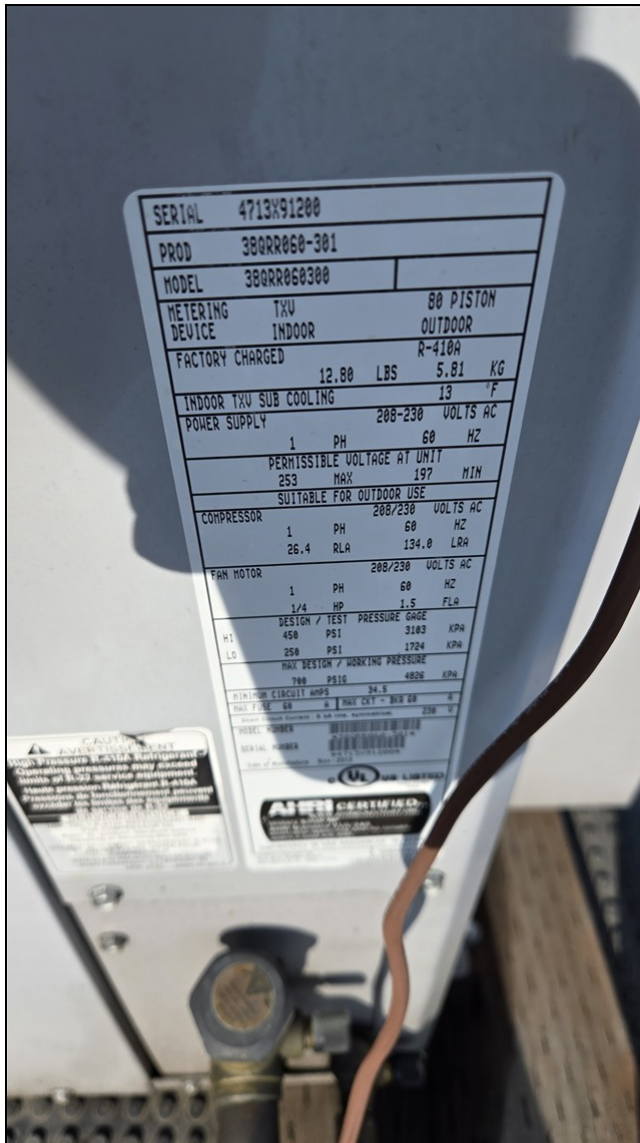
## 7.2 Item 1 (Picture)

This piece of equipment is well within a normal service life. Recommend continuing with routine maintenance..

Based on available records, inspections stickers, or the lack thereof, routine maintenance appears to be overdue. Recommend maintenance for this unit at this time.

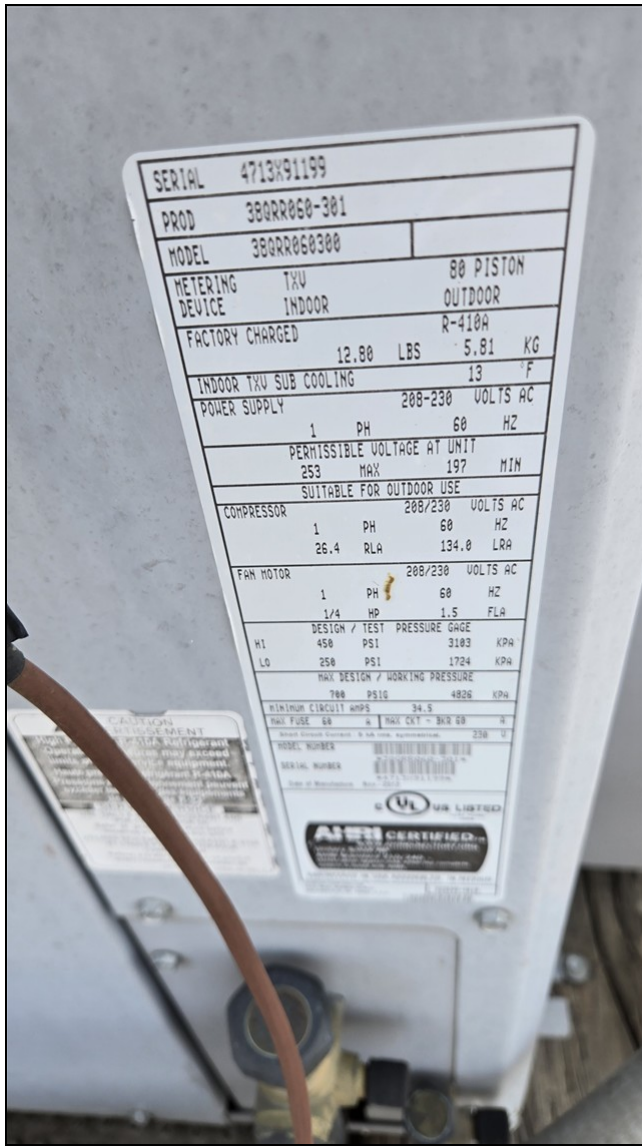
7.2 Item 2 (Picture)

(2) The second heat pump was a Carrier unit that was 12 years old. It delivered 5 tons of cooling capacity and approximately 60,000 BTUs of heating.

This piece of equipment is well within a normal service life. Recommend continuing with routine maintenance..

Based on available records, inspections stickers, or the lack thereof, routine maintenance appears to be overdue. Recommend maintenance for this unit at this time.

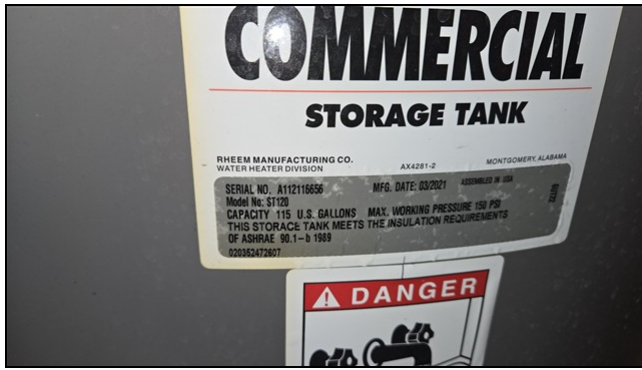
7.4 Item 5 (Picture)

(3) The third water heater was manufactured by Rheem and had a capacity of 115 gallons. This unit was 4 years old.

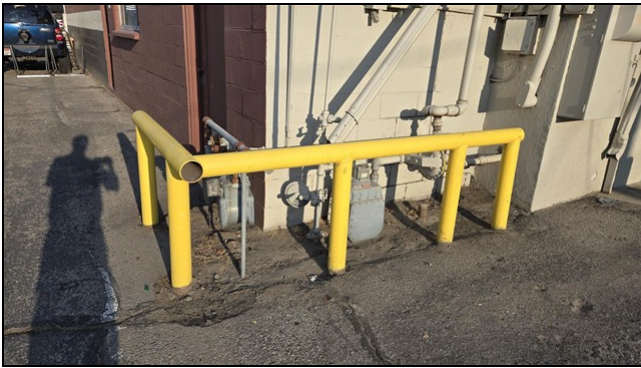
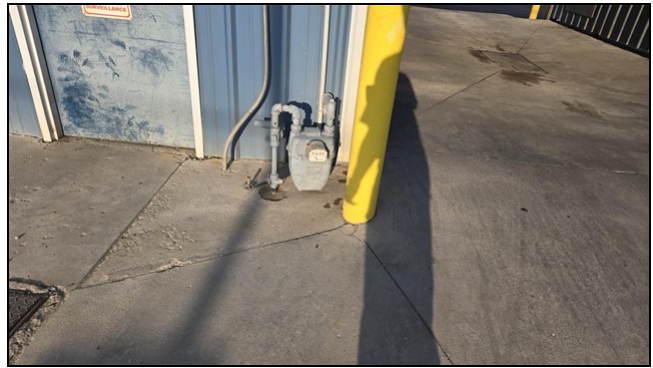
8.3 Item 1 (Picture)

The gas meters for this building was located at the Southeast corner by the doors. No readily observable material deficiencies were noted.

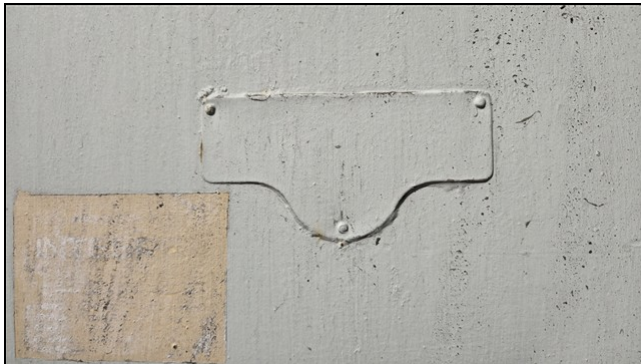
9.0 Item 1 (Picture)

The data plate for the main switch was not legible. The following are my estimates. The service entrance for the subject property is overhead to a masthead located at rear right side of the structure. The service size was 800 amps (estimated). The delivered power was a three phase, four wire system with 120/240/480V or 120/240/208V.

The Clearwire and Verizon systems had separate power. These were overhead and connected to a Square D meter pack that was rated for 800 amps.
