INSPECTION REPORT  
1422 S Tech Ln  
Meridian ID 83642

INSPECTED BY  
Paul Duffau CCPIA  
001011  
Calibre Commercial  
Inspections, LLC

INSPECTION DATE  
📅 12/5/2024  
🕒 08:00 AM

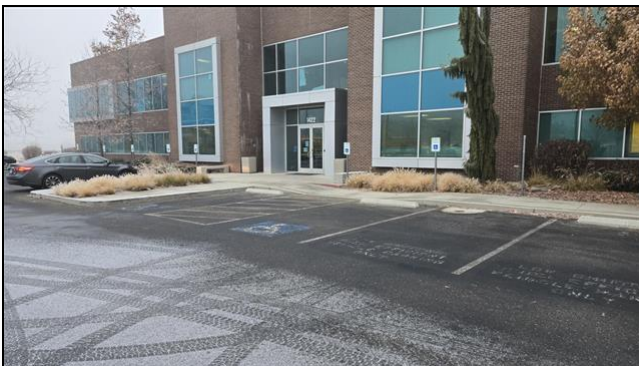
3.1 Item 1 (Picture)

(1) The subject building has surface parking lots on south and east sides. Parking lot surface materials included: asphalt surface. Paving materials appear to be constructed on a stabilized gravel base. Striping was present for parking stalls but worn. Curbing and curb stops were present.

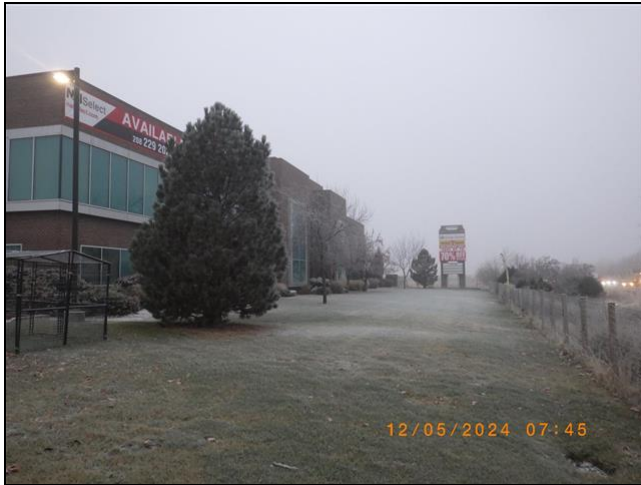
3.3 Item 1 (Picture)

Landscaping for the subject property included shrubs and trees to the front and sides with grass and trees to the rear. Sprinklers were present.

No readily observable material deficiencies were noted.

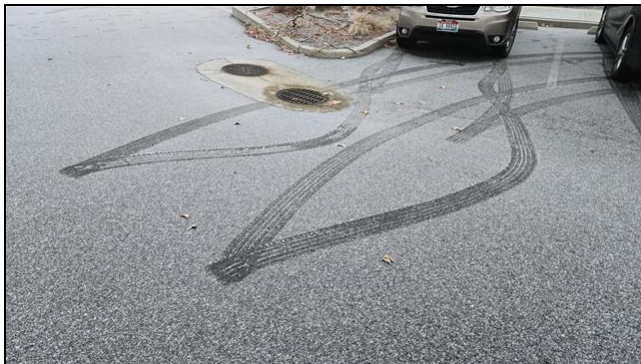
3.4 Item 1 (Picture)

Storm water management is managed in the landscaped areas through ground absorption.

No readily observable material deficiencies were noted.

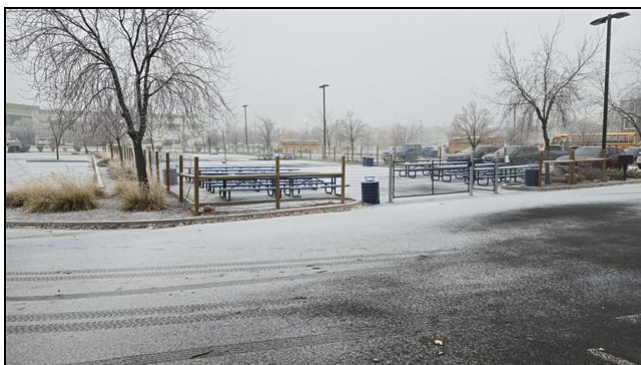
3.5 Item 1 (Picture)

(1) There is fencing within the parking lot to create a playground area for the school. This occupies approximately 20% of the total parking area. Additional fencing was present at the rear of the building.

No readily observable material deficiencies were noted.

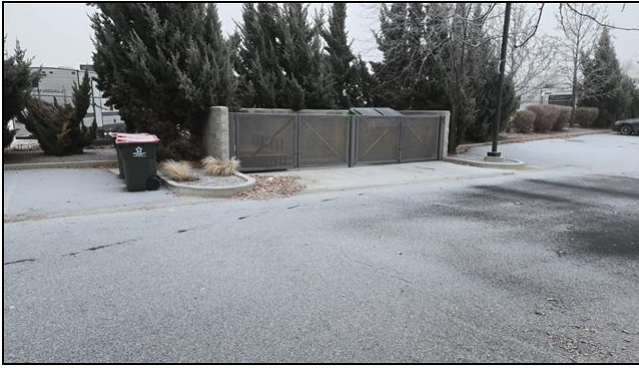
3.5 Item 2 (Picture)

(2) A trash enclosure was located at the North East corner of the parking lot. No readily observable material deficiencies were noted.

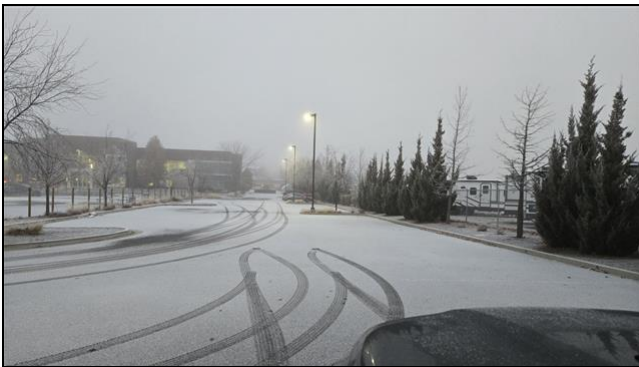
3.7 Item 1 (Picture)

Site lighting included: pole-mounted lighting, wall-mounted lighting and, lighting at entrances

No readily observable material deficiencies were noted.

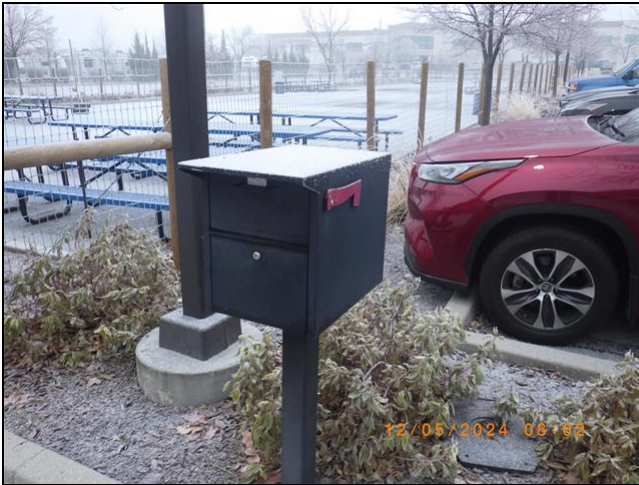
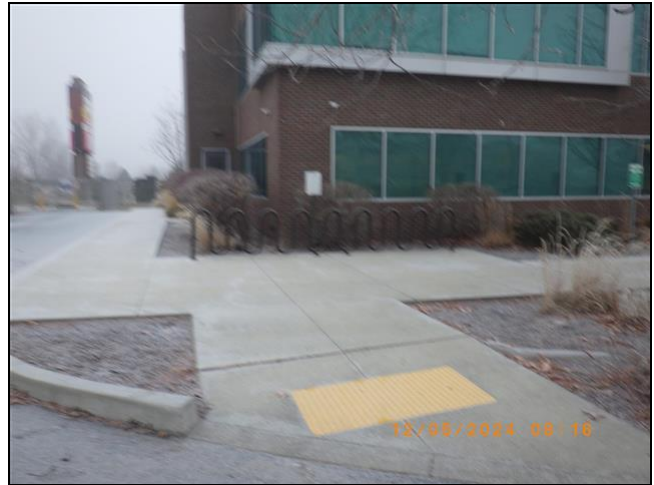
A playground was present in the parking lot with bench for eating and various sports equipment. A bicycle rack was present at the left front of the building. A mail box was present to the front of the building.

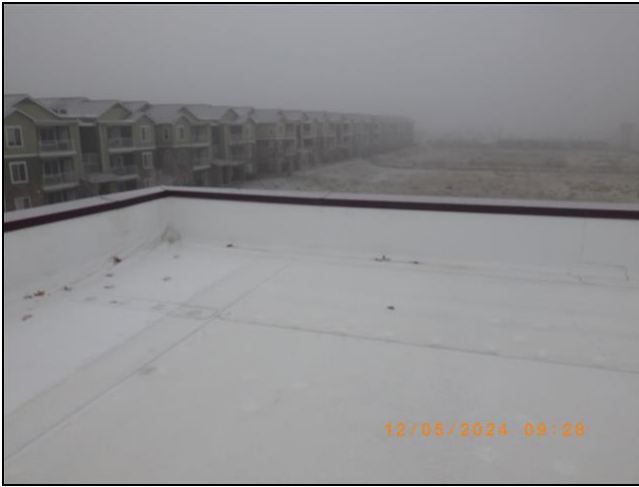
4.5 Item 1 (Picture)

Appropriate parapets are present at the edge of the roof. Safety railings were installed around the schedule access to the roof. Parapet flashings appeared in serviceable condition. No readily observable material deficiencies were noted.

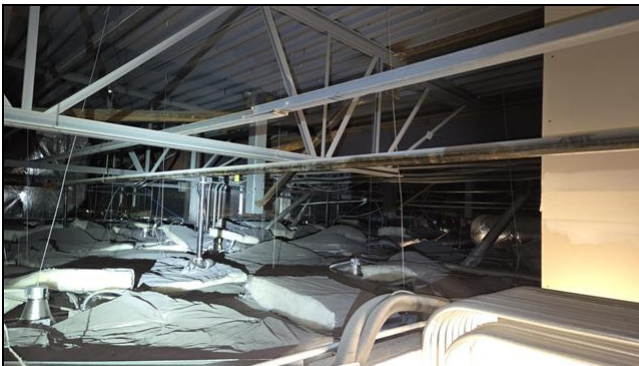
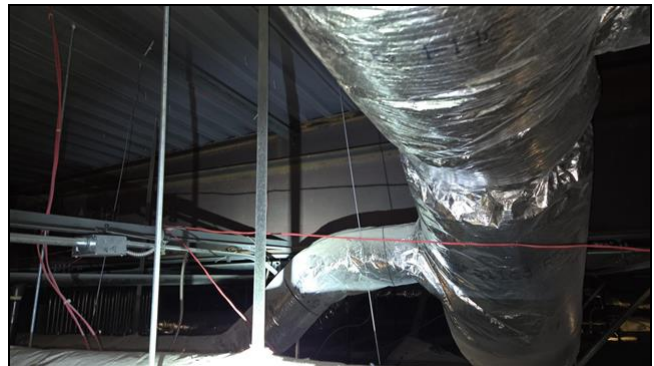
The roof structure was metal decking supported engineered metal joists bearing to structural steel beams, as visible from the interstitial spaces.

No readily observable material deficiencies were noted.

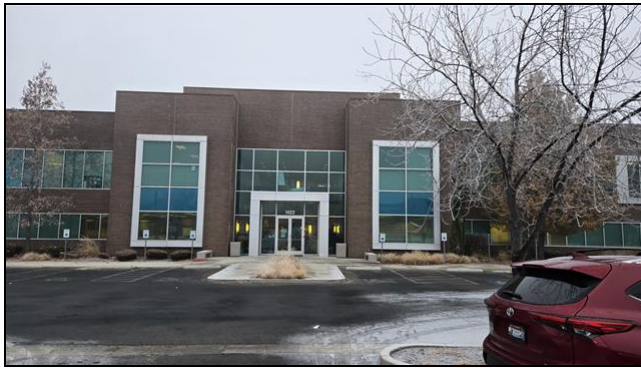
5.0 Item 1 (Picture)

(1) The exterior wall cladding of the subject property was an adhered brick face veneer with anodized metal accents and architectural glass.

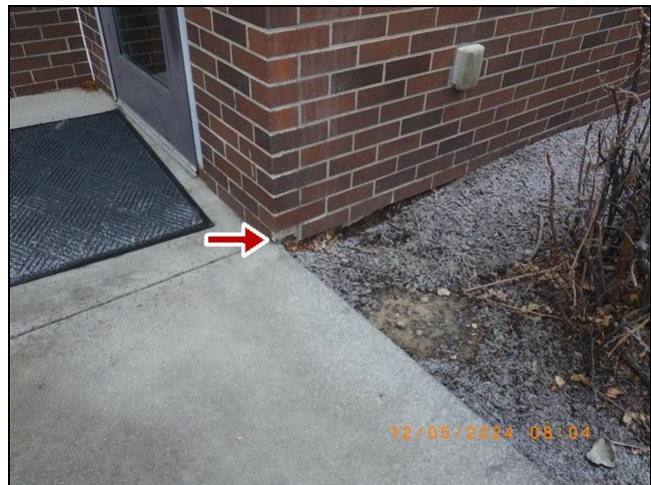
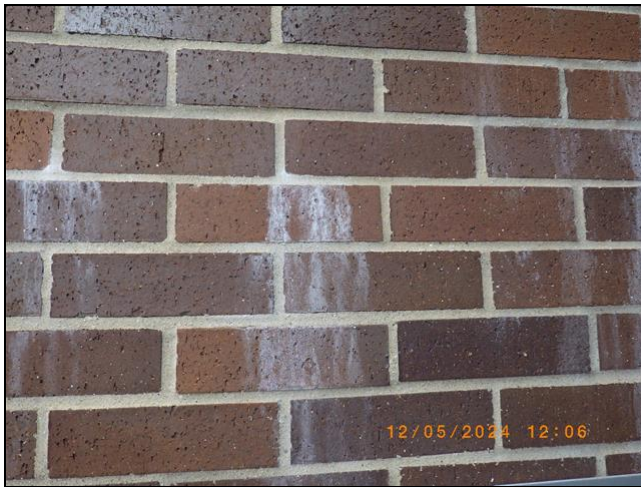
(2) Efflorescence noted on the front and right side of the building suggesting that water intrusion is occurring at the brick face. Two pieces of the veneer, both at the base of the walls, were missing.

The source of the moisture intrusion into the walls should be identified (see notes below) and corrected. Missing veneer should be replaced.

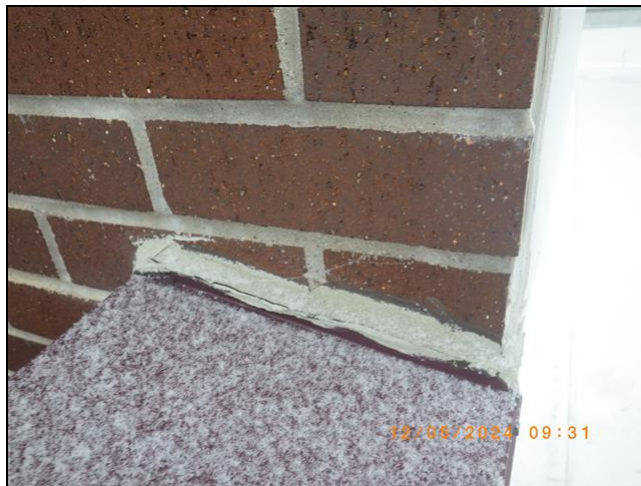
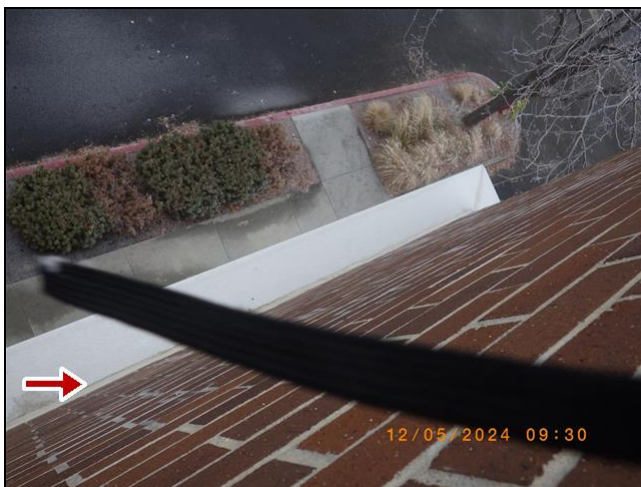
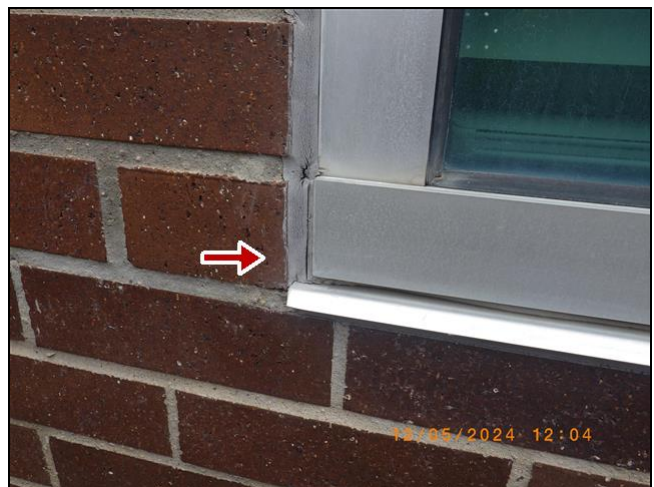
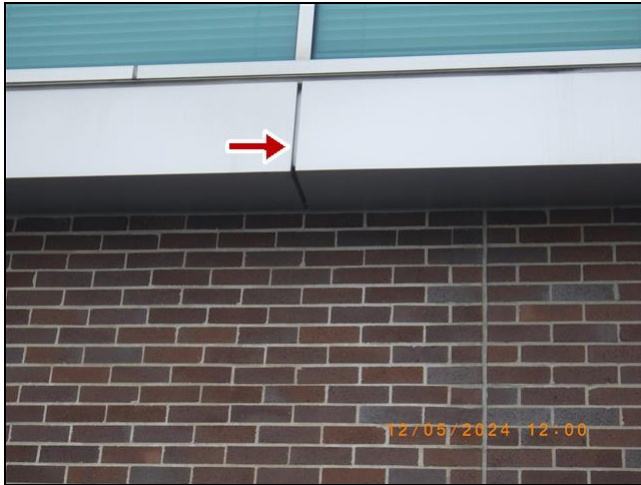
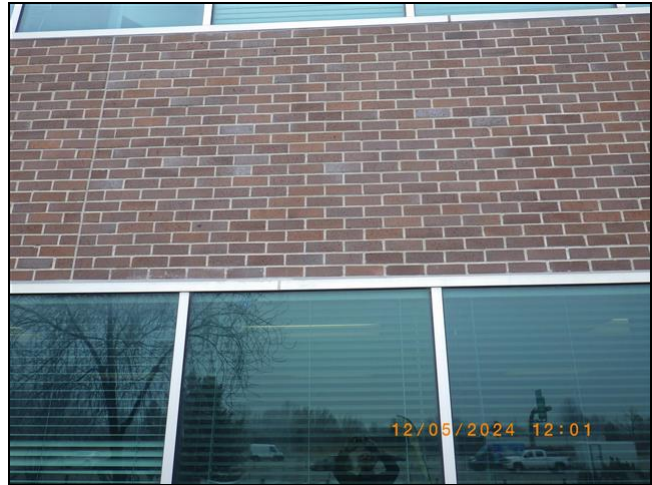
(3) Caulking is deteriorating at the edge of the windows and tops of projections as well as the intersection of wall segments. This leads to water intrusion. Recommend repair.

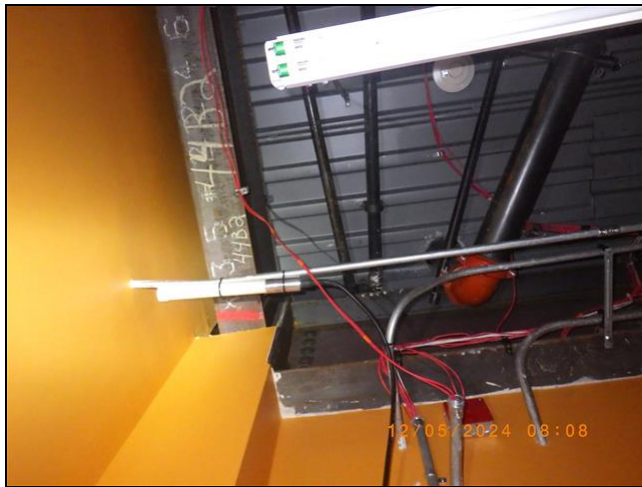
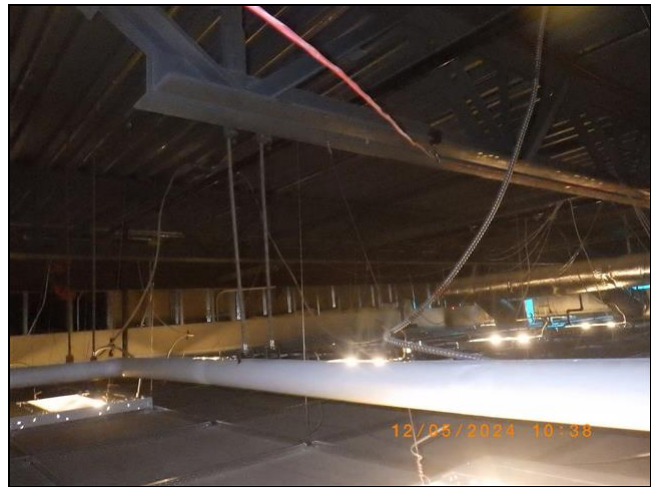
The structural frame was constructed of steel columns and beams. Wall framing appeared to be cold-formed steel. No readily observable material deficiencies were noted.

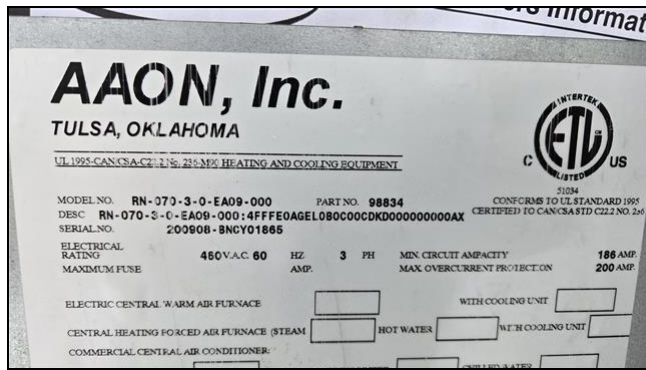
### 7.1 Item 1 (Picture)

(2) RTU 2 - This is a cooling system with an equalizer manufactured by Aaon. in 2009. The unit is rated at 70 tons of cooling.

This piece of equipment is approaching the end of a normal service life. Recommend continuing with routine maintenance and developing cash reserves for eventual replacement.

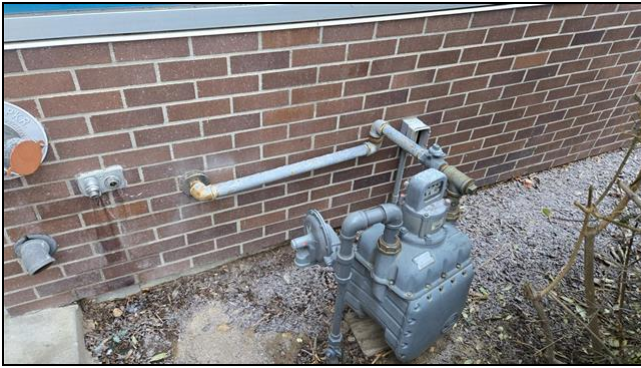
8.3 Item 1 (Picture)

The gas main was located on the right side of the building to the right of the FACP Room door. Gas meter and piping, where visible, were inspected.

No readily observable material deficiencies were noted.

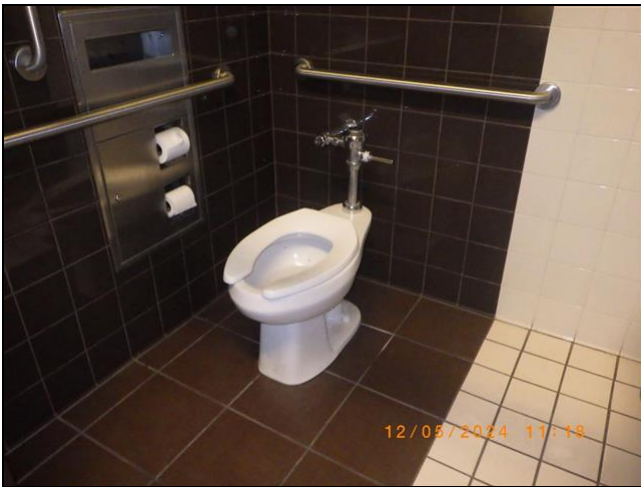
8.4 Item 1 (Picture)

(1) There were two restrooms on each floor, two each for men and women. The ground floor restrooms included sinks, toilets and stalls, urinals (men's restroom), and a shower. The upstairs restrooms were similar but did not have showers.

Restrooms had ADA compliant stalls with safety rails.

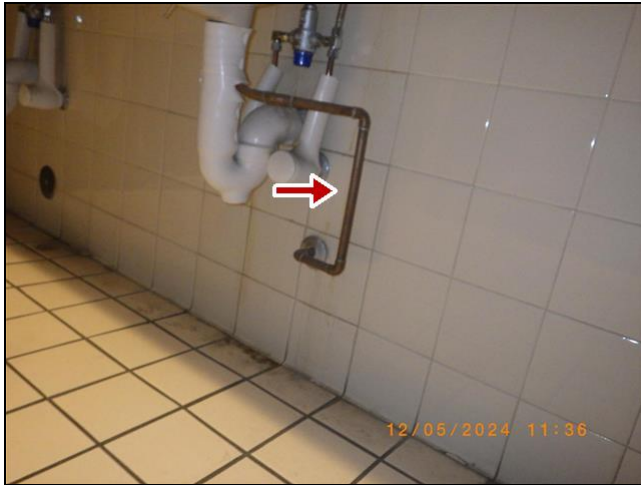
8.4 Item 4 (Picture)

(3) One exposed water pipe present in the Men's restroom on the ground floor.

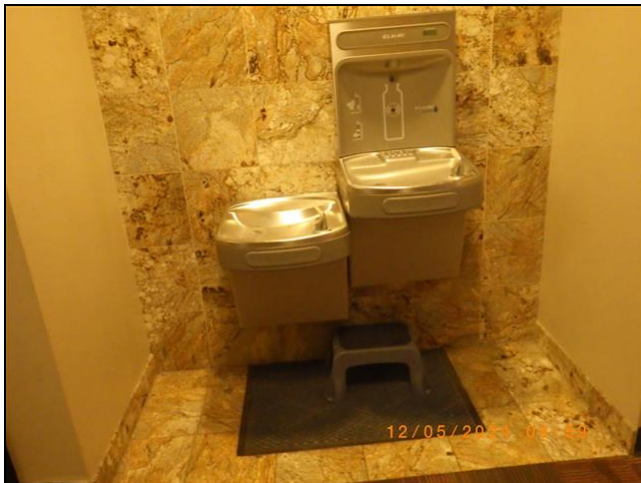
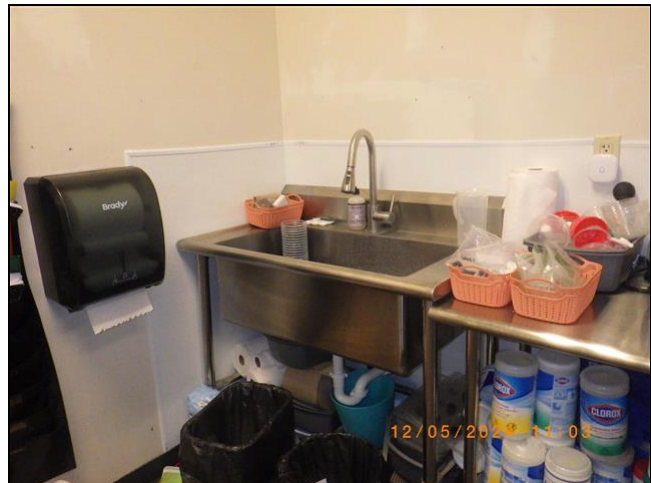
The science classrooms were equipped with deep sinks.

Several mop sinks were present.

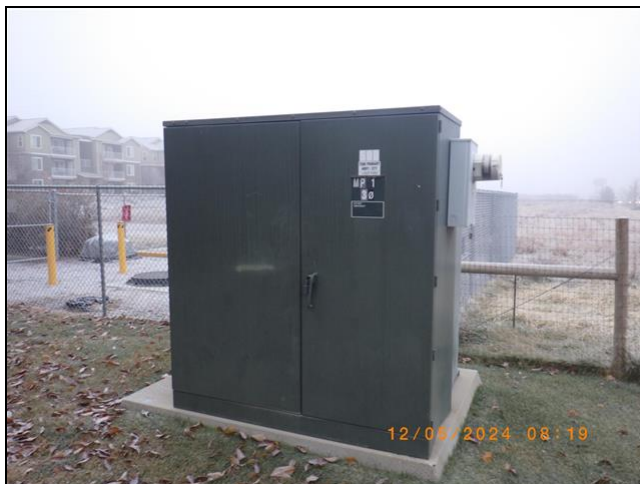
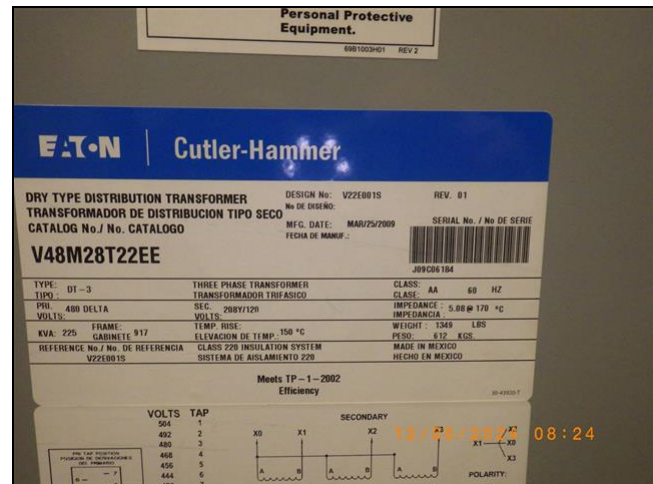
Delivered power was a three-phase, four-wire system. Two primary panels were present, each rated at 800 amps. Panels were rated at 480/277volts.

An Eaton dry type distribution transformer was present.

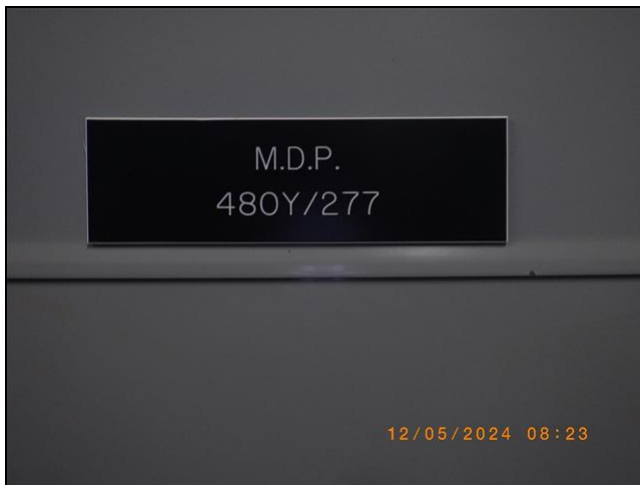
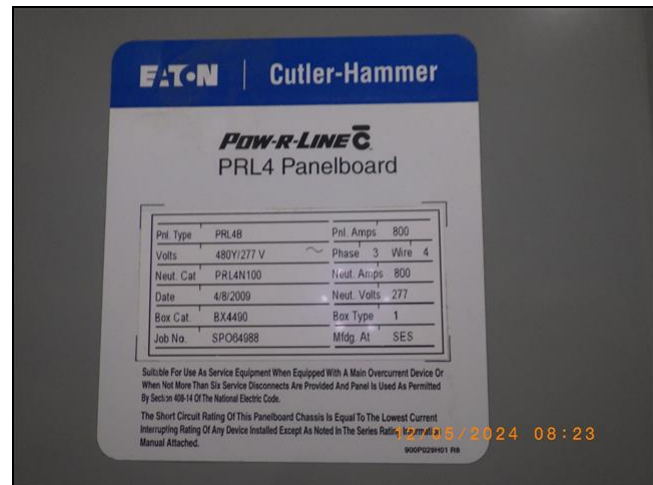
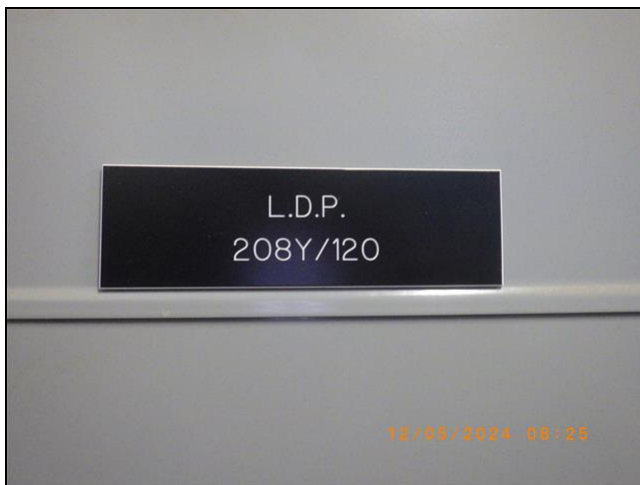
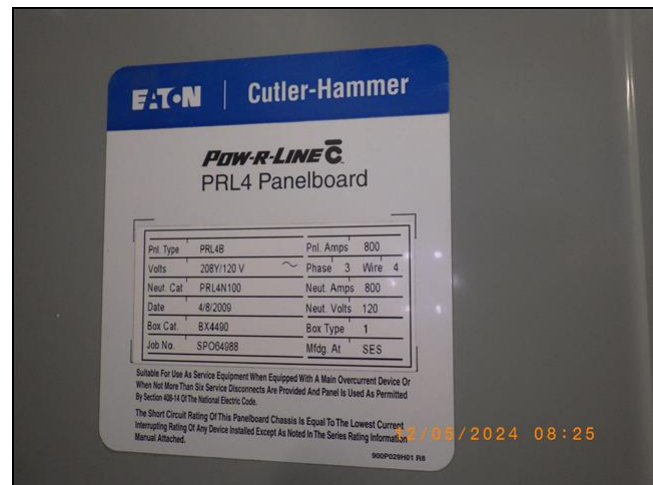
Panels L5, L6 Sec. 1 & 2 were located in the upstairs janitorial room.

All panels were manufactured by Eaton.

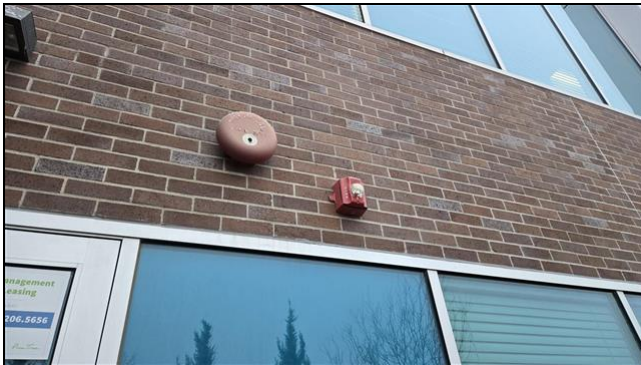
10.3 Item 1 (Picture)

A centrally reporting fire alarm system is installed with both visual and audible warning systems on the interior and exterior of the building.

No readily observable material deficiencies were noted.

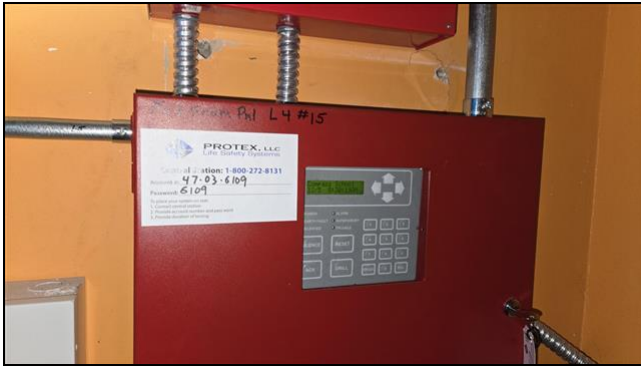
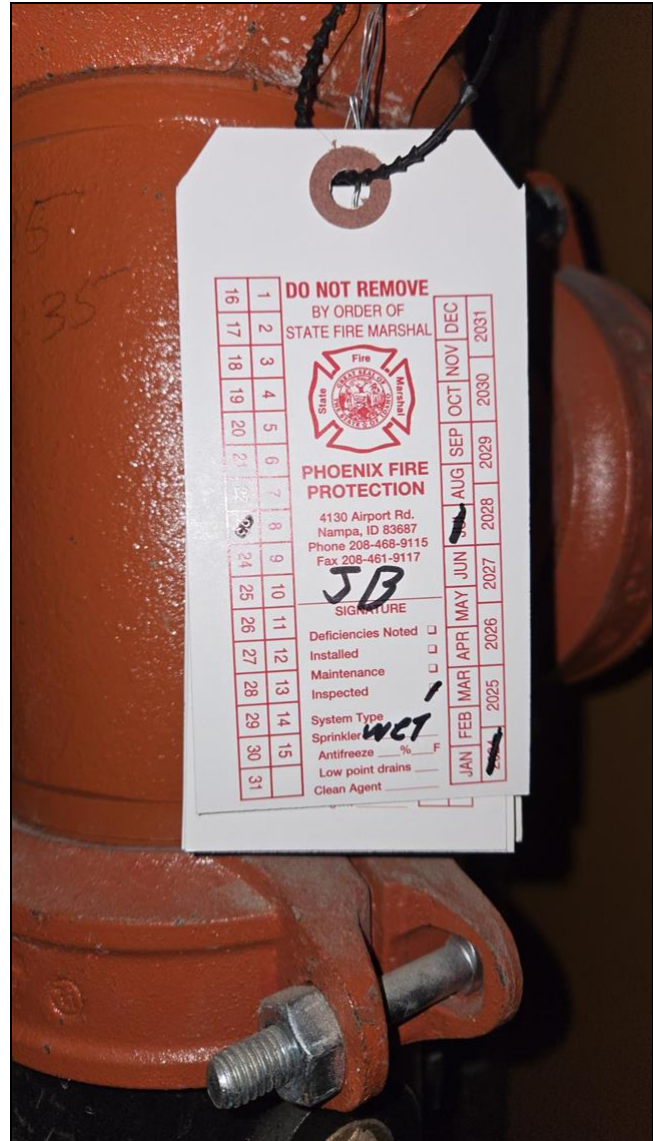
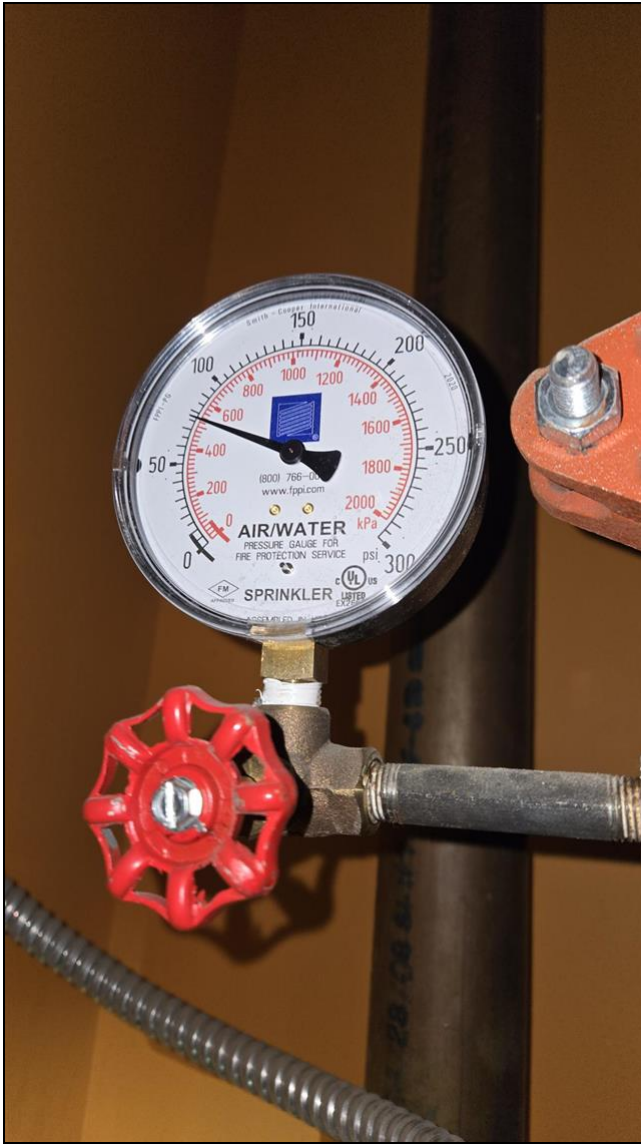
The building was equipped with a wet fire suppression system. Inspections appeared to be up-to-date. Suppression was present throughout the building.

No readily observable material deficiencies were noted.

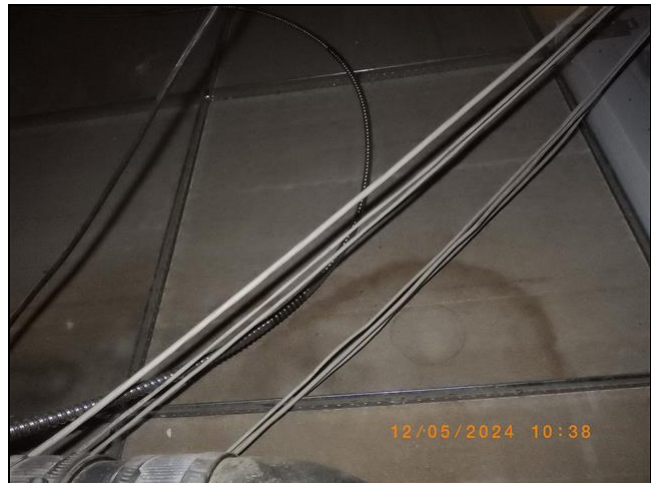
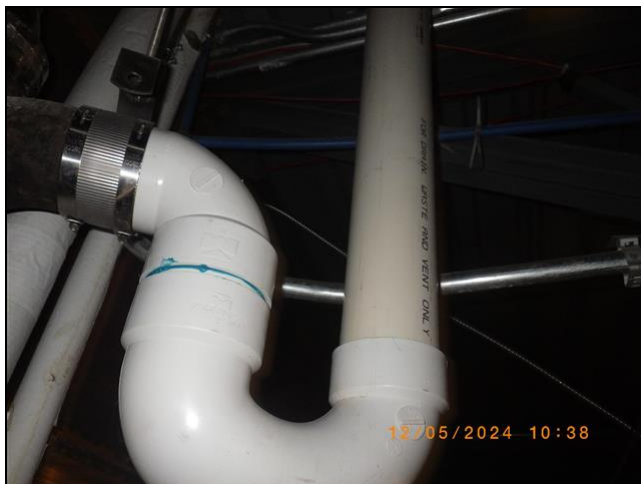
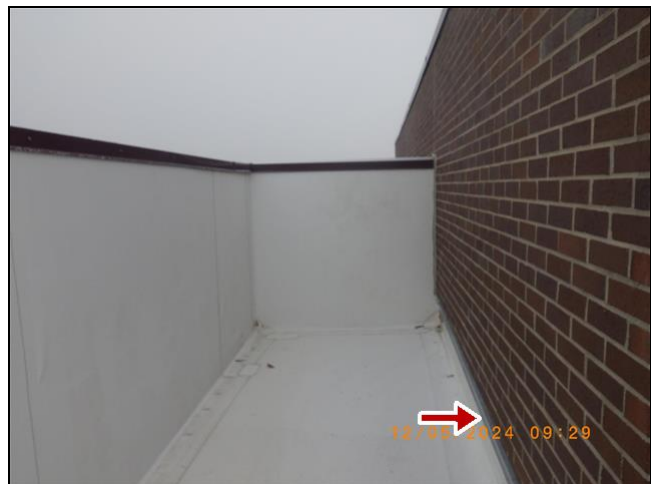
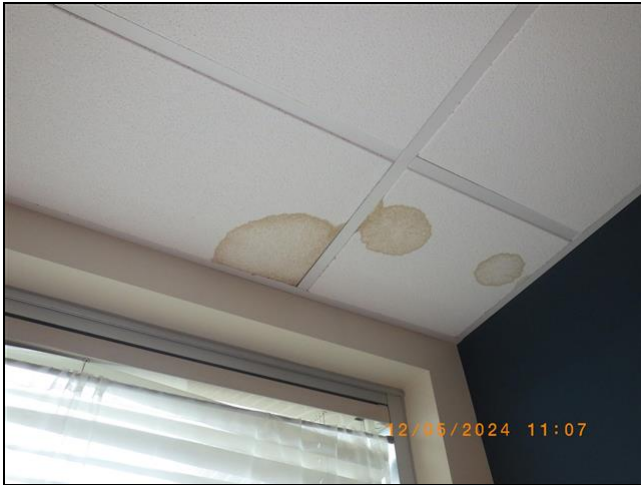
The staining on the ground floor ceilings appeared related to plumbing leaks above.

The staining on the second floor ceilings appeared related to roof leaks at the roof projections around the mechanical equipment. This was likely related to deteriorated sealants on the exterior.

All stains that were tested were dry suggesting that repairs have been made and were effective.

Monitoring is recommended.

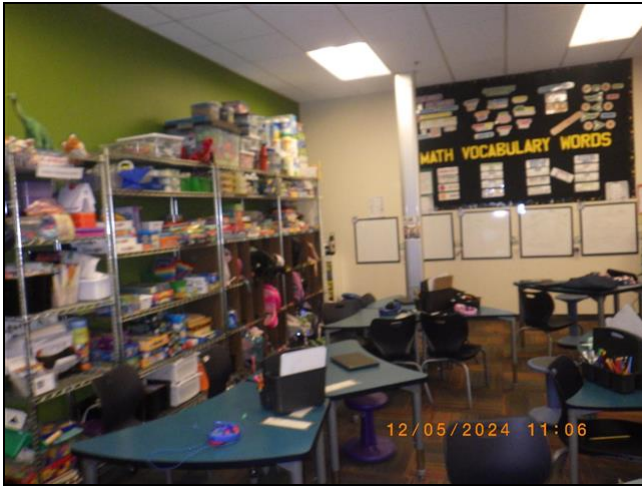
11.8 Item 1 (Picture)

Classes were in progress. Inspection of classrooms occurred during lunch breaks. Due to type of use, much of the wall areas were obscured by materials.

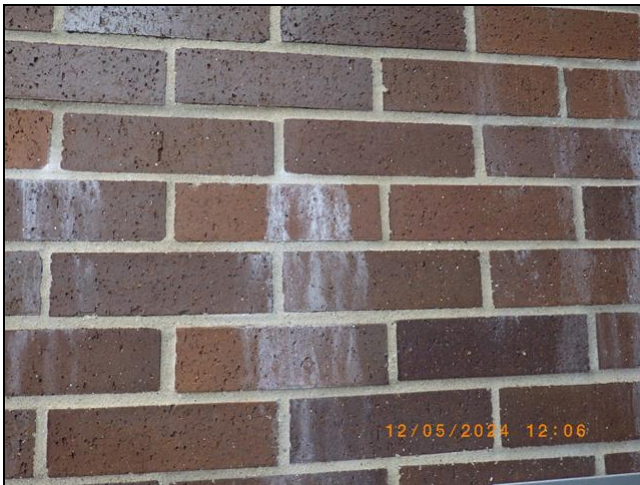
5.0 Item 5 (Picture)

(2) Efflorescence noted on the front and right side of the building suggesting that water intrusion is occurring at the brick face. Two pieces of the veneer, both at the base of the walls, were missing.

The source of the moisture intrusion into the walls should be identified (see notes below) and corrected. Missing veneer should be replaced.

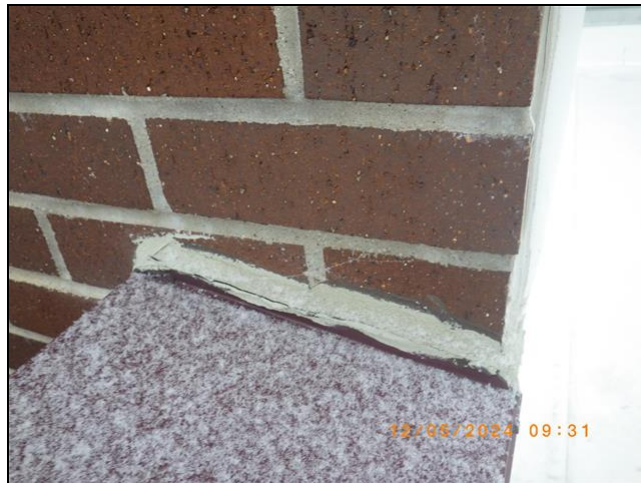
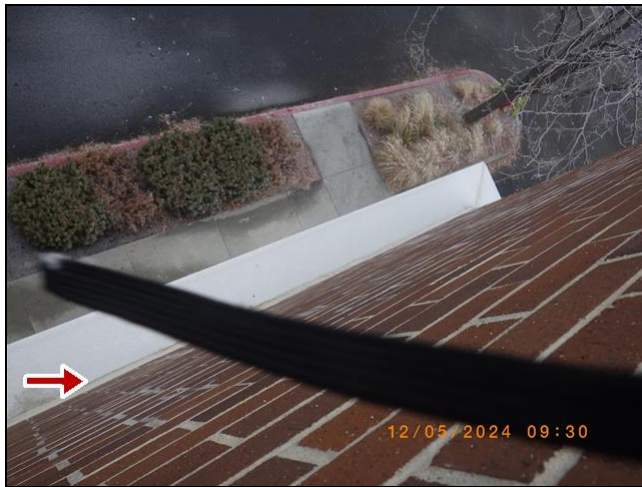
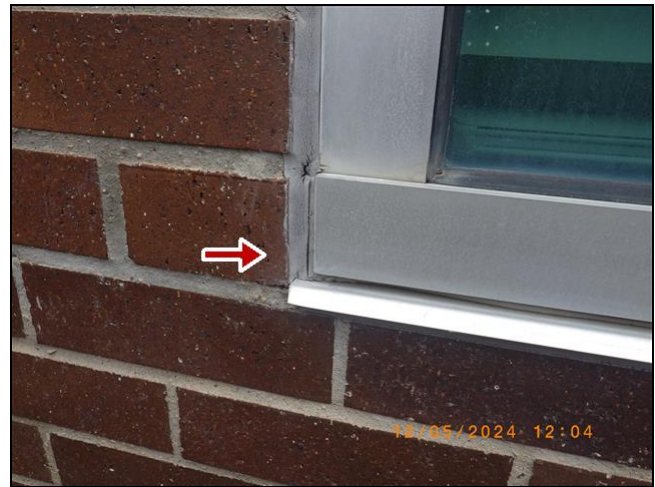
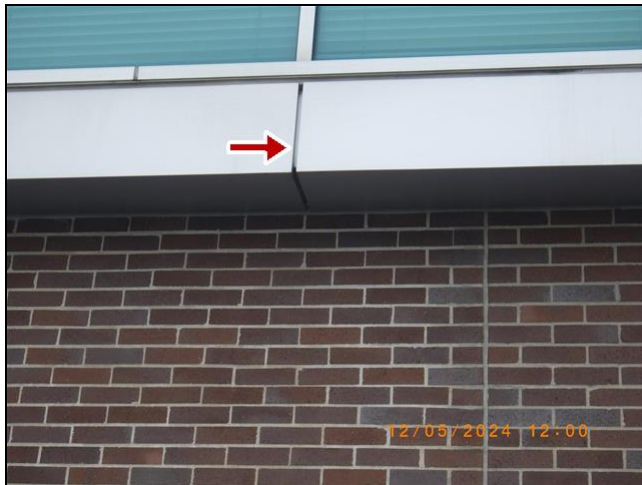
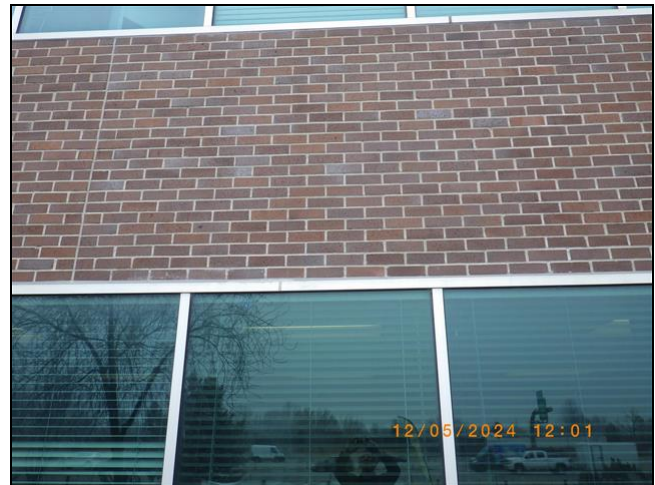
(3) Caulking is deteriorating at the edge of the windows and tops of projections as well as the intersection of wall segments. This leads to water intrusion. Recommend repair.

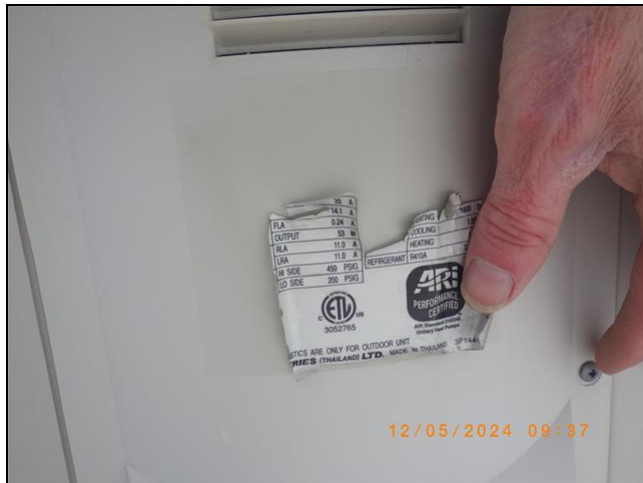
7.0 Item 4 (Picture)

(5) CU201- This is a mini-split heat pump system, with both heating and cooling, manufactured by Daiken. in 2009. The unit has a 21,00 BTU capacity.

This piece of equipment is approaching the end of a normal service life. Recommend continuing with routine maintenance and developing cash reserves for eventual replacement.

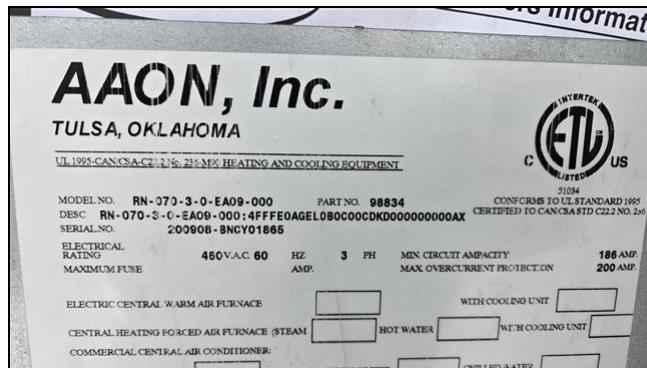
### 7.1 Item 1 (Picture)

(2) RTU 2 - This is a cooling system with an equalizer manufactured by Aaon. in 2009. The unit is rated at 70 tons of cooling.

This piece of equipment is approaching the end of a normal service life. Recommend continuing with routine maintenance and developing cash reserves for eventual replacement.

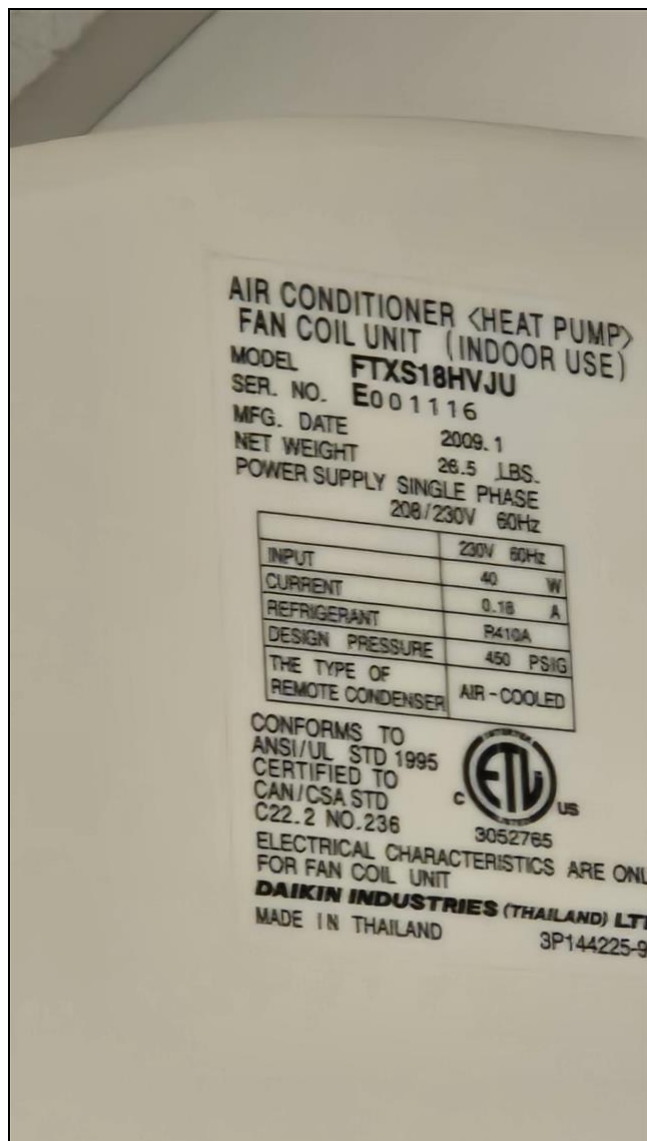
### 7.1 Item 2 (Picture)

(4) CU101- This is a mini-split heat pump system, with both heating and cooling, manufactured by Daiken. in 2009. The unit has a 1.5 ton cooling capacity.

This piece of equipment is approaching the end of a normal service life. Recommend continuing with routine maintenance and developing cash reserves for eventual replacement.

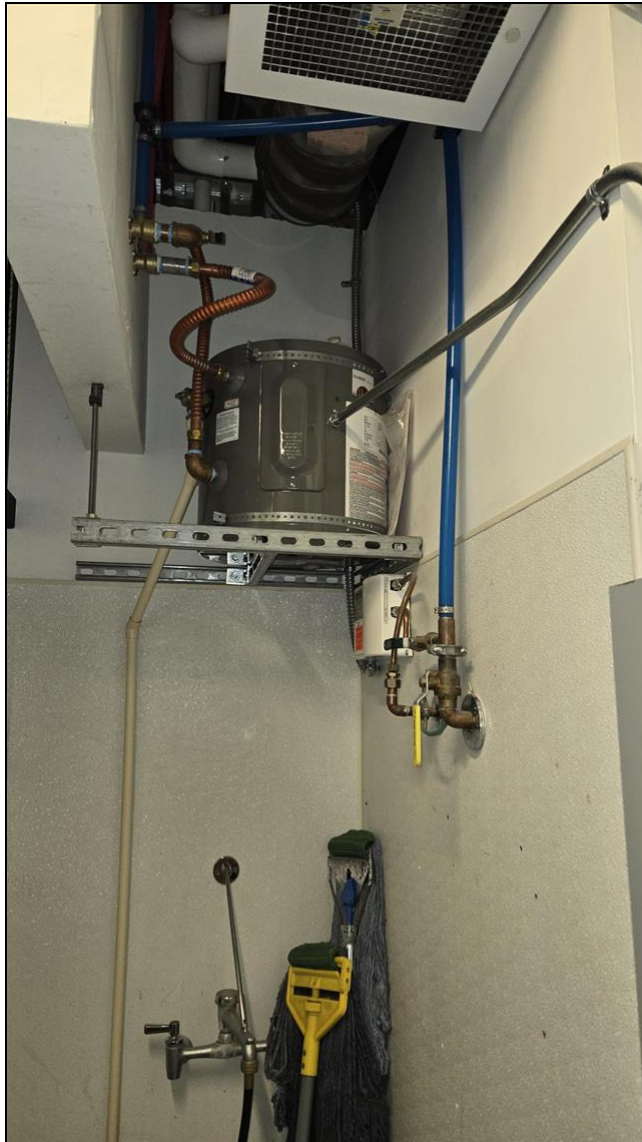
7.3 Item 3 (Picture)

This piece of equipment is at the end of a normal service life. Recommend continuing with routine maintenance and developing cash reserves for eventual replacement..
