# Commercial Inspection Report

Property Address:

Broadway

Spokane WA 99201

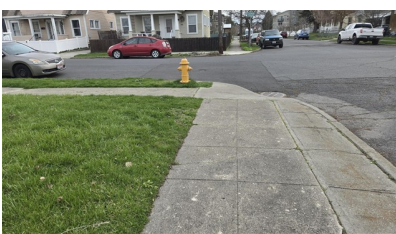
**3.2 Item 1 (Picture)**

The nearest fire hydrant was observed at the corner of West College Avenue and North Oak Street. No readily observable material deficiencies were noted.
