INSPECTION REPORT  
Spokane Valley WA 99206

INSPECTED BY  
Paul Duffau CCPIA  
001011  
Calibre Commercial  
Inspections, LLC

INSPECTION DATE  
📅 11/7/2024  
🕒 07:00 AM

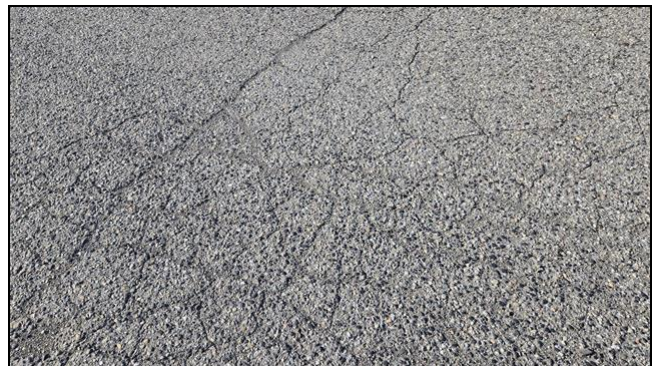
3.1 Item 4 (Picture)

(2) The asphalt surface in multiple locations throughout the yard was damaged as evident by localized alligator cracking suggesting a localized structural failure of the surface, potholes, and possibly the subsurface structure.. Recommend evaluation by a licensed and qualified paving contractor to determine the full scope of the necessary work.

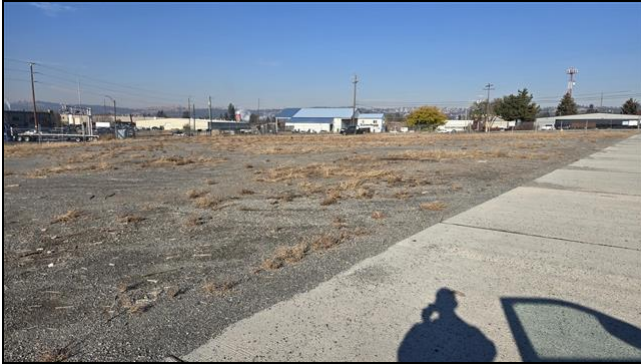
3.3 Item 1 (Picture)

Landscaping is not present. Areas of unimproved lot are dirt with controlled weed growth.

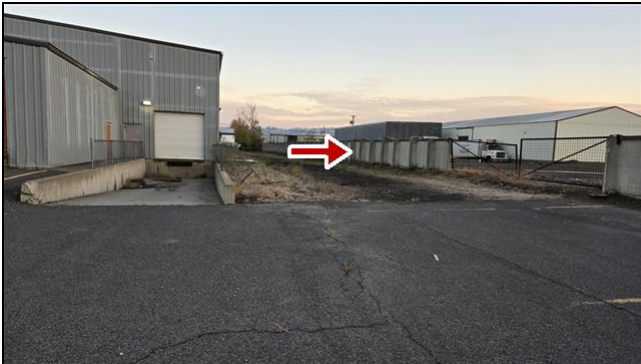
3.5 Item 1 (Picture)

The property is fully fenced, primarily with chain link. One section by Building A has a concrete barrier fence.

No readily observable material deficiencies were noted.

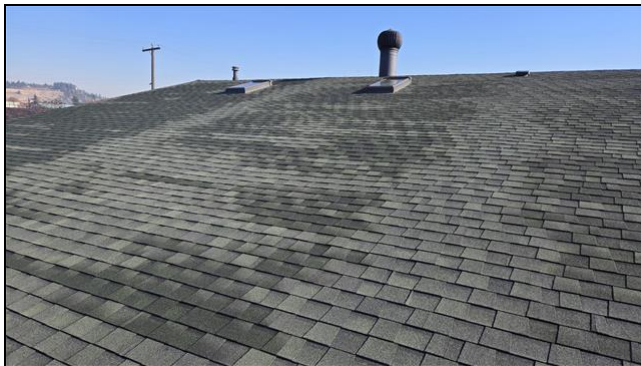
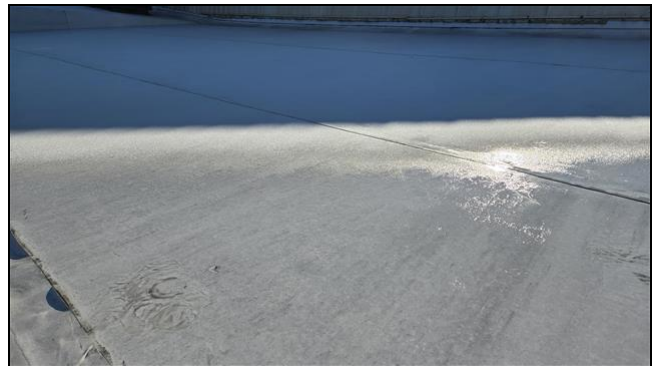
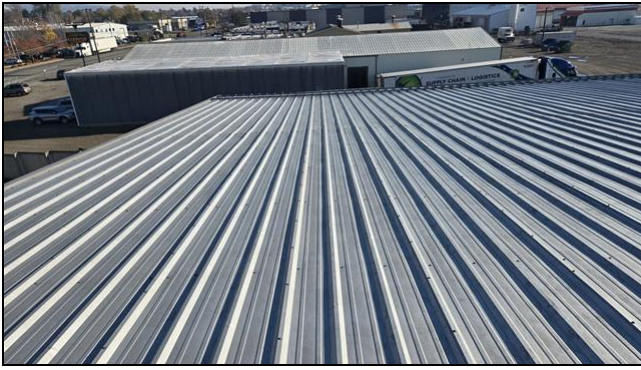
The membrane is aging. Recommend holding reserves for replacement.

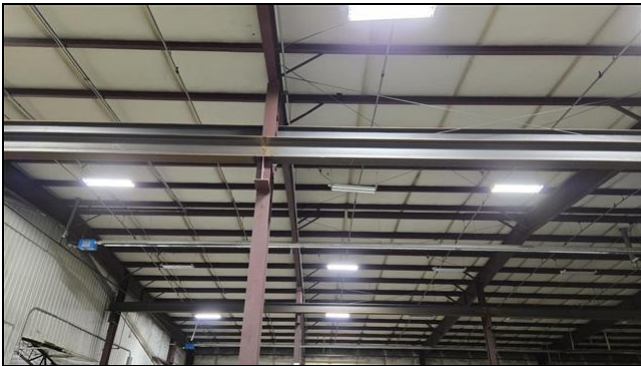
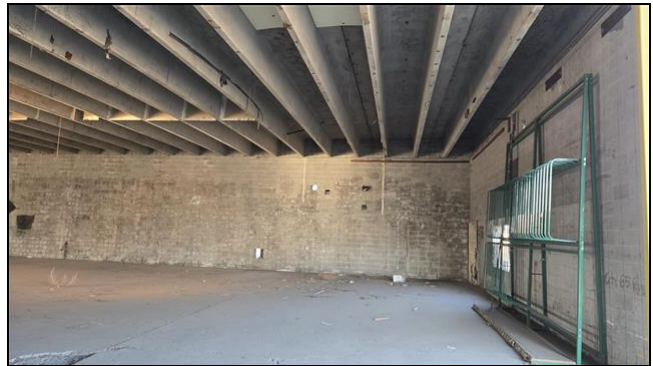
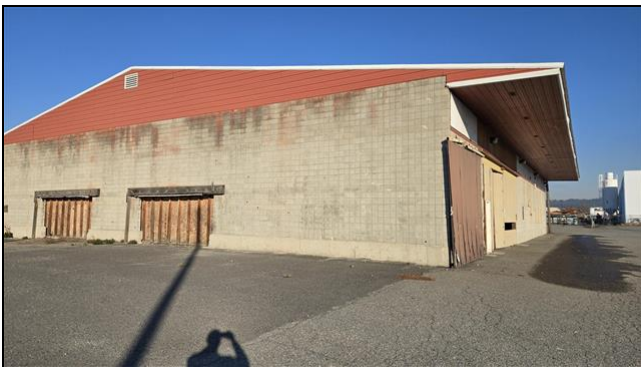
The roof structure for Buildings B, C, E, and F were framed using manufactured roof trusses. Manufactured roof trusses are designed by a structural engineer and prefabricated in a manufacturing facility under controlled conditions. Truss designs and their installation specifications are specific to individual structures.

Building B also had a concrete ceiling that may originally been part of a flat roof.

No readily observable material deficiencies were noted.

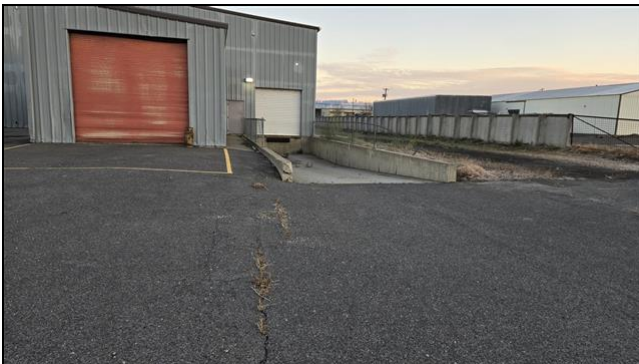
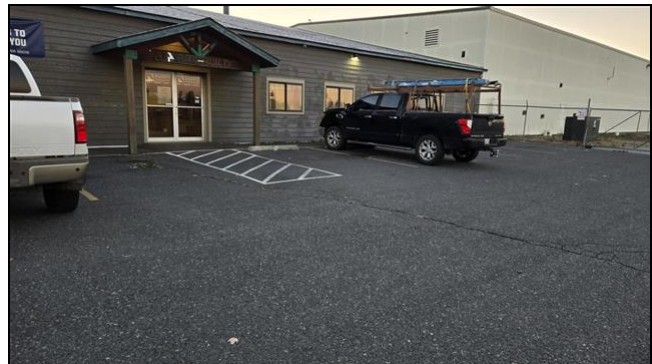
(1) Building A had a combination of steel security doors and anodized metal with thermally glazed entry doors for pedestrians. There was also a roll-up door for the truck dock. There were roll-up doors for the warehouse.

No readily observable material deficiencies were noted.

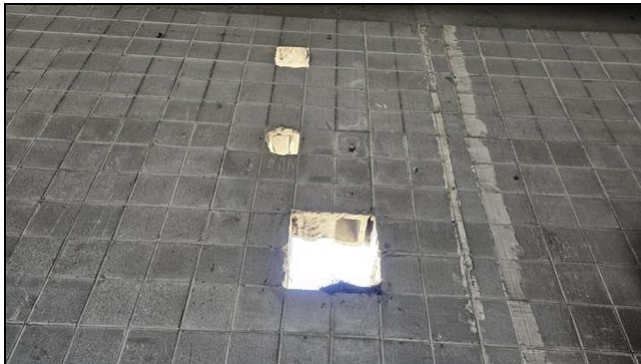
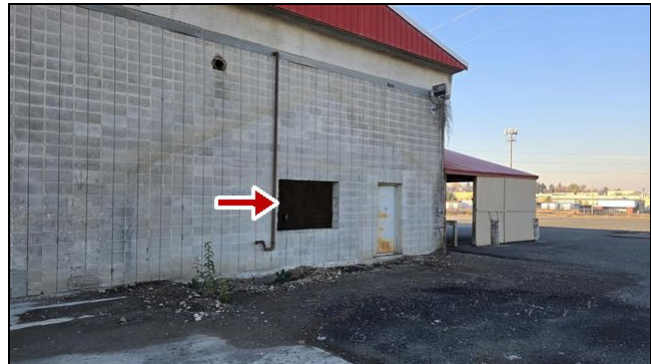
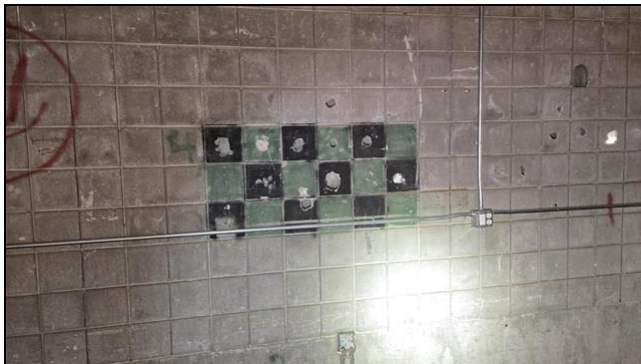
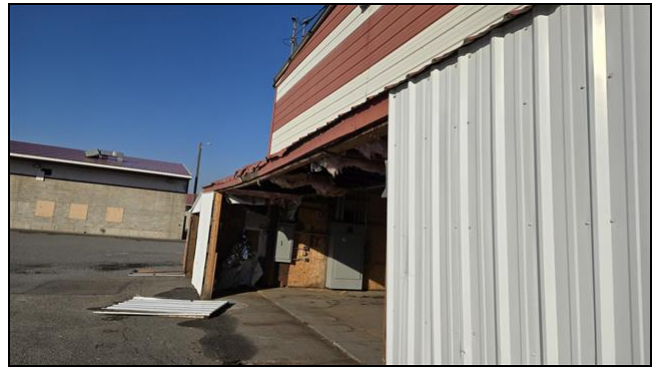
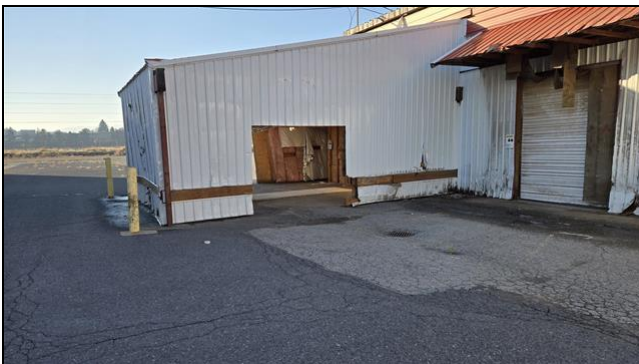
(2) Buildings B and C had concrete masonry wall systems. Substantial opening were made in the walls, especially on Building B, without adequate reinforcement. Building C has substantial damage to individual cells of the block. Recommend repair.

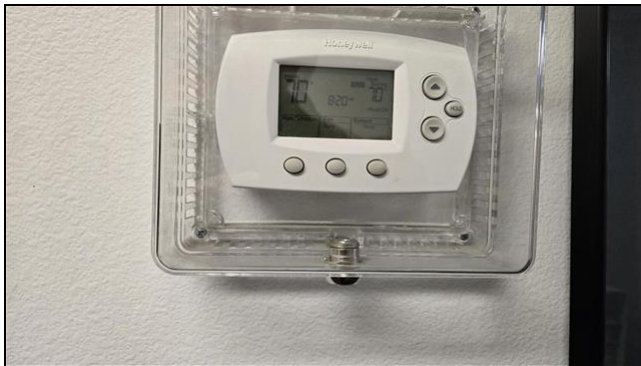
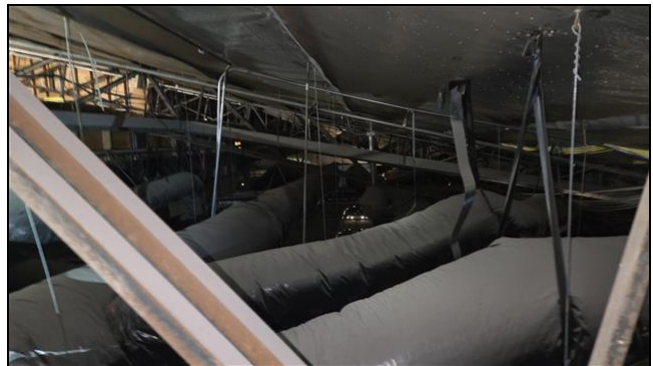
The gas-fired forced air furnaces used insulated ductwork. Distribution appeared satisfactory. Thermostats appeared in good operating condition.

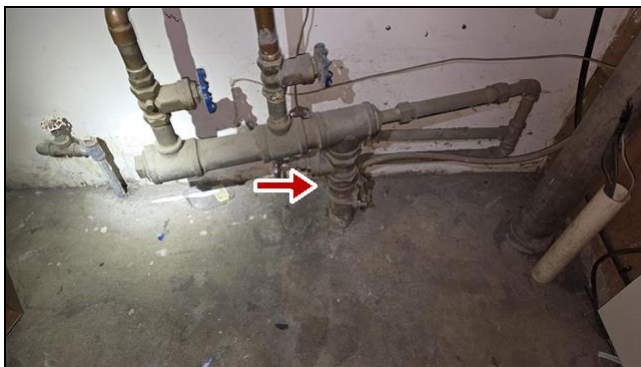
9.1 Item 1 (Picture)

Grounding was to both plumbing supply piping and to driven ground rods.

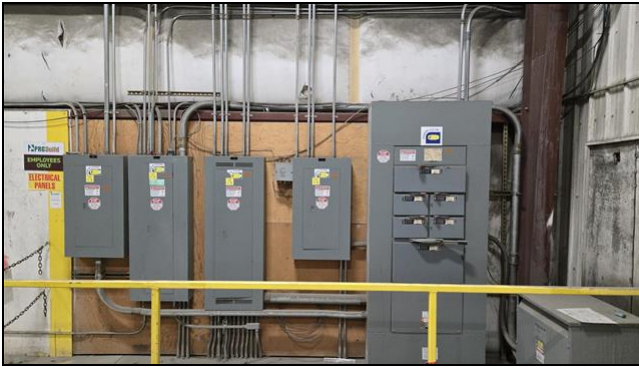
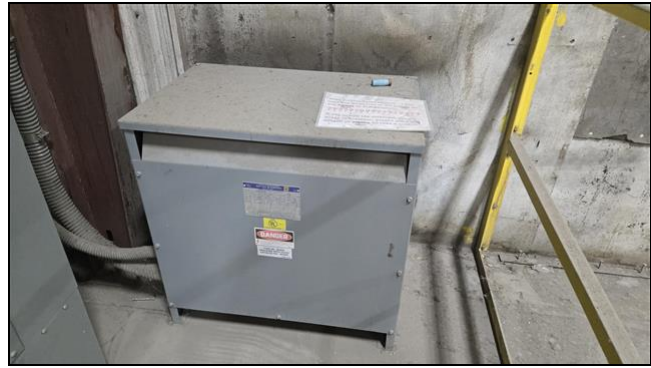
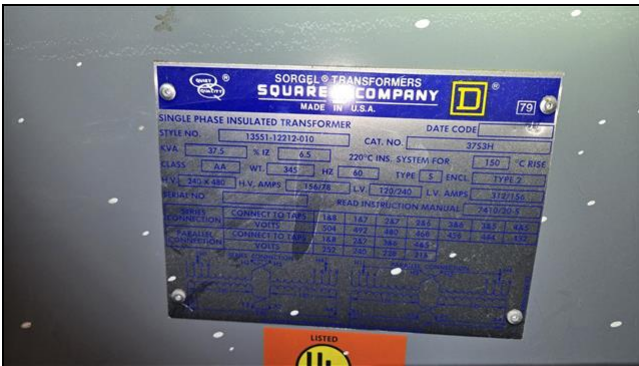
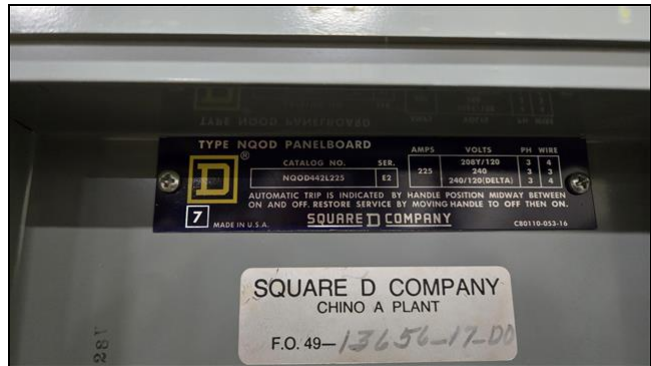
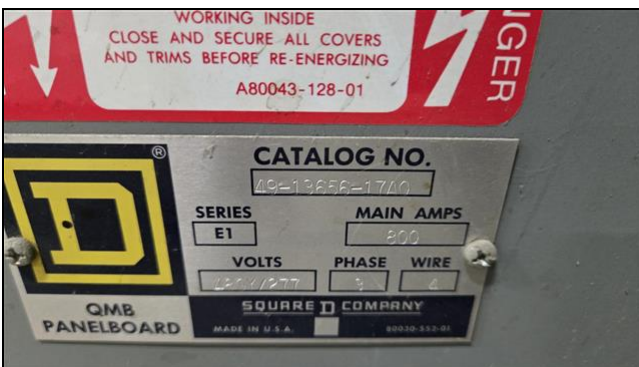
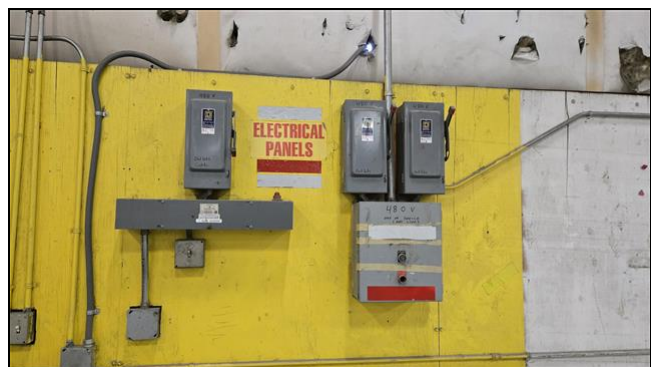
(2) Building A (addition) The main cabinet is in the warehouse and manufactured by Square D. Power appeared to be 120/240/480v and 480Y/477v with amperage ranging from 100 to 400 amps.

Two breakers were marked in the KVA range - I believe these are designating transformers and do not represent the voltage at the breaker. A total of 4 transformers were present, three in the mezzanine area and one by the addition's panels.

No readily observable material deficiencies were noted.

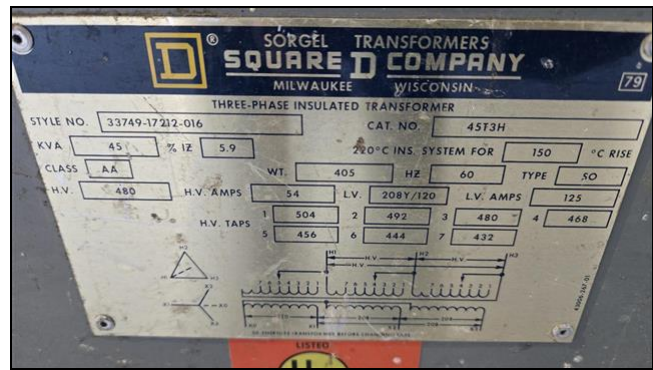
9.2 Item 11 (Picture)

(3) Building B had a 400 amp Square D service. A transformer was located in this building. The main fuse and panel system is aging and due for replacement. The main panel was locked.

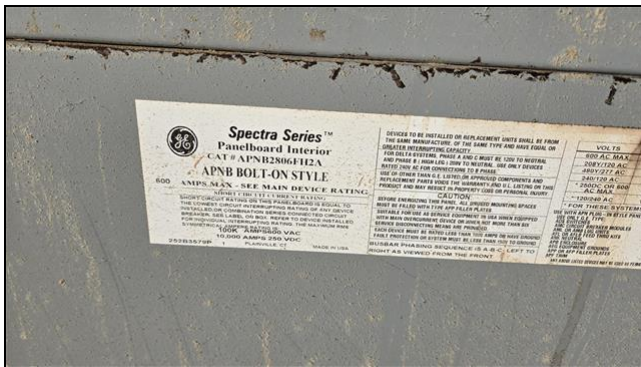
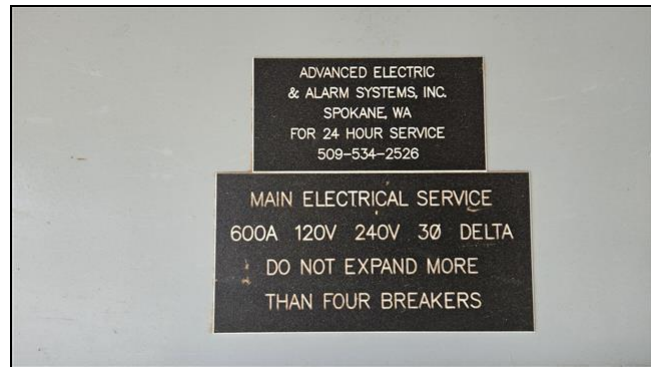
(5) Buildings D1/D2 - Building D2 had a 600 amp service in a General Electric panelbox. This appeared to feed several 200 and 225 amp secondary panels in both buildings.

No readily observable material deficiencies were noted.

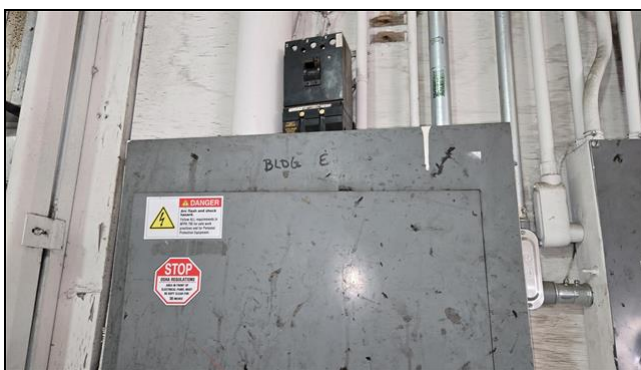
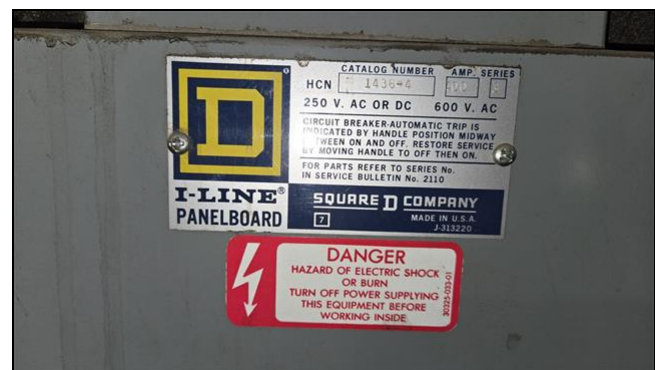
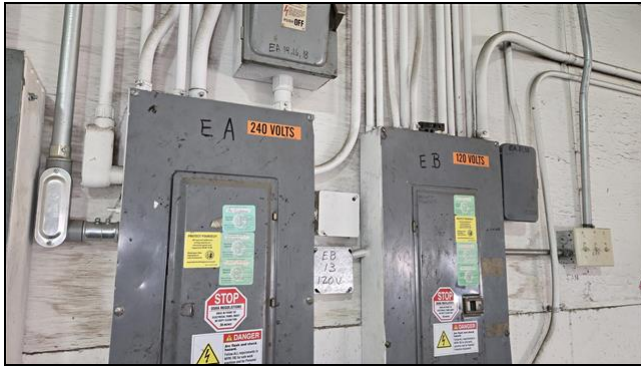
(6) Building E had a Square D main panel with 400 amp capacity. This fed several secondary panels.

No readily observable material deficiencies were noted.

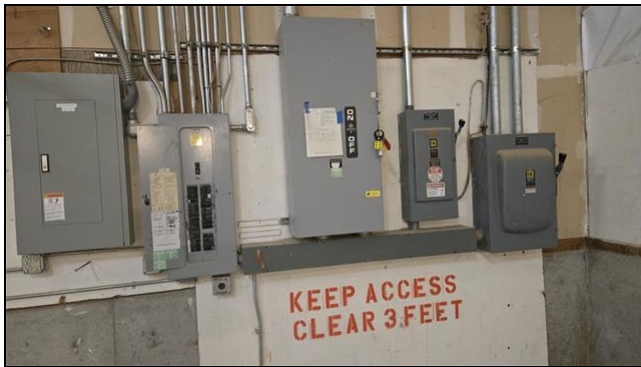
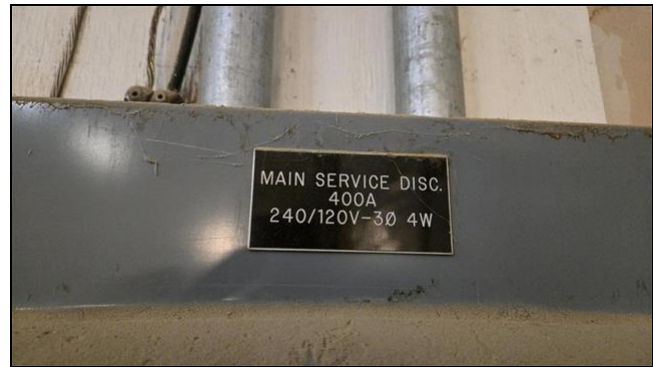
(7) Building F had a 400 amp service. Power was a 3-phase, 4-wire system with 240/120v.

No readily observable material deficiencies were noted.

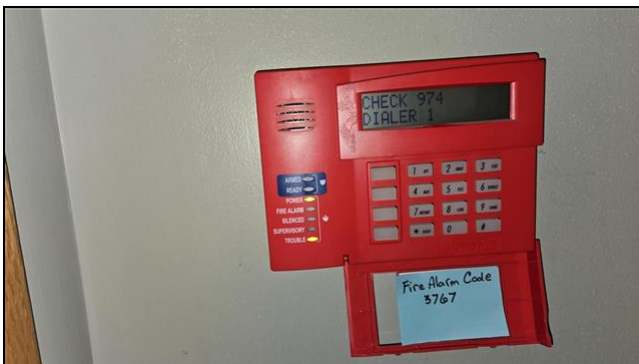
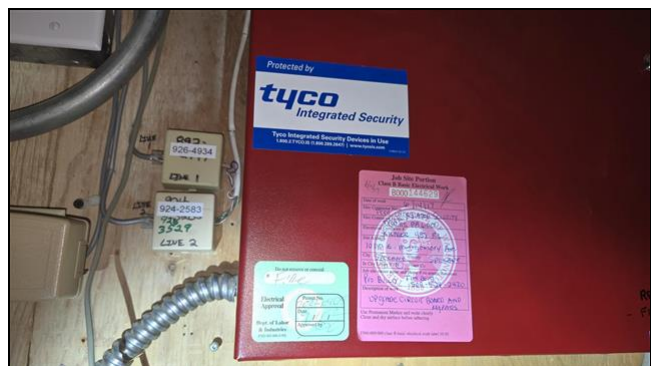
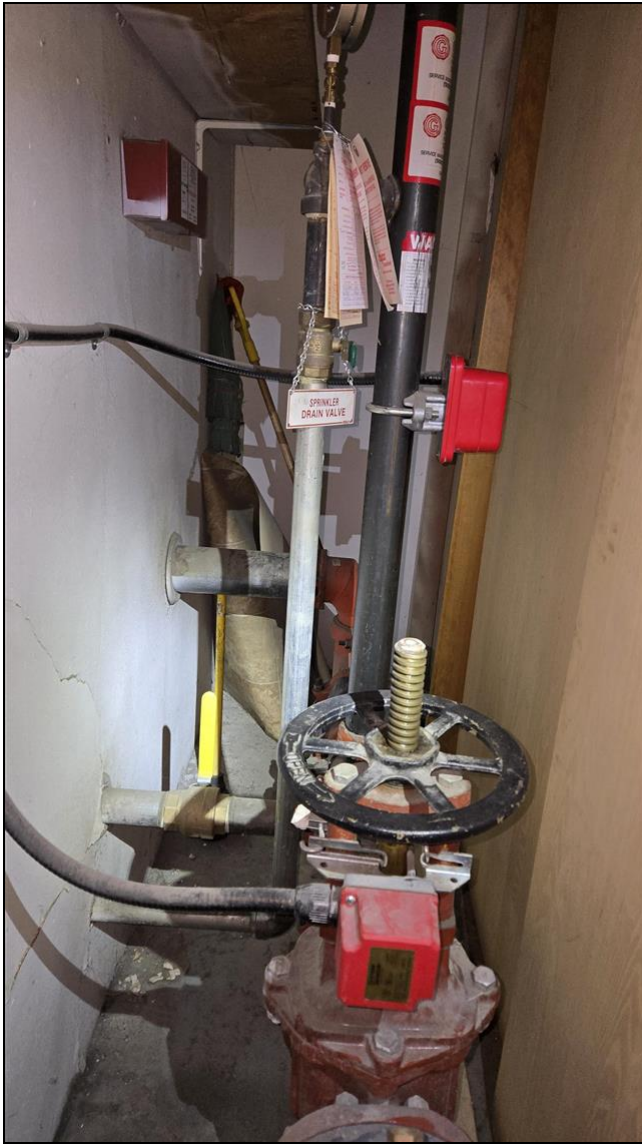
Building A had a fire suppression system installed.

No readily observable material deficiencies were noted.

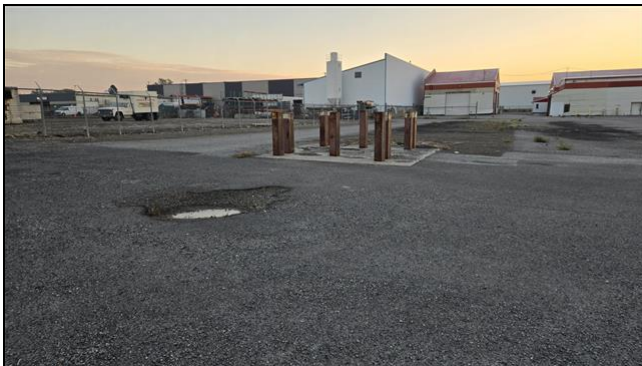
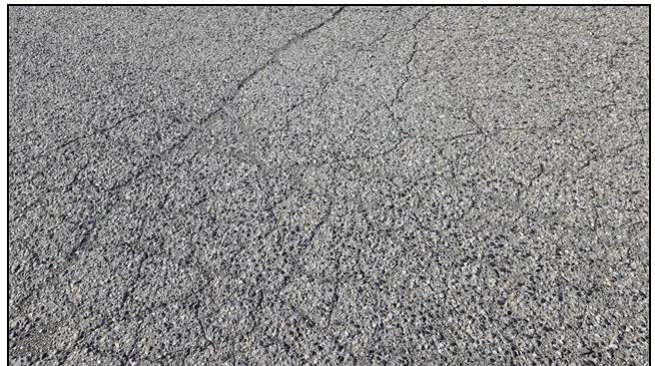
(2) The asphalt surface in multiple locations throughout the yard was damaged as evident by localized alligator cracking suggesting a localized structural failure of the surface, potholes, and possibly the subsurface structure.. Recommend evaluation by a licensed and qualified paving contractor to determine the full scope of the necessary work.

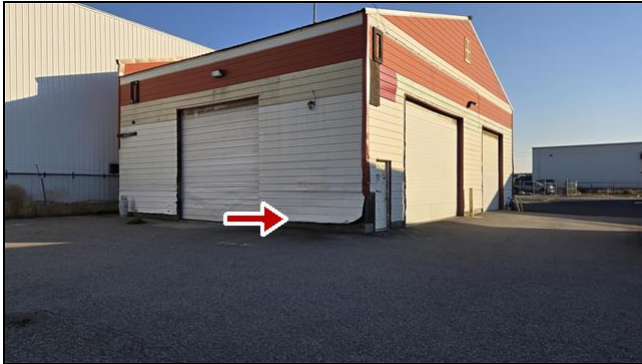
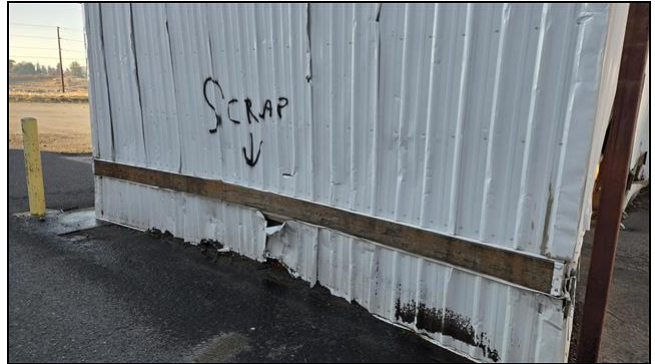
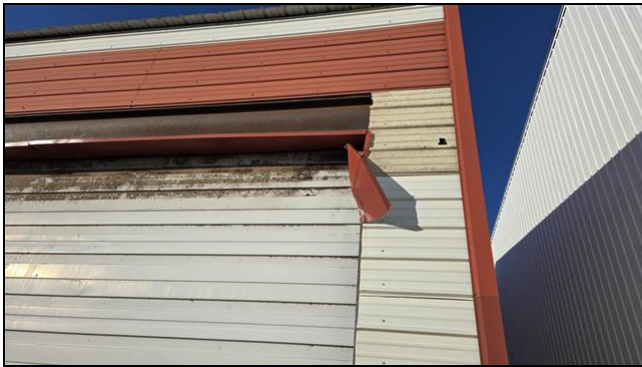
(4) Both D buildings had substantial siding damage that significantly impacts the integrity of the system. Water intrusion noted in multiple locations. Repairs are recommended.

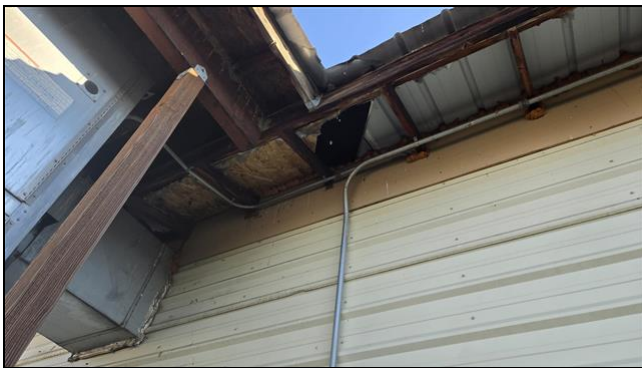
5.0 Item 11 (Picture)

(6) Birds are entering into Buildings E and F through soffits and holes in the siding. Recommend correction.

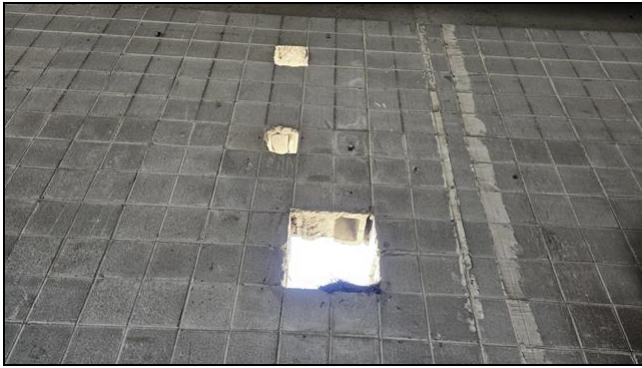
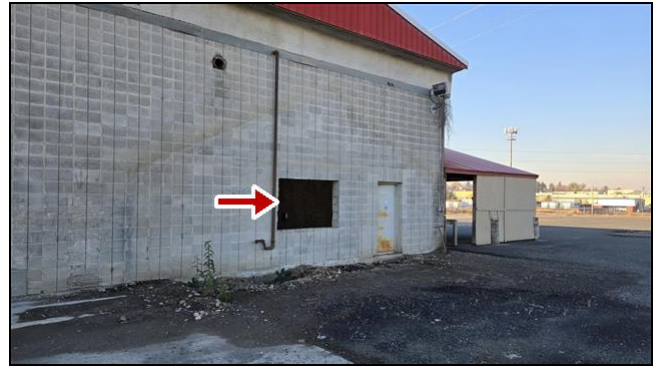
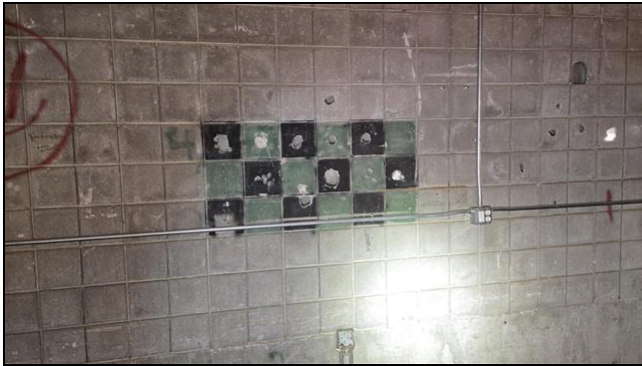
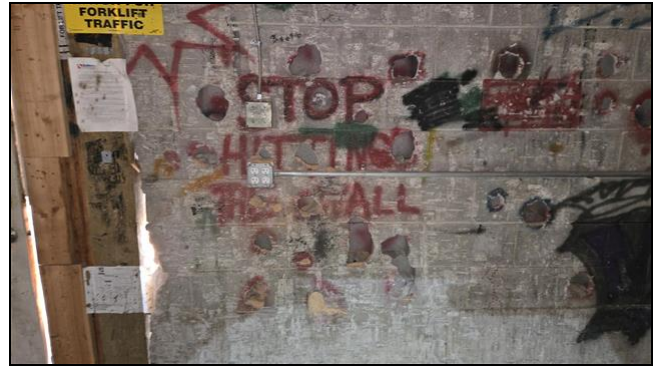
(2) Buildings B and C had concrete masonry wall systems. Substantial opening were made in the walls, especially on Building B, without adequate reinforcement. Building C has substantial damage to individual cells of the block. Recommend repair.

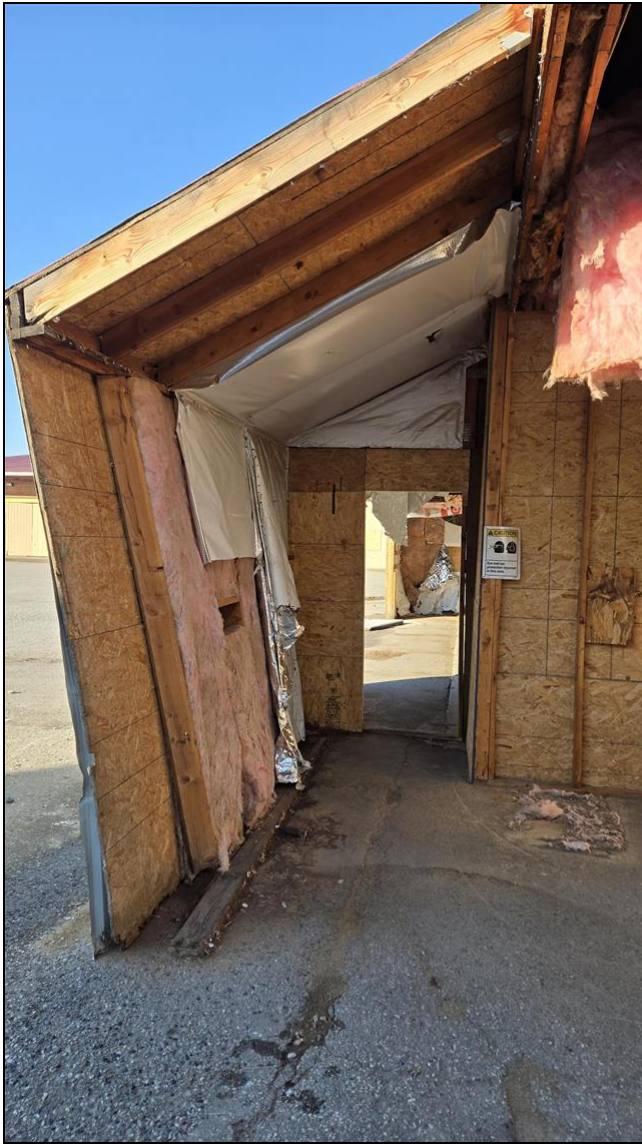
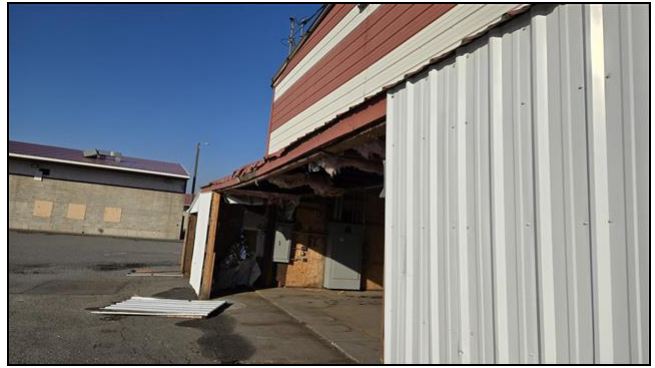
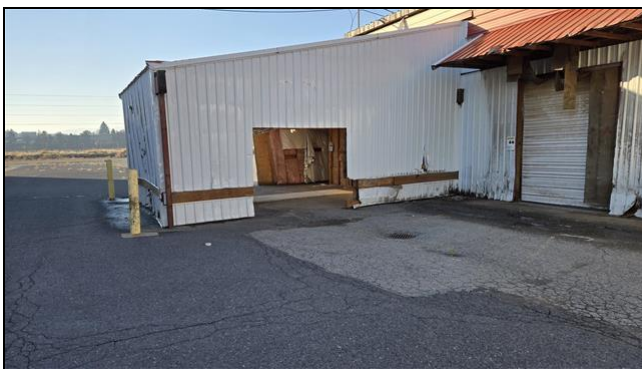
(3) Building D2 had multiple lean-to and shed additions made. These are in very poor repair and collapse is possible. Recommend repair or removal at the earliest opportunity.

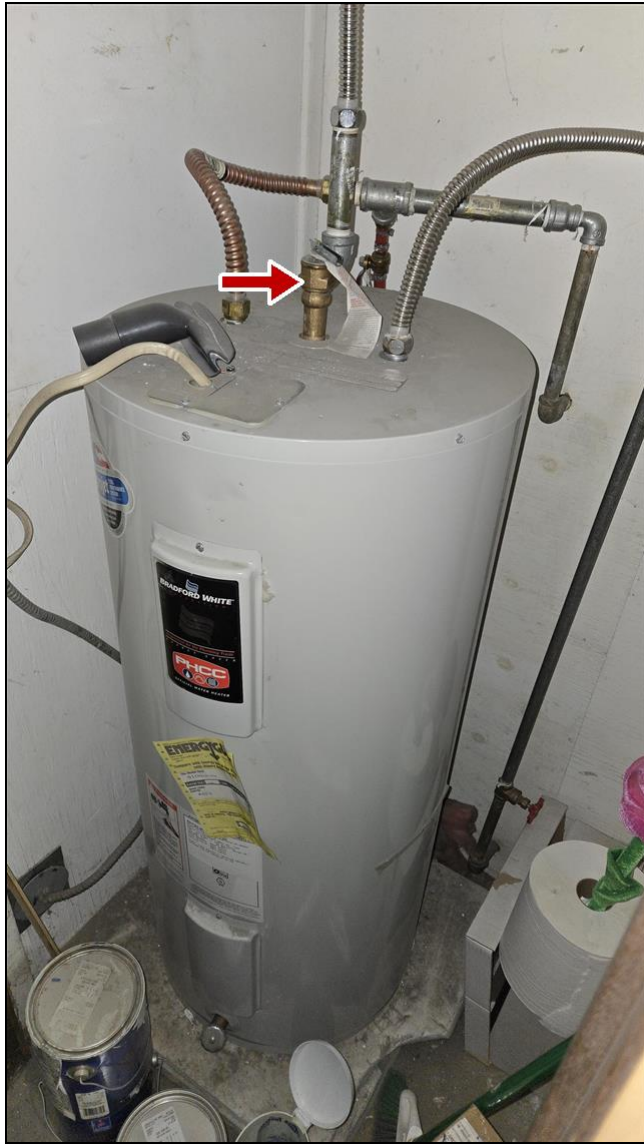
7.3 Item 1 (Picture)

This piece of equipment is at the end of a normal service life. Recommend continuing with routine maintenance and developing cash reserves for eventual replacement. Based on available records, inspections stickers, or the lack thereof, routine maintenance appears to be overdue. Recommend maintenance for this unit at this time.

\The water heater's temperature-pressure relief valve drain line is routed upward. This valve is an emergency device, but periodically small amounts of water could be discharged. If the drain is routed up, water can collect near the valve and that can lead to corrosion and impair the operation of the valve during an emergency. Therefore, drain line must be routed either down or horizontally. It cannot be routed up, even over a short distance. Recommend having a qualified plumbing contractor fully evaluate and repair so the drain line is properly routed down or horizontally.

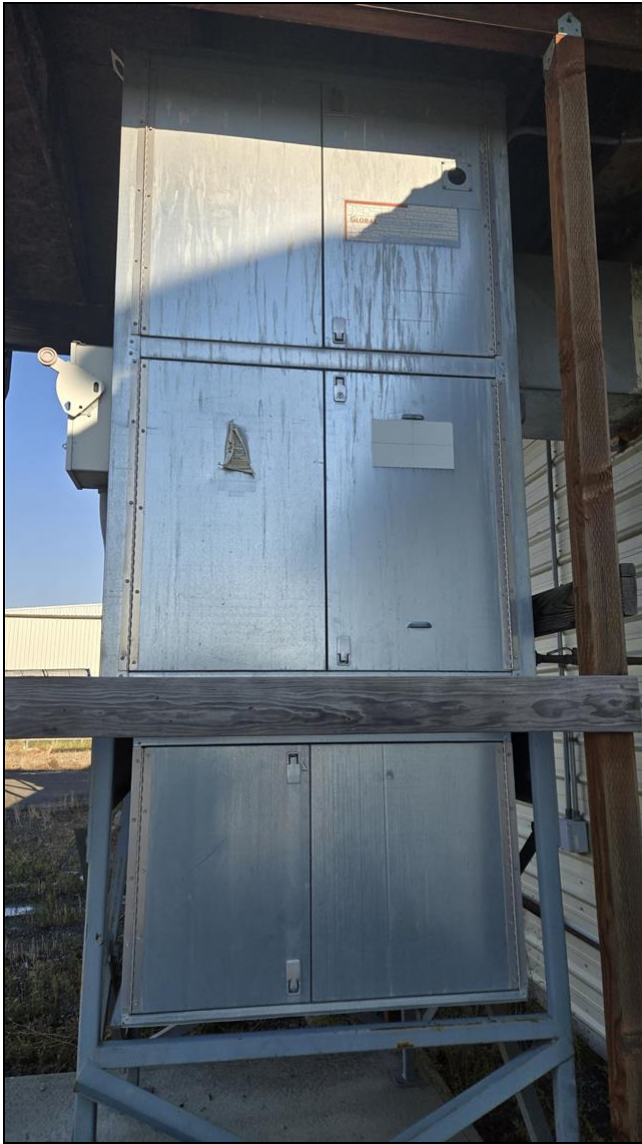
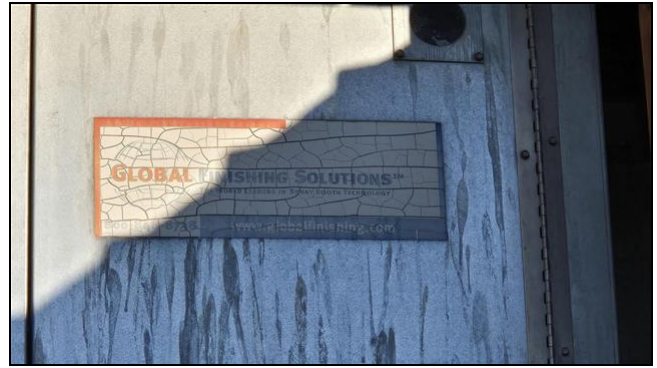
Two ventilation systems were present at Building F for spray booth systems.

Service is unlikely to be up-to-date. Recommend completing now.

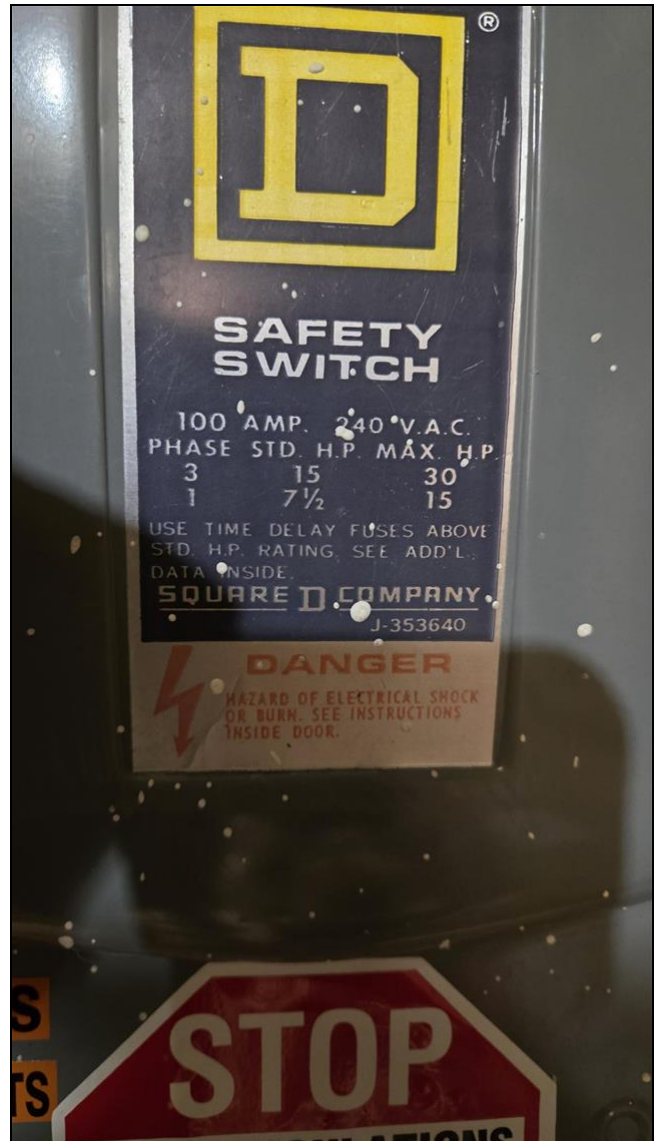
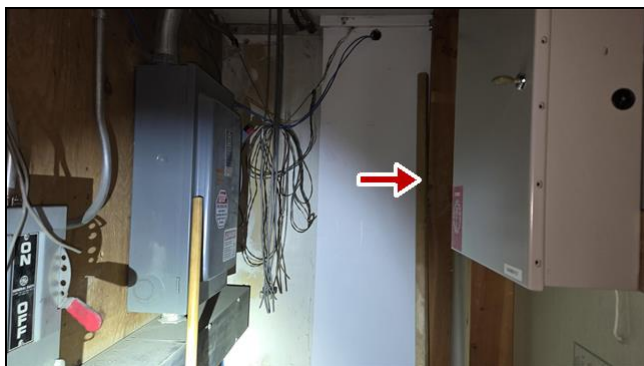
(1) Building A (original building) had an antiquated main fuse. The case could not be opened without turning off power to the entire building. This main services on the front half of the building. There were multiple secondary panels present along with dedicated switches for equipment. Much of this electrical equipment is overdue for replacement. Many of the switches are using fuses. Plans to upgrade these to modern circuit breaker protection should be considered. Panels and switches were manufactured by Square D and Cutler Hammer.

One panel lacks proper clearance in front due because a wall was built too close to the panel. Recommend correction.

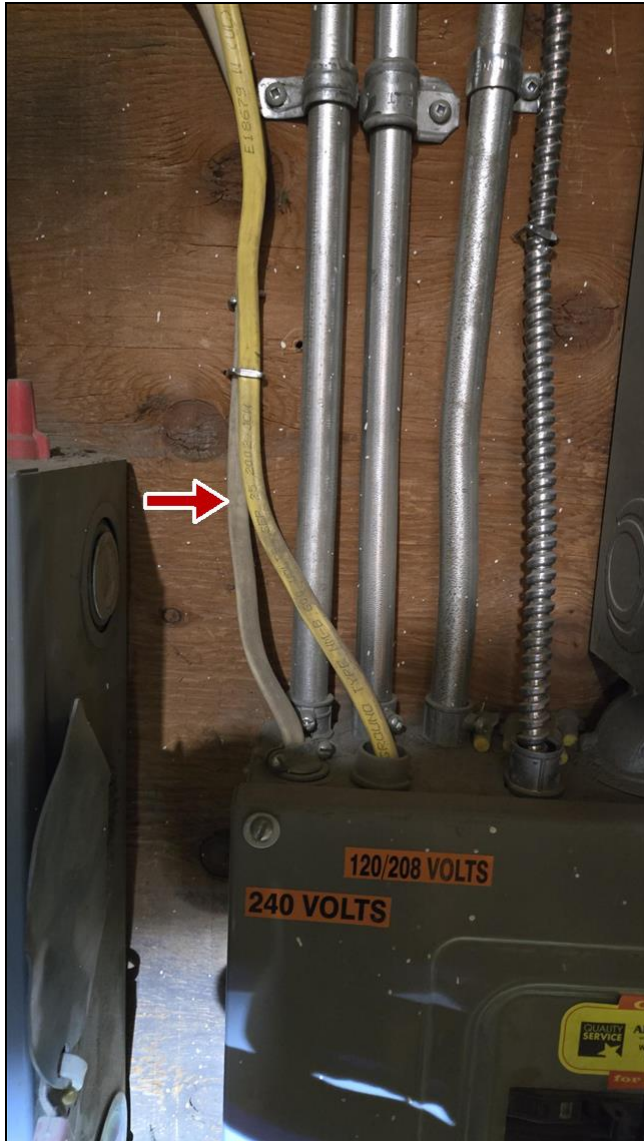
9.3 Item 1 (Picture)

Newer wiring in Building A did not conform to current safety standards. It was installed without conduit. Recommend repair by a licensed and qualified electrical contractor.

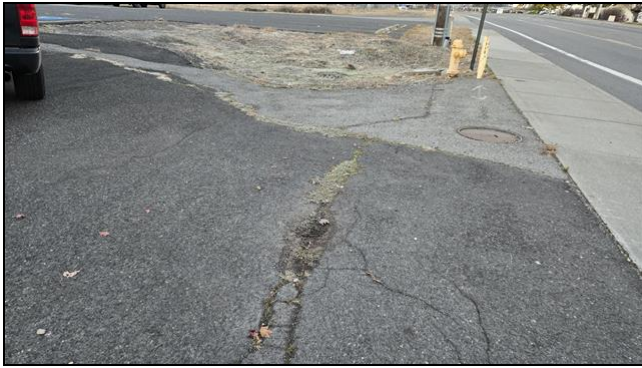
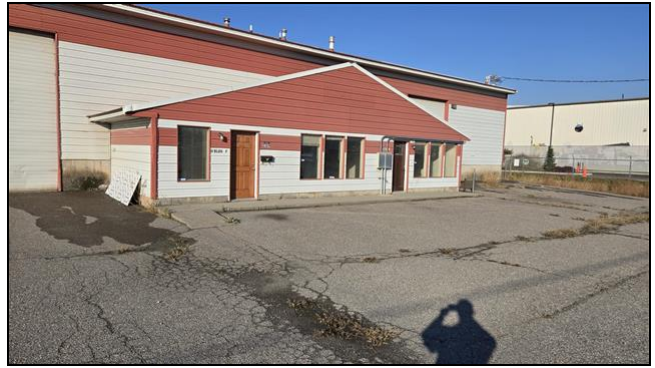
(1) Two parking lots were present for Building A, located in front and to the right side. Approximately 20 spots were present with one ADA space on the right side. Striping appears in satisfactory condition.

Additional parking was available at the various buildings but was not marked/striped.

The following maintenance related issues were noted: the asphalt is due for seal-coating to preserve the surface and extend the service life and vegetation should be removed from parking lot surfaces to minimize future damage

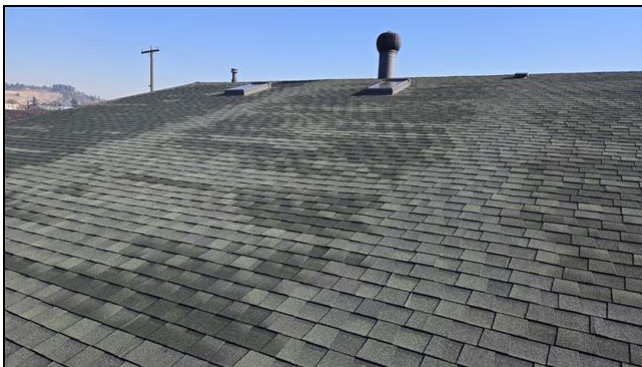
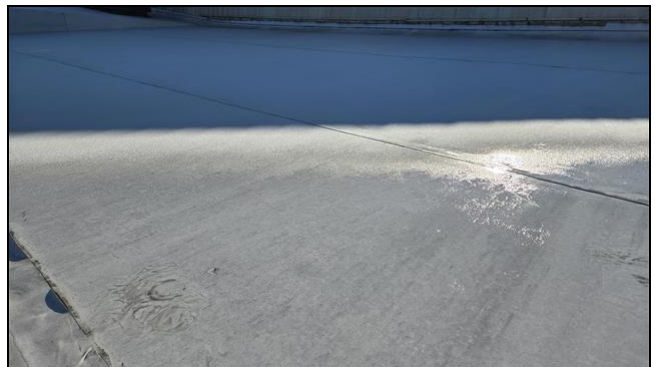
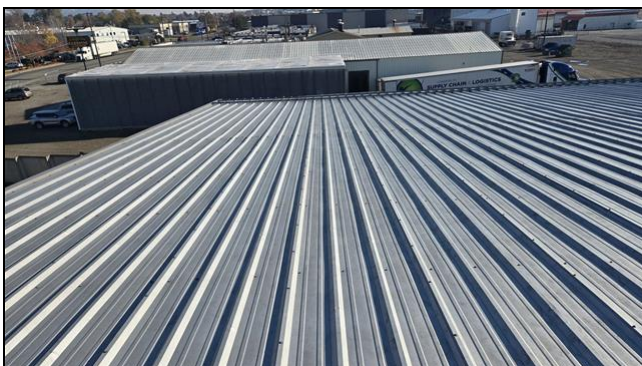
The membrane is aging. Recommend holding reserves for replacement.

No readily observable material deficiencies were noted.

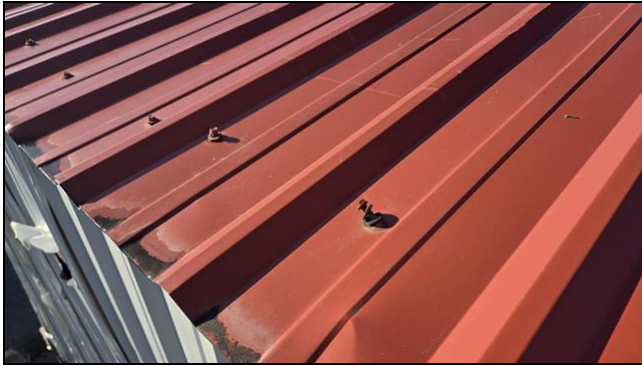
4.1 Item 4 (Picture)

(2) Buildings B-F had metal roofs. The re-roofing of these structures appears to have occurred at the same time as the materials are similar and the degree of fading consistent. Roofs appear to be approximately 20 years old. Numerous loose fasteners noted across all these buildings. Routine maintenance has not been performed. Recommend completion.

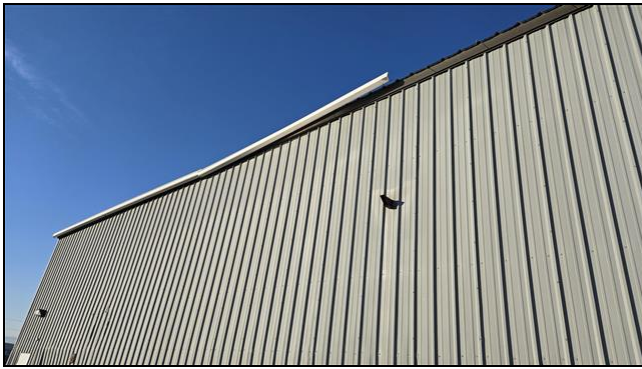
4.4 Item 1 (Picture)

The gutters on Building A were damaged. Recommend repair.

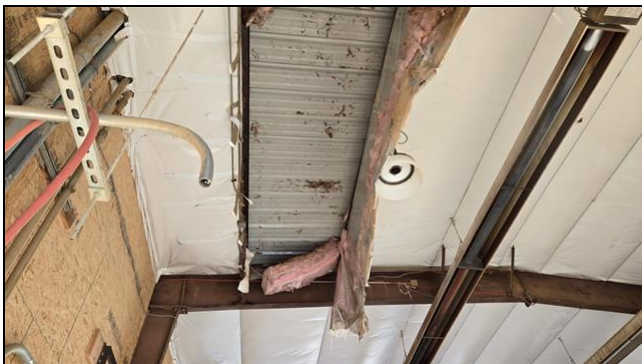
4.8 Item 1 (Picture)

(2) Insulation in D1 and D2 was damaged and falling from ceiling cavities. Recommend repair.

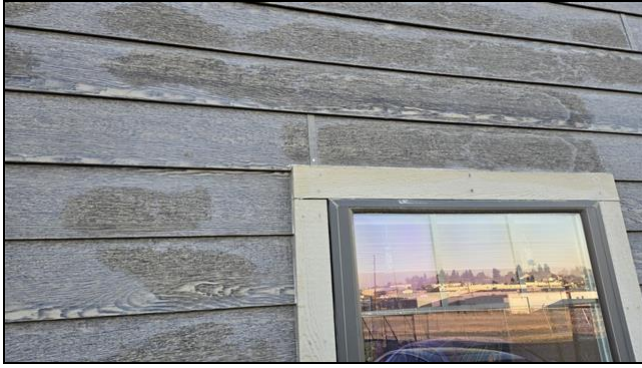
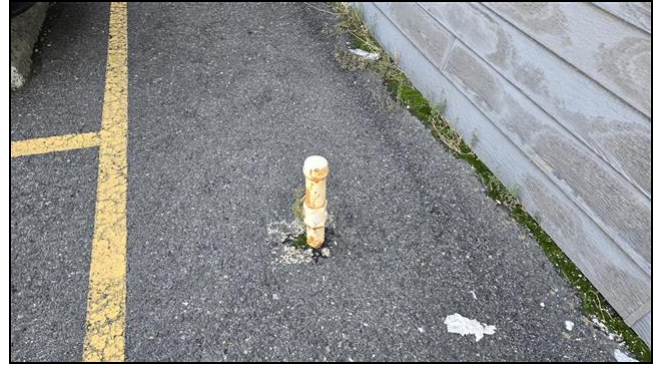
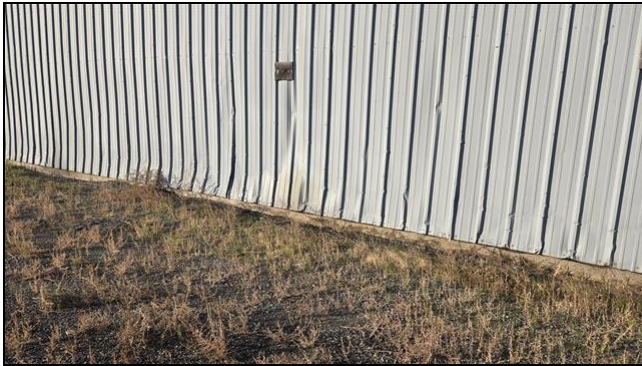
(2) Building A had some minor siding damage to the metal portions of siding. The cement hardboard was improperly installed with poor clearance to grade and hardscape as well as missing head flashing over windows and doors. The cement fiber siding is overdue for painting.

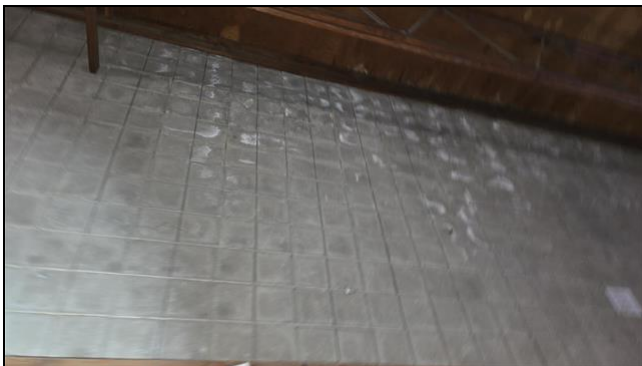
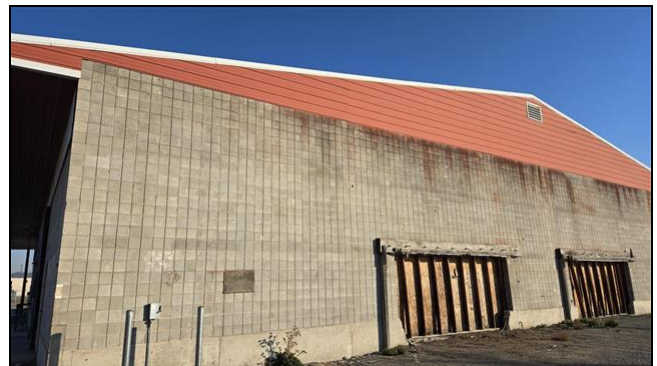
(3) Building B and C had concrete masonry for the wall and wall covering. Deficiencies in these walls are addressed in the Structural System.

Building C had considerable efflorescence from apparent leakage from the roof assembly. Flashing was missing. Recommend repair.

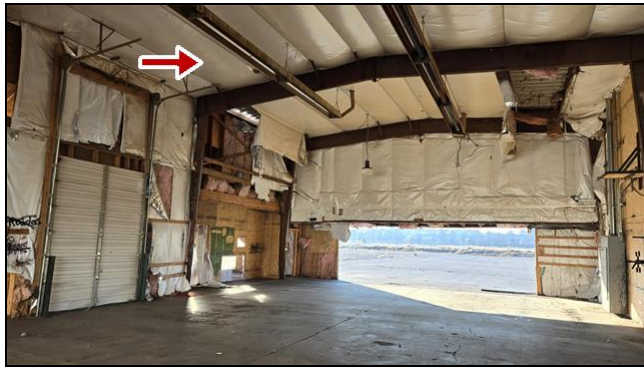
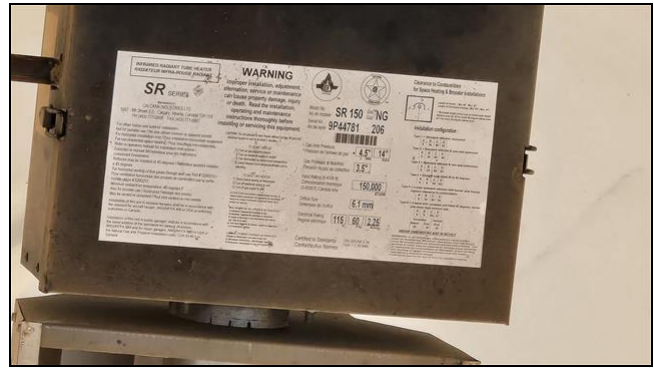
(3) Building D2 had a pair of infrared heaters. Data tags were not fully legible. They were manufactured by Calcana Industries and rated at 150,000 BTUs. These appeared to be approximately 15 years old. Recommend service.
