INSPECTION REPORT  
Spokane Valley WA 99206

INSPECTED BY  
Paul Duffau CCPIA  
001011  
Calibre Commercial  
Inspections, LLC

INSPECTION DATE  
📅 11/7/2024  
🕒 07:00 AM

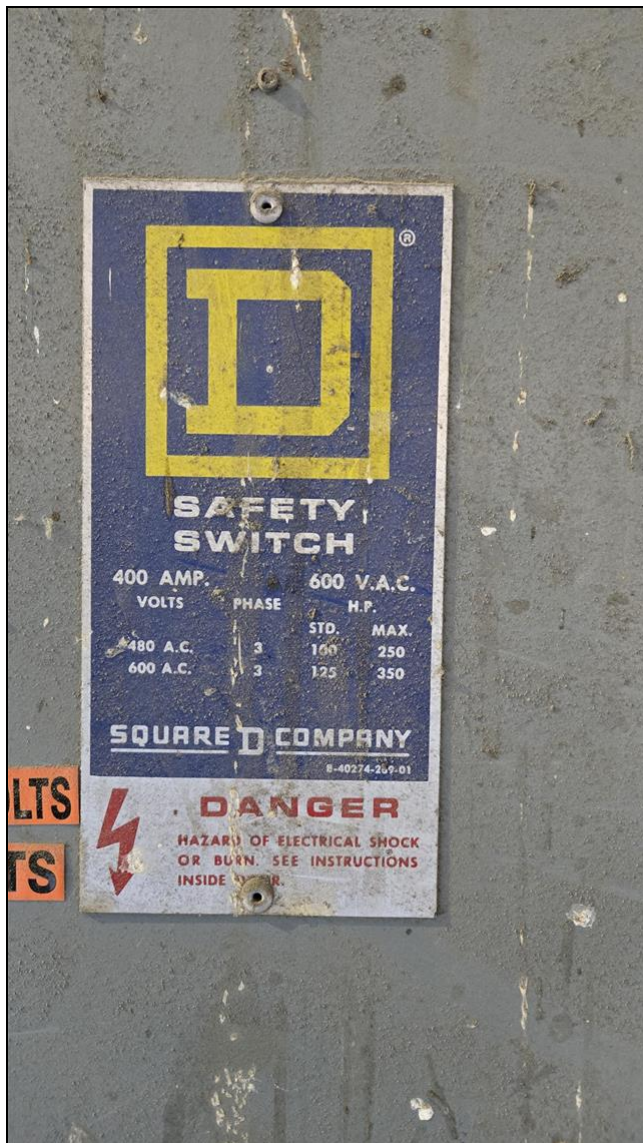
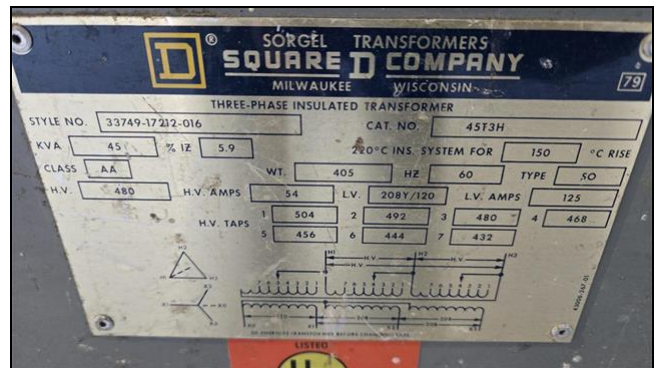
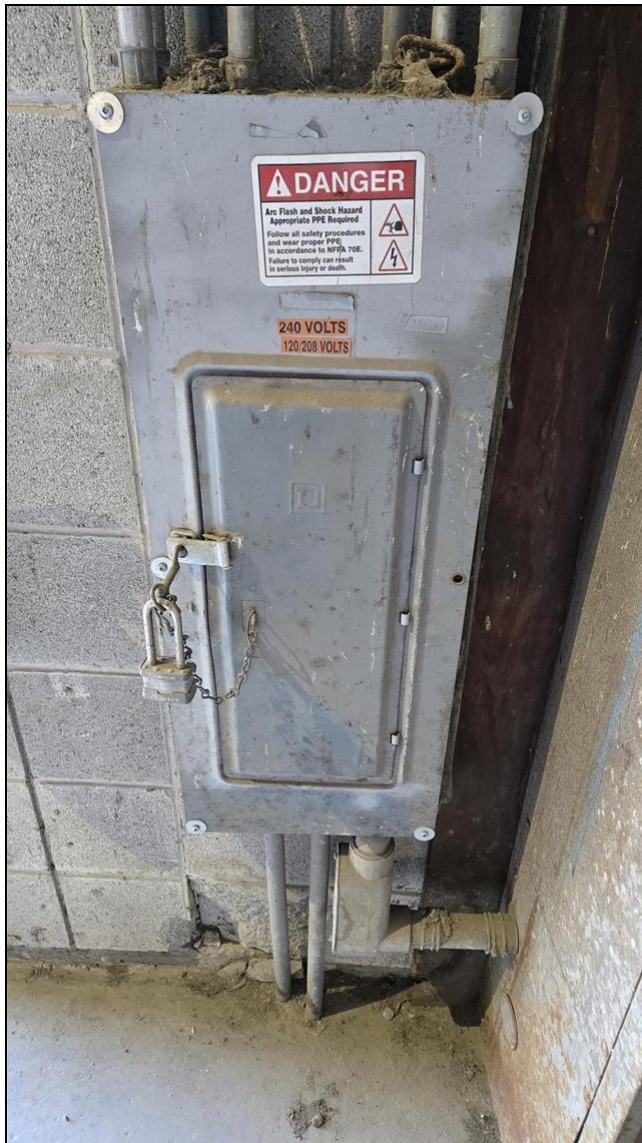
(3) Building B had a 400 amp Square D service. A transformer was located in this building. The main fuse and panel system is aging and due for replacement. The main panel was locked.

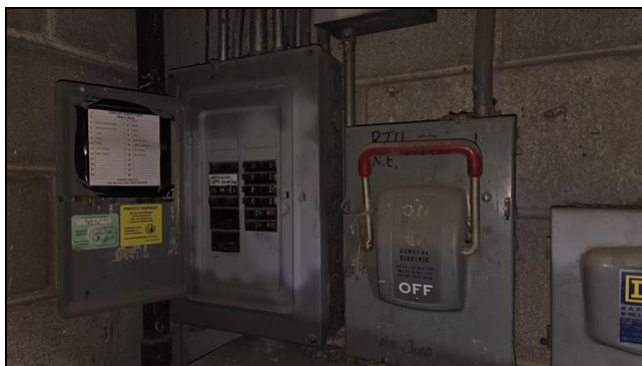
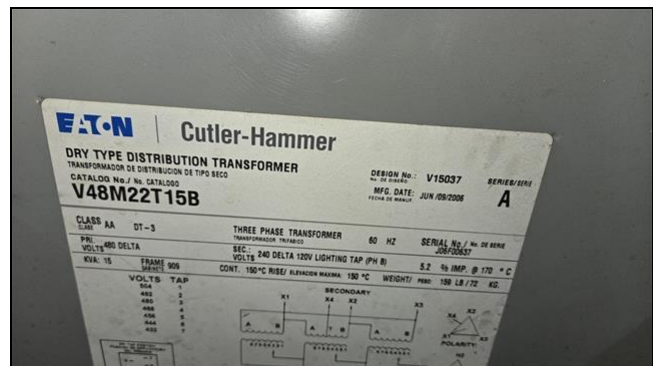
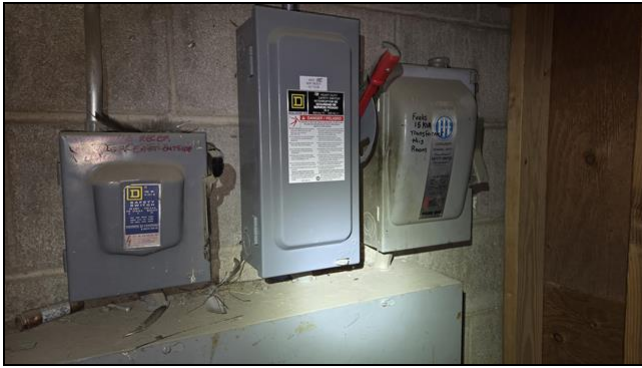
(4) Building C had antiquated main fuses. A transformer was located in this building. The main fuse and panel system is aging and due for replacement. Power appeared to be 120/208v. The main fuse was rated at 200amps. Multiple switches and secondary panels were present, almost all aging.

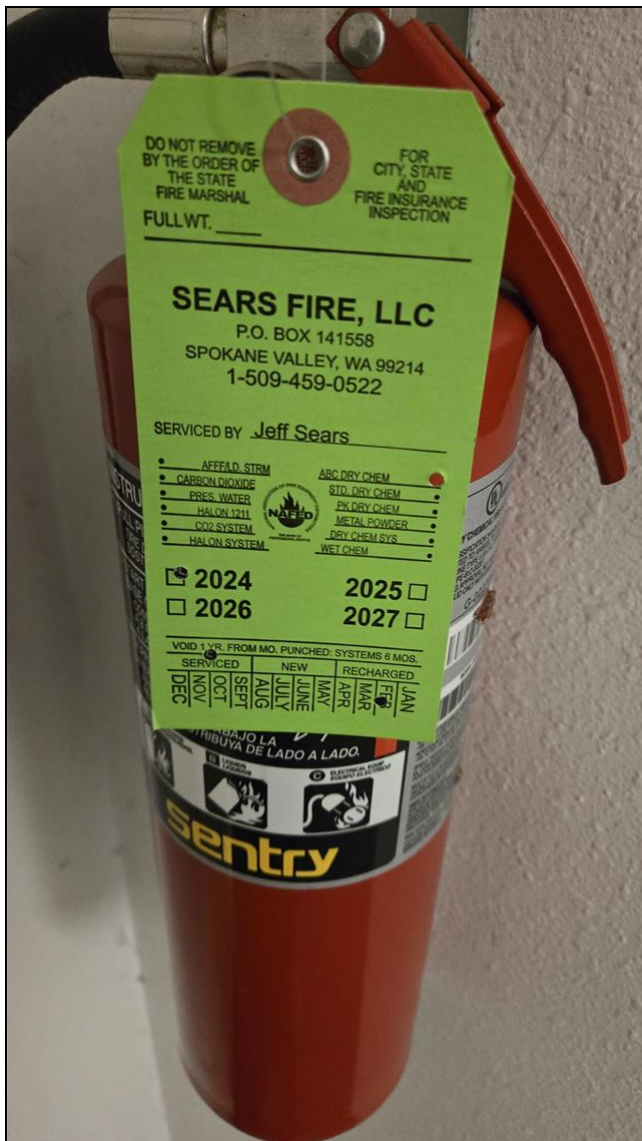
10.4 Item 1 (Picture)

Present but universally out-of-date or missing for all the buildings except Building A. Recommend correction.

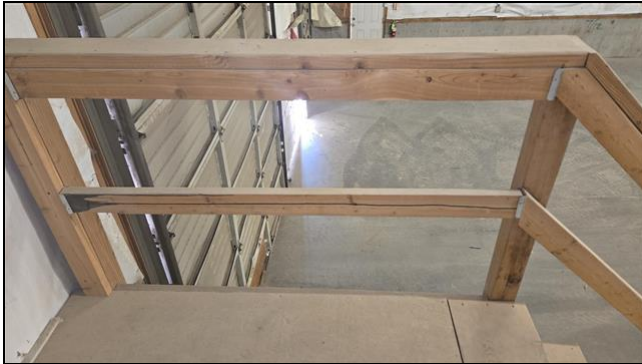
11.4 Item 1 (Picture)

Stair railings to loft/mezzanines in Buildings E and F do not have proper baluster spacing. Recommend repair.
