| <b>Property Address</b> | <b>Date of Inspection</b><br>8/30/2024 | <b>Report ID</b><br>20240830-12003-Vancouver-WA |

| <b>Building Use:</b><br>OFFICE | <b>Number of Buildings:</b><br>ONE | <b>Approximate building size:</b><br>5000+ square feet |

This is a Commercial Building Inspection Report developed using the Standards of Practice for the CCPIA.

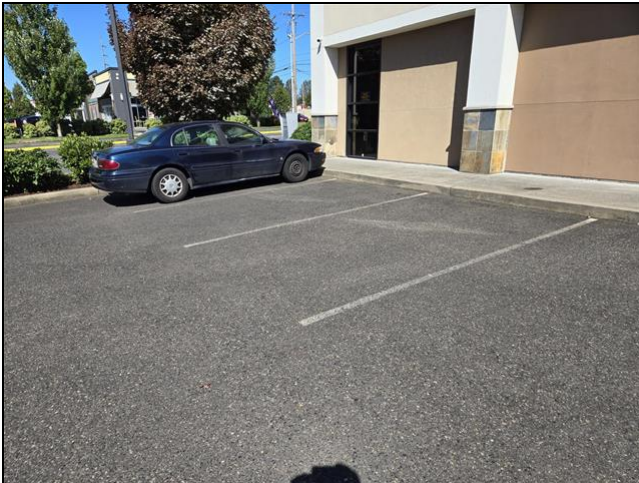
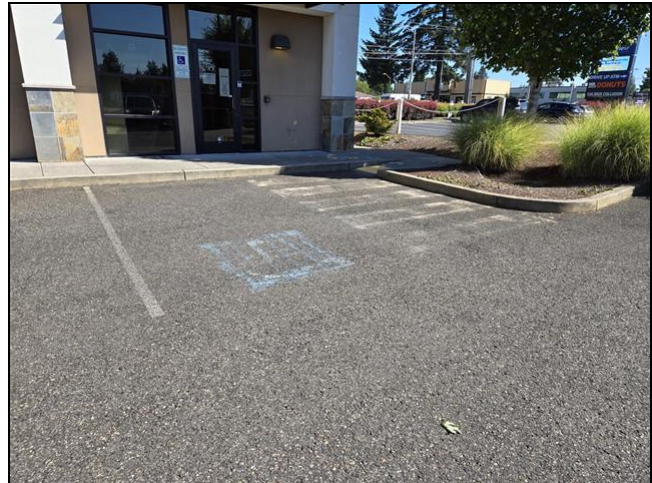
2.1 Item 1 (Picture)

(1) Parking lot surfaces materials included: asphalt surface. Paving materials appear to be constructed on a stabilized gravel base. A total of 12 spaces were counted in a surface parking lot on the South side of the subject property. One of these were marked for accessible use.

(2) The following maintenance related issues were noted: the asphalt is due for crack seal-coating to preserve the surface and extend the service life. Recommend consulting a licensed and qualified paving contractor for an estimate of costs.

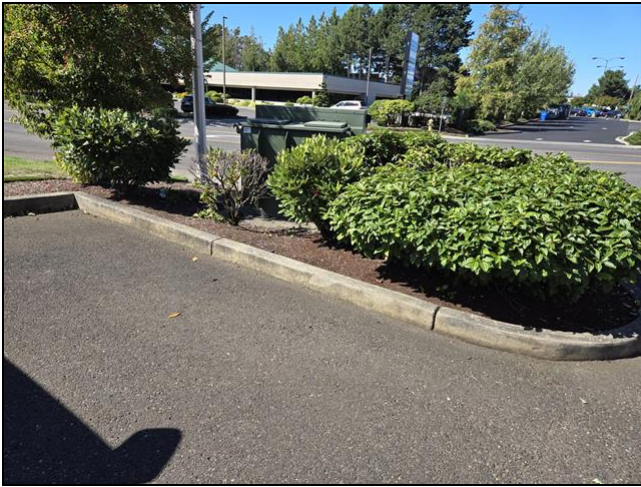
2.3 Item 1 (Picture)

Landscaping for the subject property included grass areas , low shrubs , and trees. Sprinklers were present.

No readily observable material deficiencies were noted.

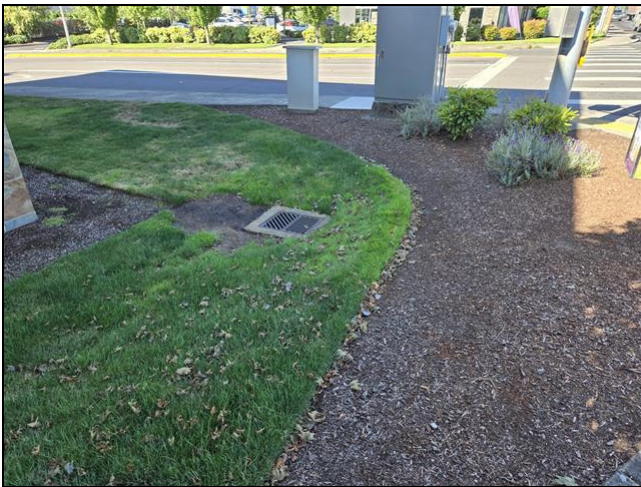
2.4 Item 1 (Picture)

The parking lot managed stormwater runoff by sheeting action to the gutters at the street. Lot runoff was managed by three stormwater drains located at three corners of the building.

No readily observable material deficiencies were noted.

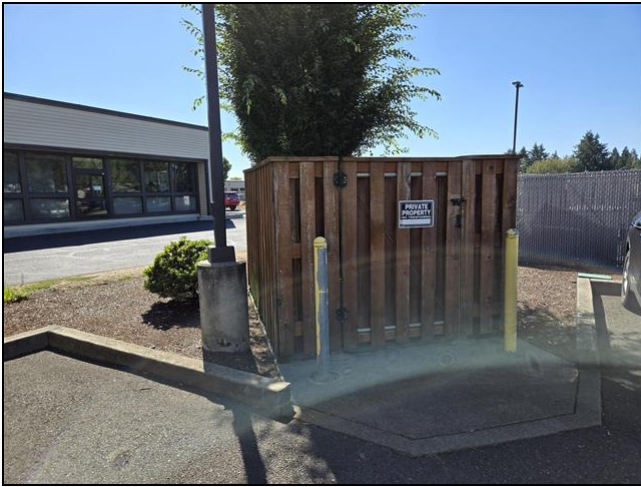
2.5 Item 1 (Picture)

A fenced trash enclosure was located in the southeast corner of the lot.

No readily observable material deficiencies were noted.

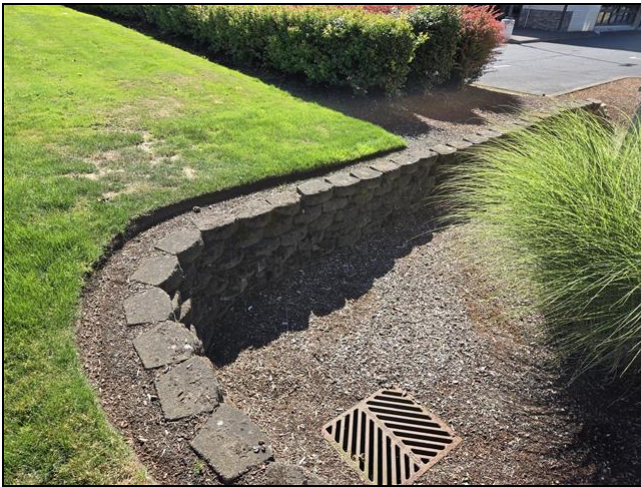
2.6 Item 1 (Picture)

Retaining walls were noted on the property. These were used to manage the landscaping and were not structural to the building. The retaining walls were constructed of concrete masonry block.

No readily observable material deficiencies were noted.

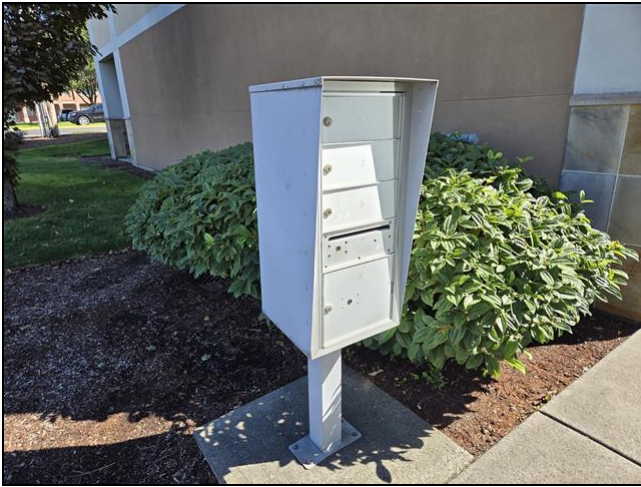
2.9 Item 1 (Picture)

A mailbox was located on the corner of the building near the driveway.

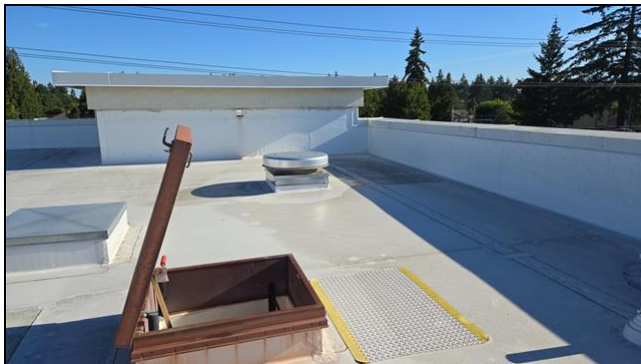
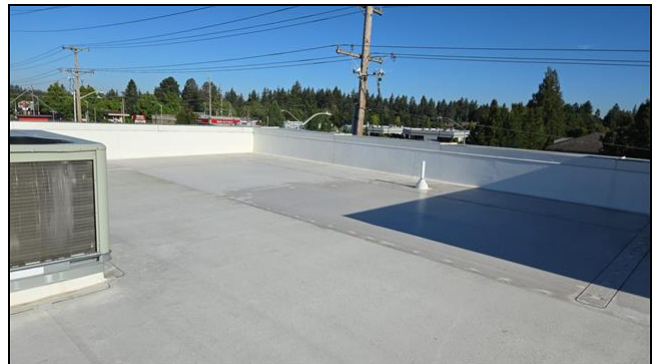
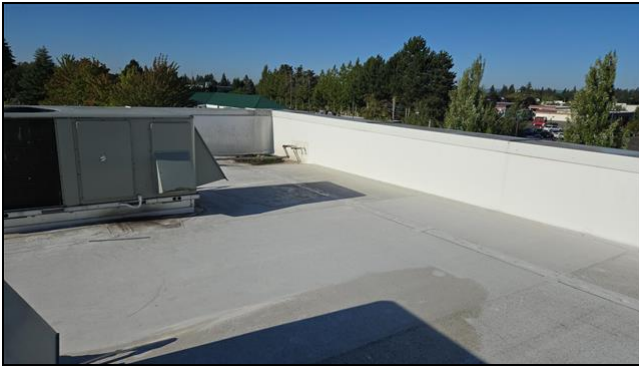
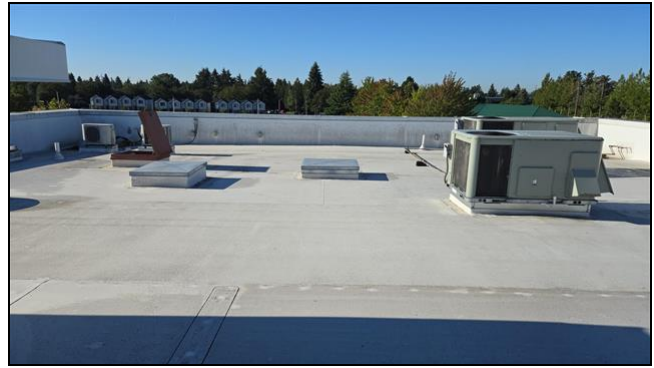
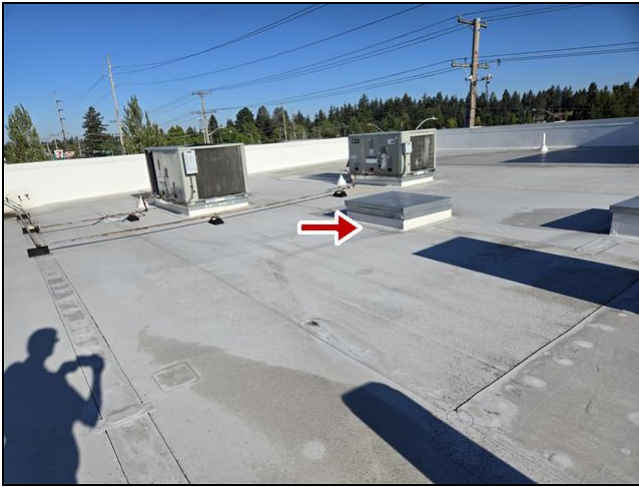
3.1 Item 1 (Picture)

The roof covering is a TPO flat roof membrane. This membrane appears to be original to the building. It is in the last quarter of a normal lifespan. Evidence of prior leakage noted inside the building and repairs appear to have been made. The existing roofing appears to be serviceable condition. Recommend routine maintenance.

The roof had multiple equipment curbs that were in used for heating/cooling plants and for ventilation systems. Two additional curbs were built for addition HVAC system in the future.

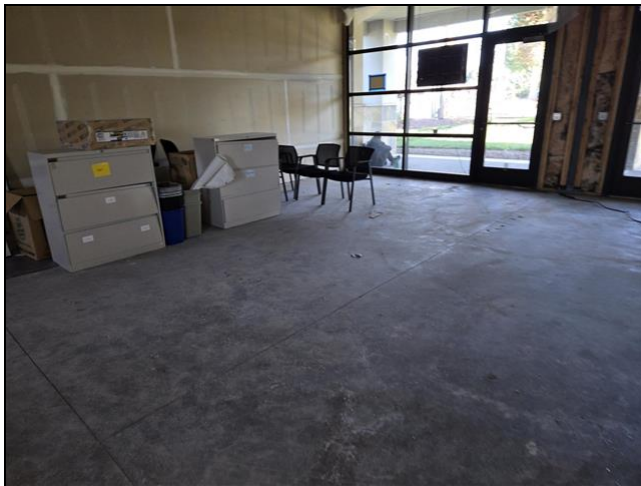
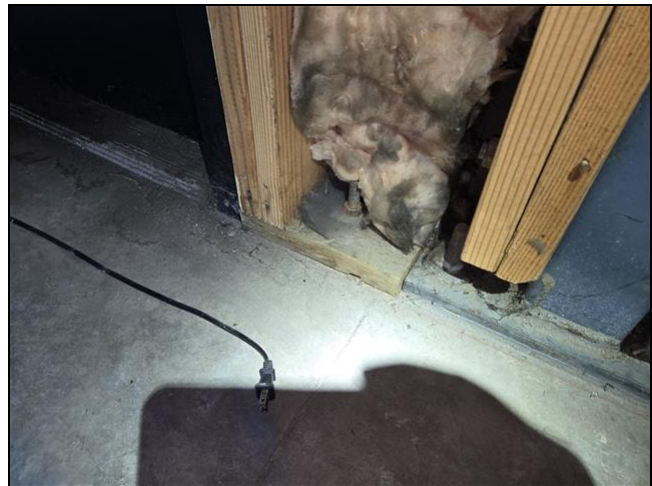
5.0 Item 1 (Picture)

The subject property had a slab-on-grade foundation system.

The foundation appeared to be constructed of poured concrete with reinforcing steel. Anchor bolts were present and, were directly observed, appeared to meet standard.

No readily observable material deficiencies were noted.

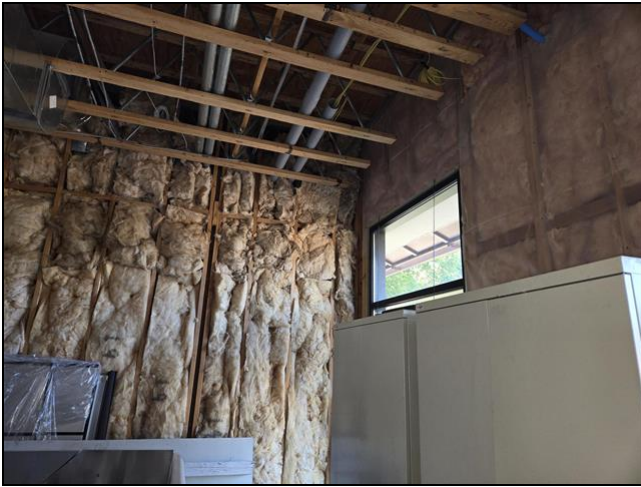
5.1 Item 1 (Picture)

(1) We could not fully observe the wall structure materials because they are covered by finish materials. We do not express a finding about the nature and condition of concealed materials. We believe the exterior wall structure is framed using 2x6 wood studs.

(2) The sill plate at the water main appears to have wood rot/wood-destroying fungus present. Recommend repair.

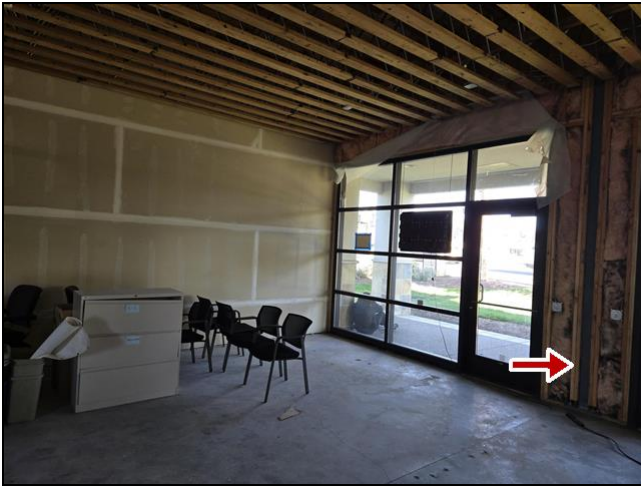
5.2 Item 1 (Picture)

Tube steel appeared to be used from structural columns.

No readily observable material deficiencies were noted.

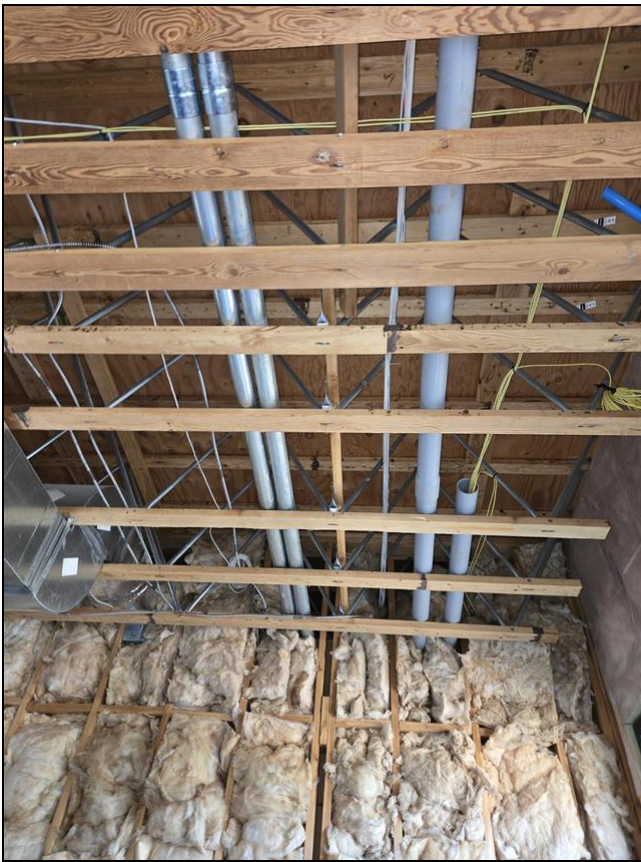
5.3 Item 1 (Picture)

No readily observable material deficiencies were noted.

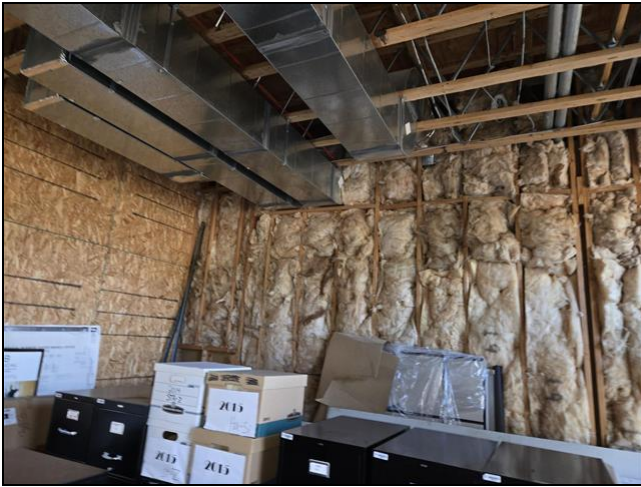
5.4 Item 1 (Picture)

No readily observable material deficiencies were noted.

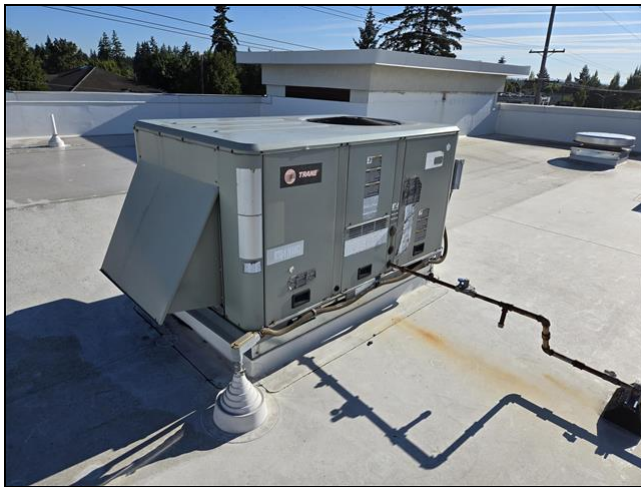
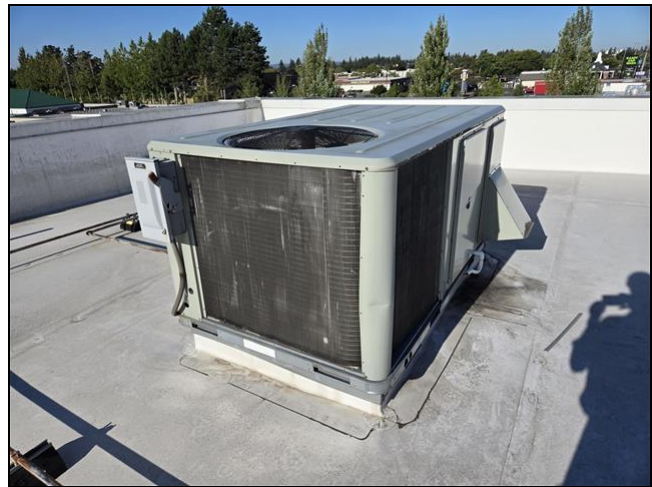
6.0 Item 1 (Picture)

Based on available records, inspections stickers, or the lack thereof, routine maintenance appears to be overdue. Recommend maintenance for this unit at this time.

This piece of equipment is in the last third of a normal service life. Recommend continuing with routine maintenance and developing cash reserves for eventual replacement..

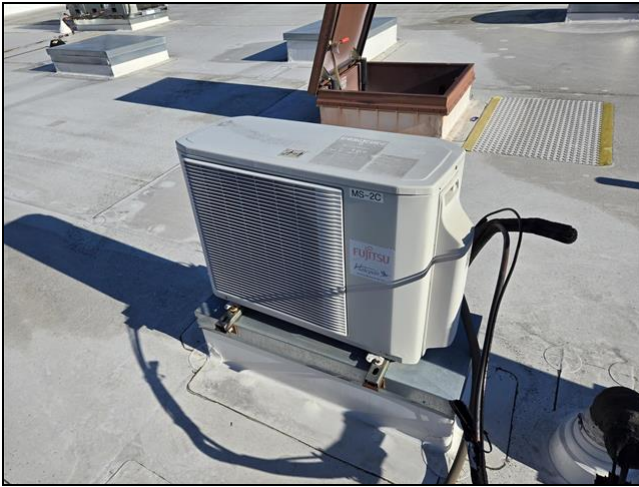
6.1 Item 1 (Picture)

Based on available records, inspections stickers, or the lack thereof, routine maintenance appears to be overdue. Recommend maintenance for this unit at this time.

This piece of equipment is in the last third of a normal service life. Recommend continuing with routine maintenance and developing cash reserves for eventual replacement..

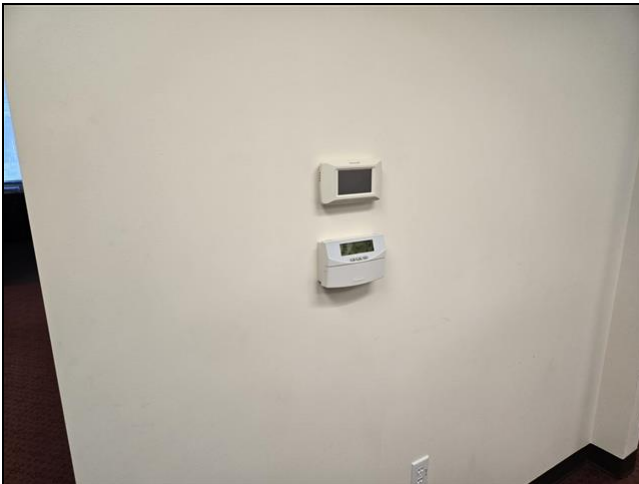
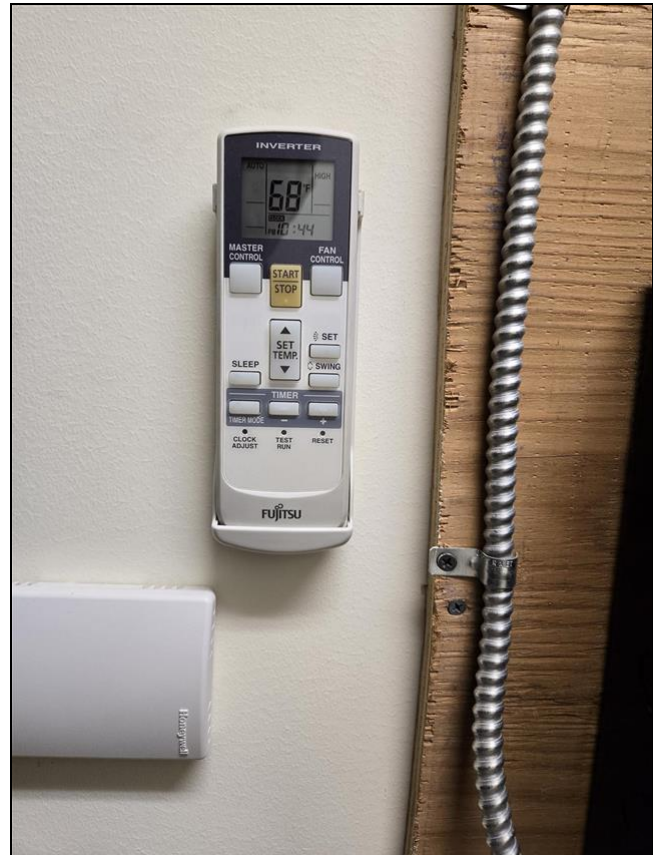
6.2 Item 1 (Picture)

Thermostats were present in several locations in the upper suite. The mini-splits were operated by remote controls.

No readily observable material deficiencies were noted.

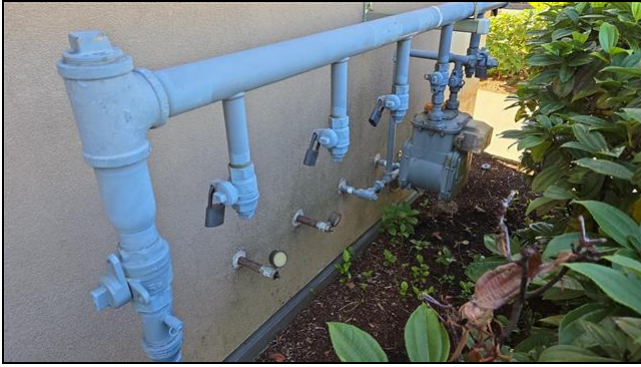
7.3 Item 1 (Picture)

The plumbing service system had capacity for four separate gas hook-ups. Only one was in use.

No readily observable material deficiencies were noted.

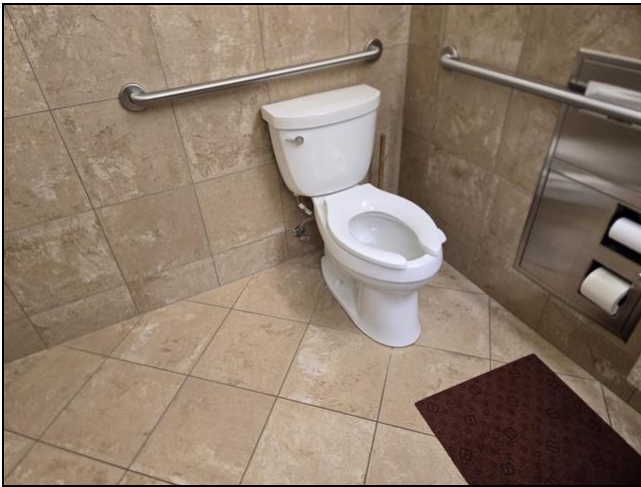
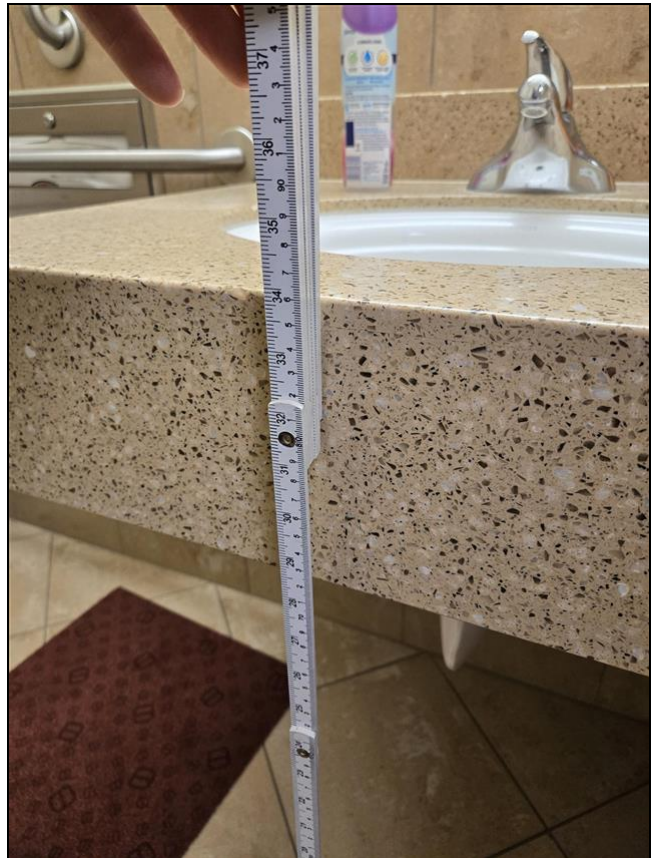
7.4 Item 1 (Picture)

There were two restrooms. Both were equipped with a sink and a toilet. The restrooms appeared to be ADA compliant with appropriate height to the sink and toilet, protect below the counter for the piping, and safety rails.

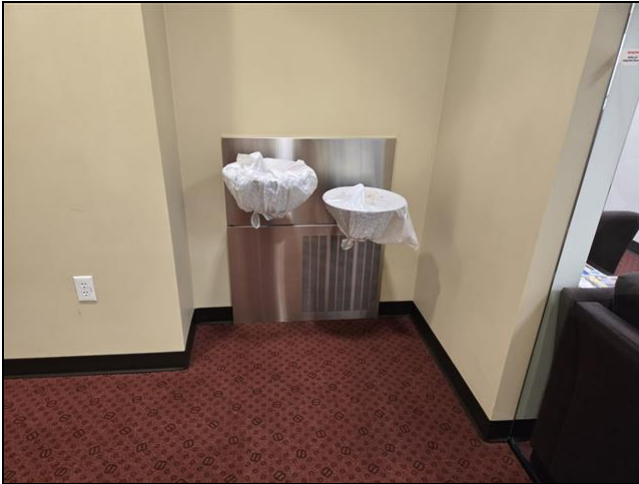
7.6 Item 1 (Picture)

Water fountains were present at the second floor but covered with plastic and not in use.

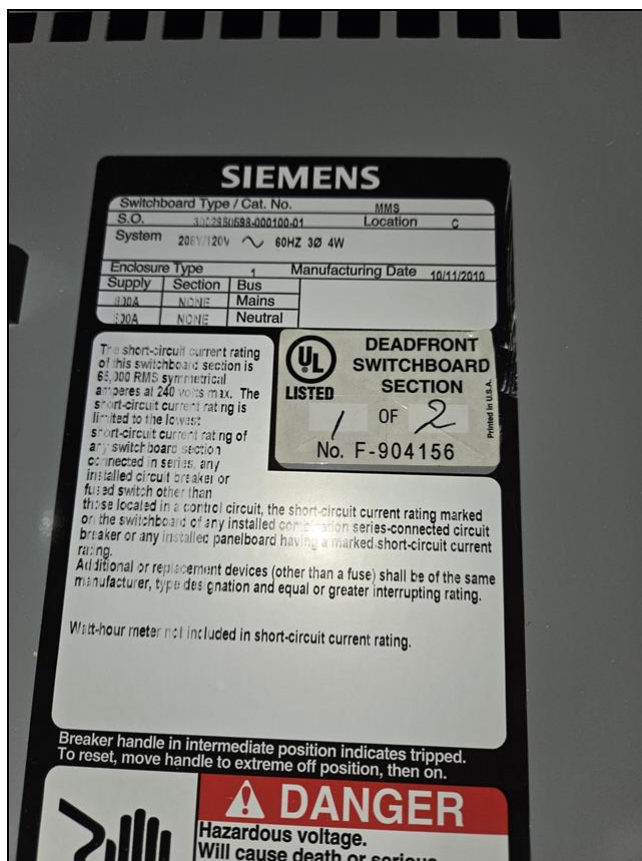
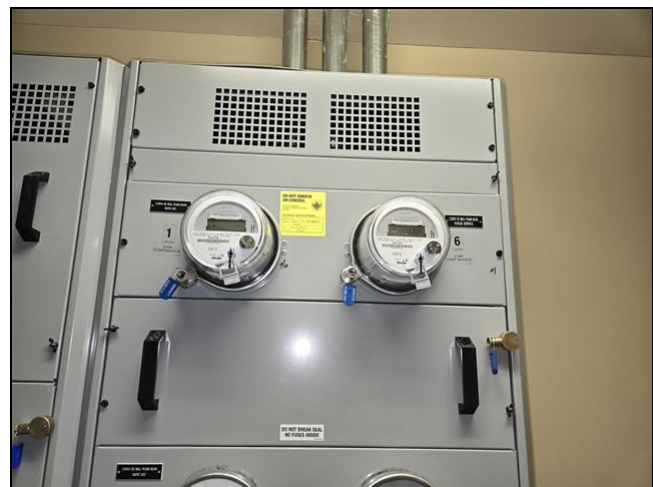
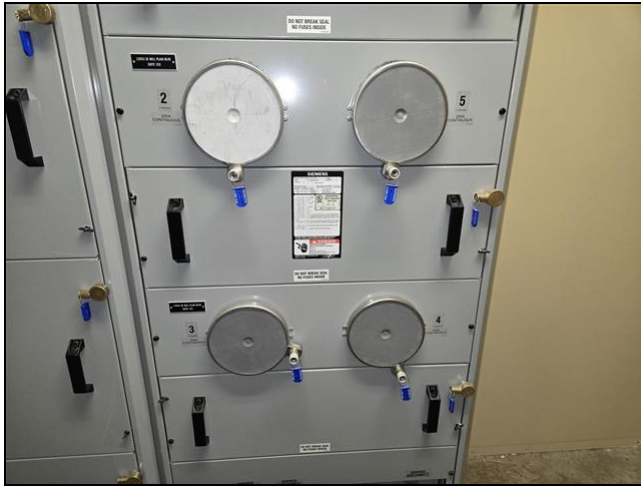
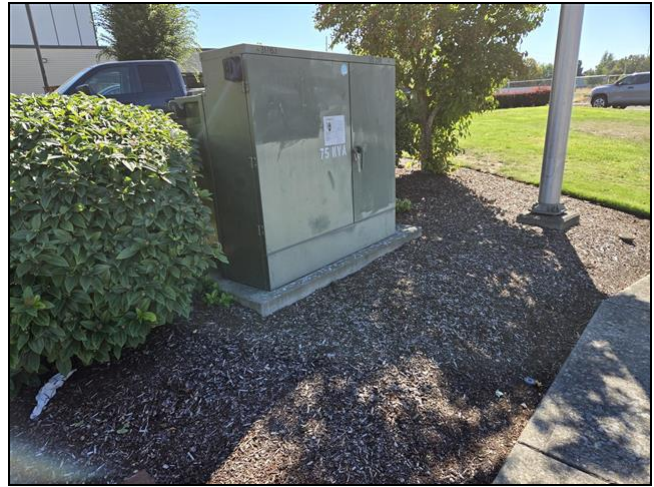
8.0 Item 1 (Picture)

The electrical service entrance was underground via riser to the downstairs mechanical room from a transformer located on the right rear corner of the property. Delivered power was 120/240/208v with 800amps of capacity on a 3-phase, 4-wire system. The switchboard panel was manufactured by Siemens Corporation and led to two installed meters with capacity for a total of six meters.

No readily observable material deficiencies were noted.

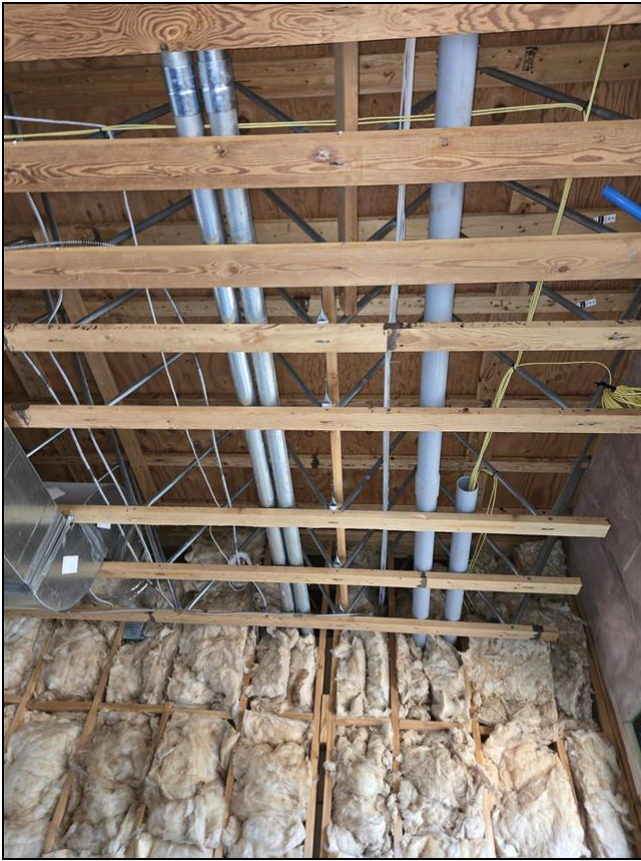
8.3 Item 1 (Picture)

No readily observable material deficiencies were noted.

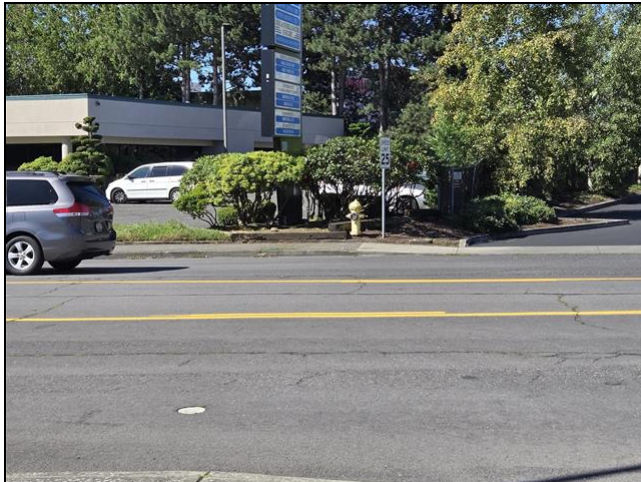
9.2 Item 1 (Picture)

The nearest fire hydrant is located to the west of the property, across SE 121sst Ave.

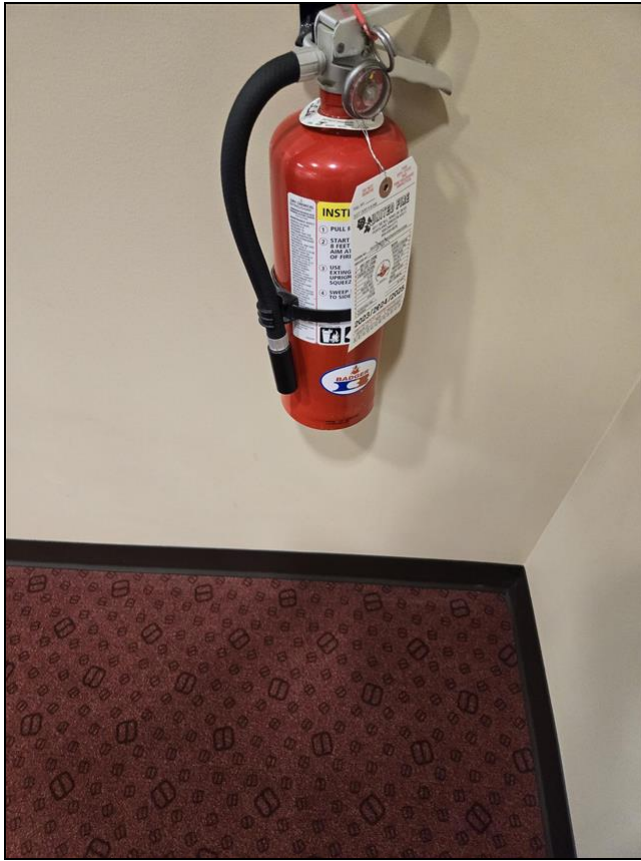
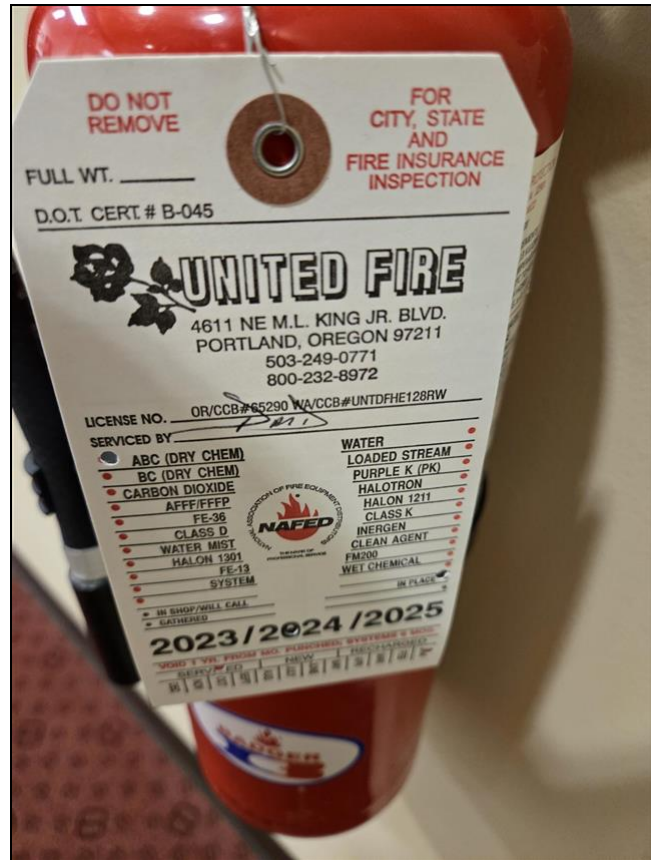
9.4 Item 1 (Picture)

No readily observable material deficiencies were noted.

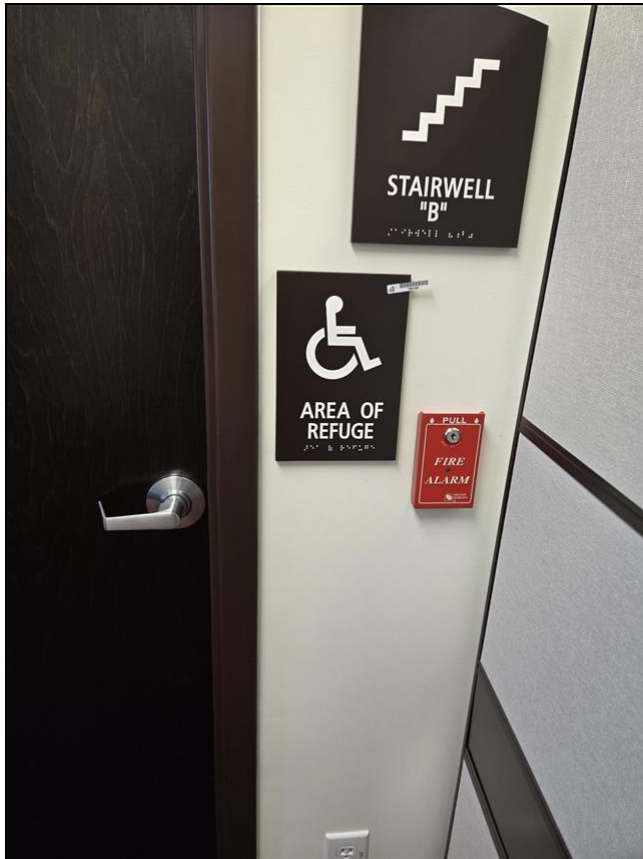
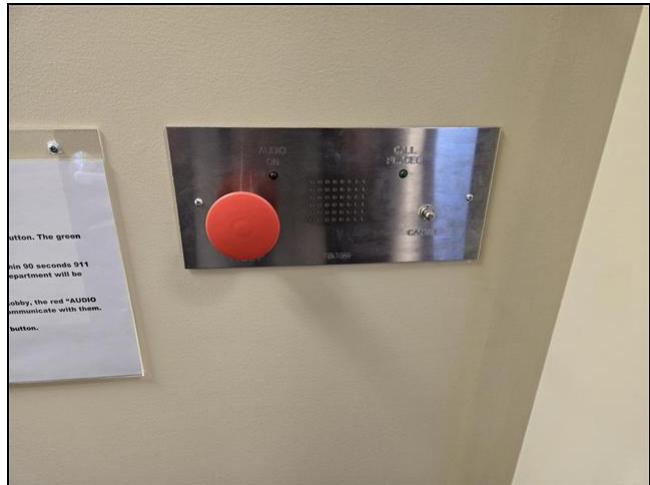
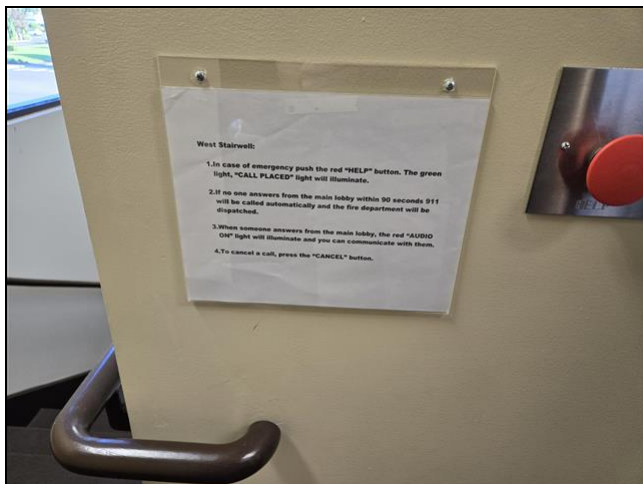
10.4 Item 1 (Picture)

Two flights of stairs were present. The primary stairs were next to the elevator. The secondary stairs were on the west (opposite) side of the building and served as an area of refuge for disabled individuals.

No readily observable material deficiencies were noted.
