INSPECTION REPORT  
Walla Walla WA 99362

INSPECTED BY  
Paul Duffau, CCPIA  
081041  
Calibre Commercial  
Inspections, LLC

INSPECTION DATE  
9/24/2022  
08:00 AM

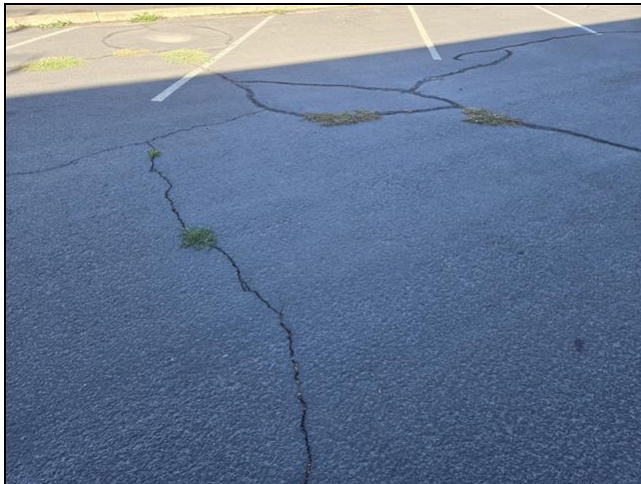
3.1 Item 1 (Picture)

(2) The asphalt surface in several locations in the lumber yard was damaged as evident by localized alligator cracking suggesting a localized structural failure of the surface and possibly the subsurface structure.. Recommend evaluation by a licensed and qualified paving contractor to determine the full scope of the necessary work.

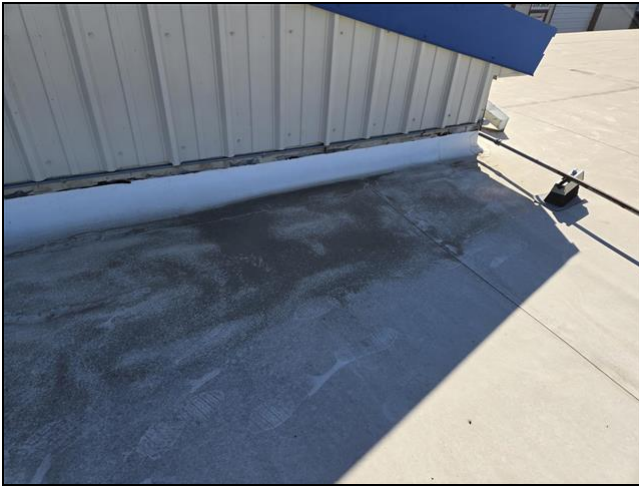
4.1 Item 3 (Picture)

Installation of the roofing appeared generally poor with substantial rippling present. While TPO products typically do have expansion/contraction properties, the size of these, on a day that was relatively moderate in temperature, suggests that the normal range of movement has been exceeded. In addition, ponding is occurring at the junction of the flat roof to the gable roof assembly. Sidewall installation was sealed with adhesives which will leak over time.

Recommend evaluation by a licensed and qualified roofing contractor to determine the best means of correction and to obtain estimates of associated costs.

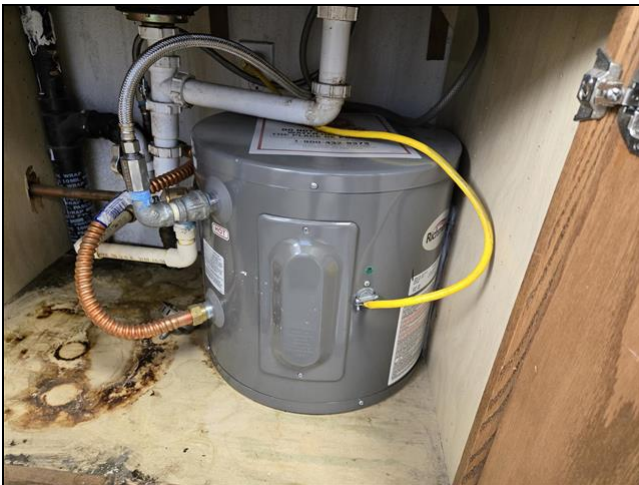
7.3 Item 2 (Picture)

(2) The break room had a small water heater manufactured by Rheem. The heater is electric and has a 6 gallon capacity.

The heater lacks the following required elements: an insulated pad under the heater; a catch pan under the heater; seismic strapping.

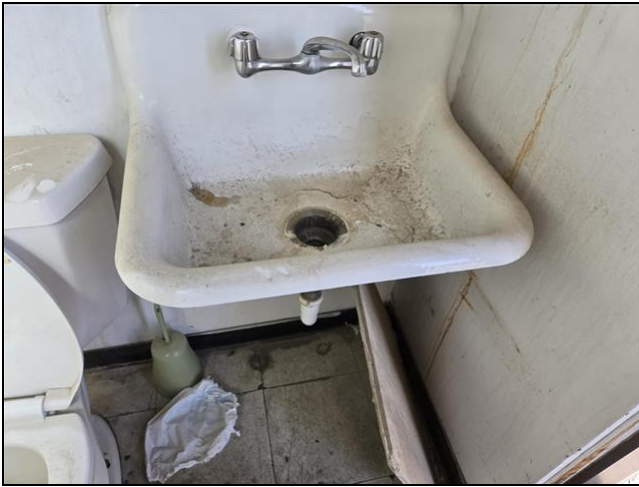
8.4 Item 1 (Picture)

None of the bathrooms were ADA accessible.

Fixtures in the outside restroom were old and overdue for upgrade.

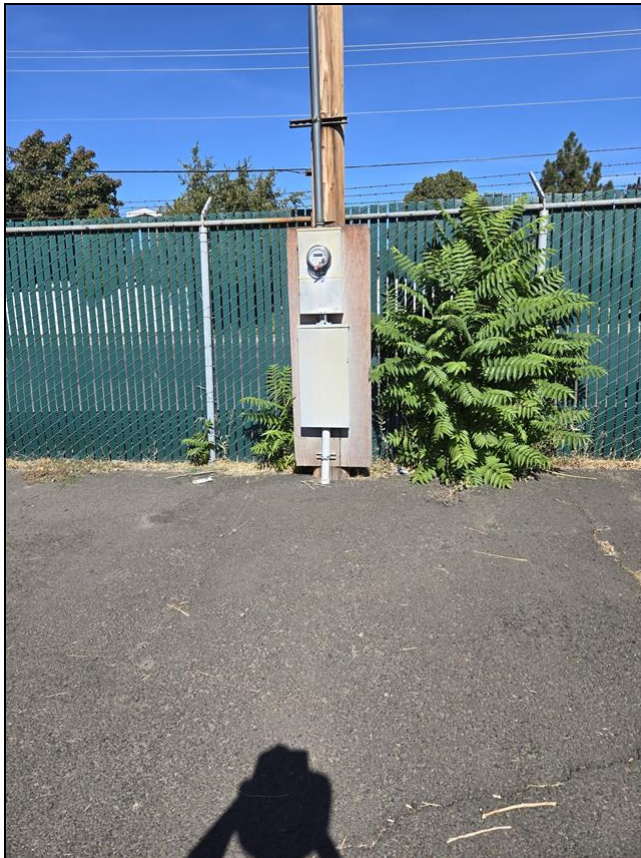
9.0 Item 1 (Picture)

(1) It appears that there are two service entrances. The first pulls from the transformers at the edge of the property and runs on a drop at the rear of the primary building. There is a box there that was locked. I think that this box holds a meter. Recommend gaining access to the panel to verify.

(2) A meter is located at a utility pole by the newer lumber rack. This panel appears to have been installed to provide power to this rack as the inspection stickers are dated at 2006/7.

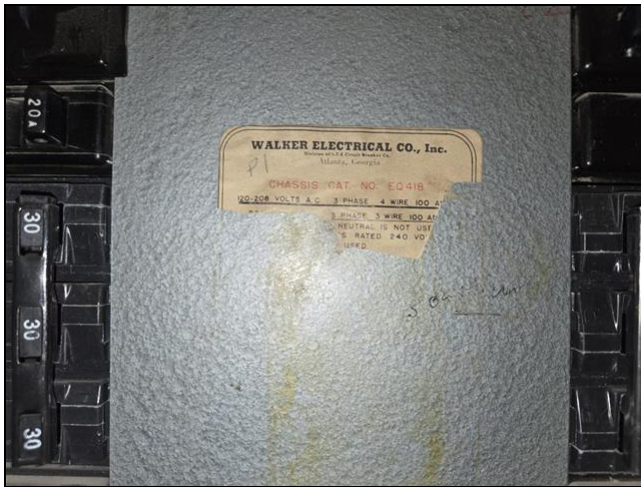
9.0 Item 3 (Picture)

(3) The delivered power appears to be three-phase, four-wire 120/240/208v based on the rating labels in the older panels. The largest amperage breaker appeared to be rated at 200 amps. However, it is possible that there is another main breaker at the location of the suspected meter. Based on the installed equipment, much of which has been permitted and inspected by the state, it appears that the total amperage may be 400 amps. Recommend accessing the locked box on the exterior to provide greater clarification.

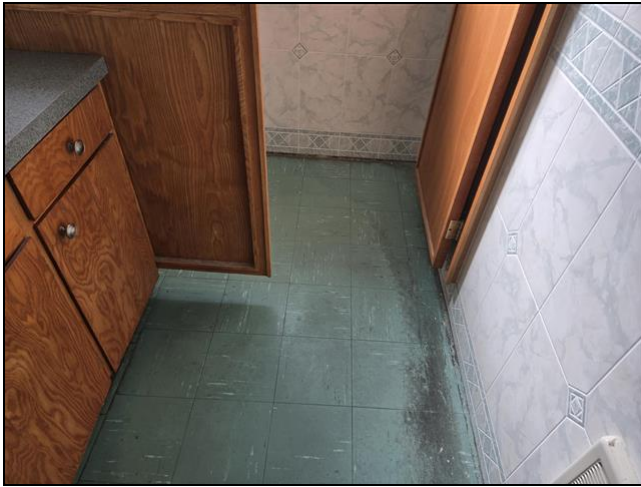
11.2 Item 1 (Picture)

The 9-inch tiles used in the women's bathroom flooring may be asbestos containing. It is not possible to determine the presence of asbestos on a visual inspection.

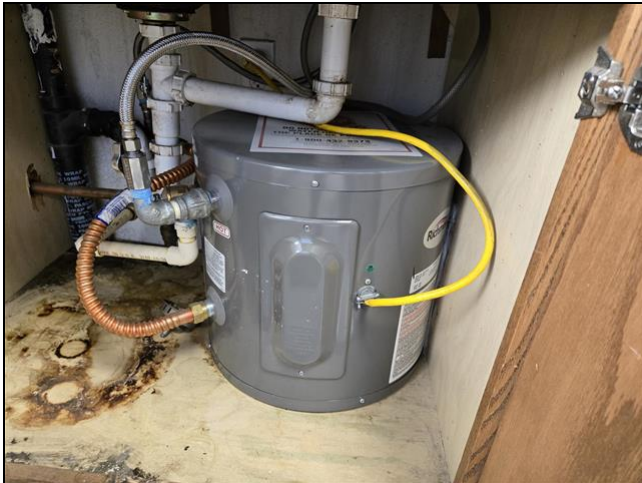
7.3 Item 2 (Picture)

(2) The break room had a small water heater manufactured by Rheem. The heater is electric and has a 6 gallon capacity.

The heater lacks the following required elements: an insulated pad under the heater; a catch pan under the heater; seismic strapping.
